# Building Inspection Report

Client: Paul Sumich - Bayleys  
Location: 127 Kiripaka Road  
Tikipunga  
Whangarei

Inspection Date: 22/07/2022

RE: Building Inspection Report, 127 Kiripaka Road, Tikipunga, Whangarei.

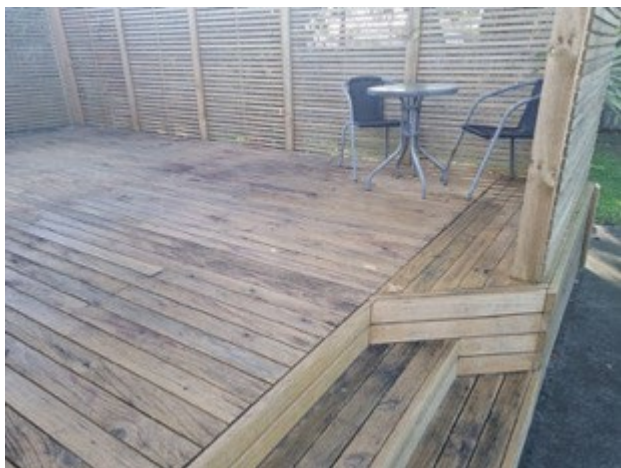
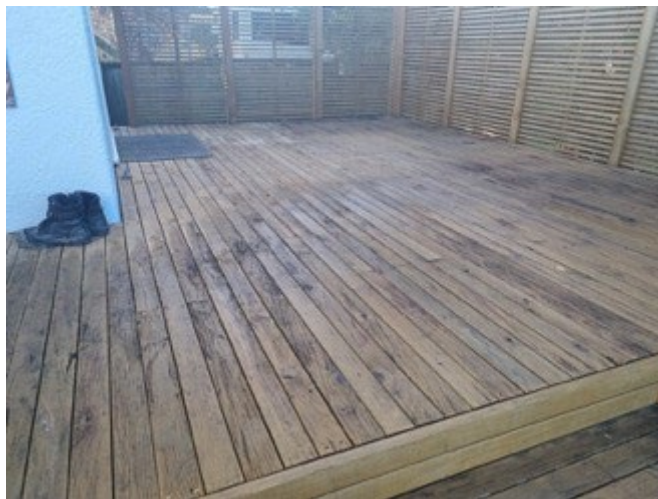
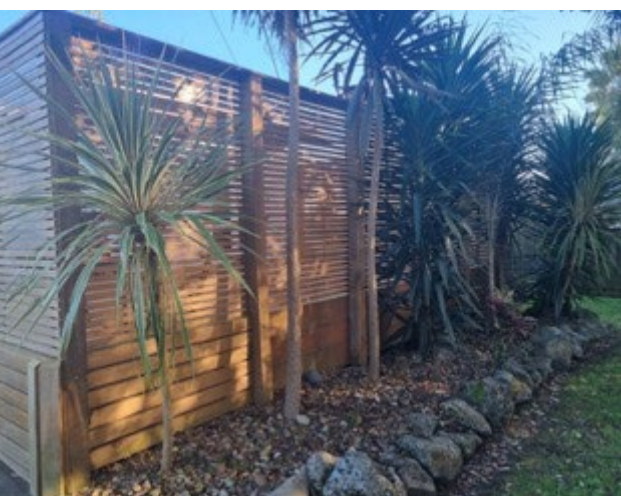
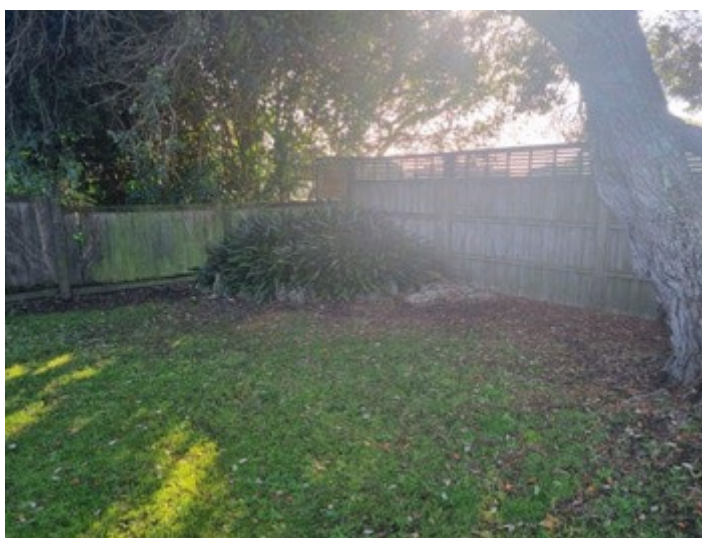
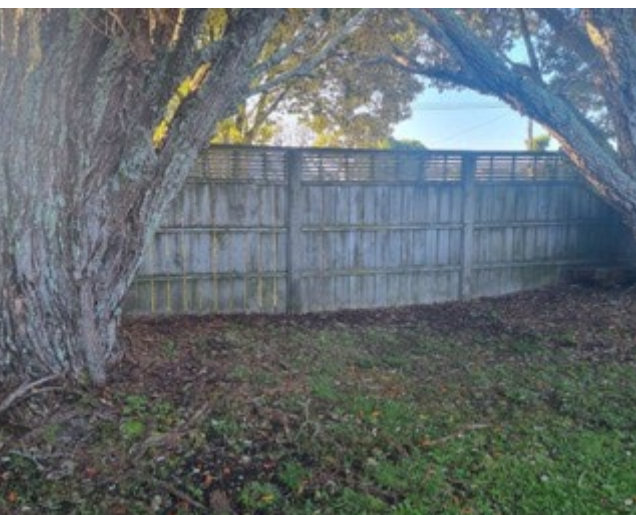
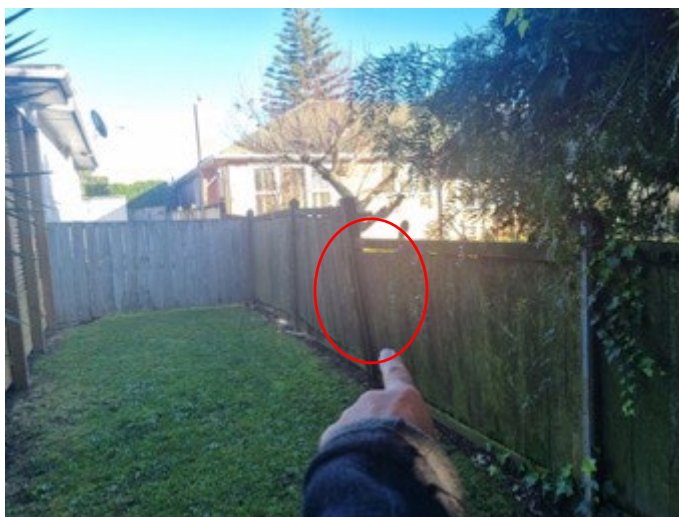
Sub framing to deck not viewed

...enance, boards showing signs of deterioration at bottom and fence leaning over.

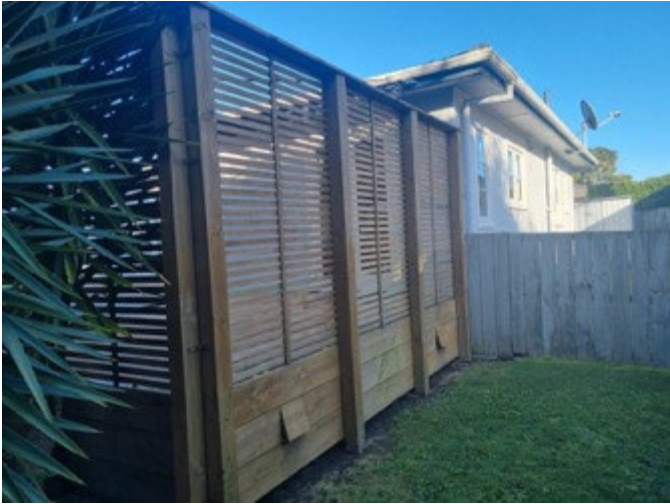
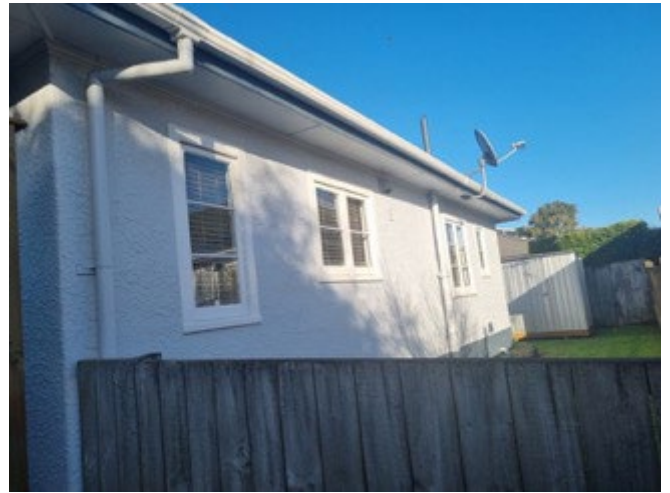
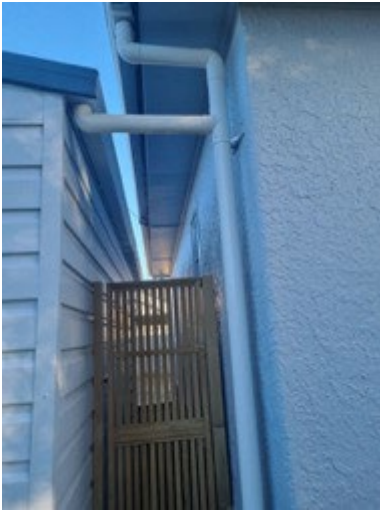
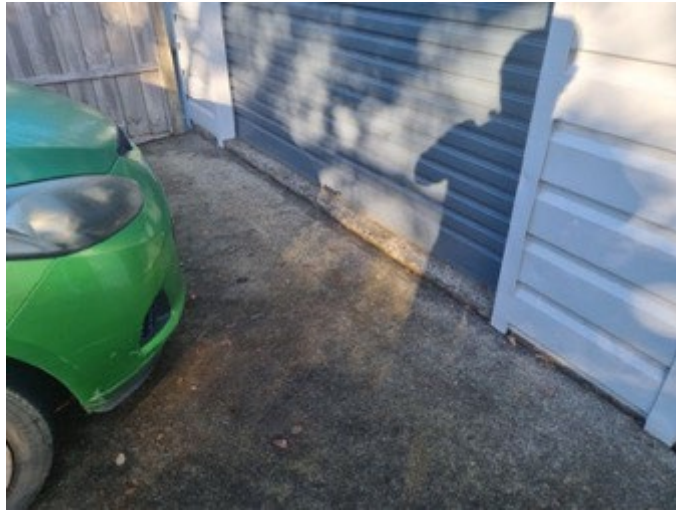
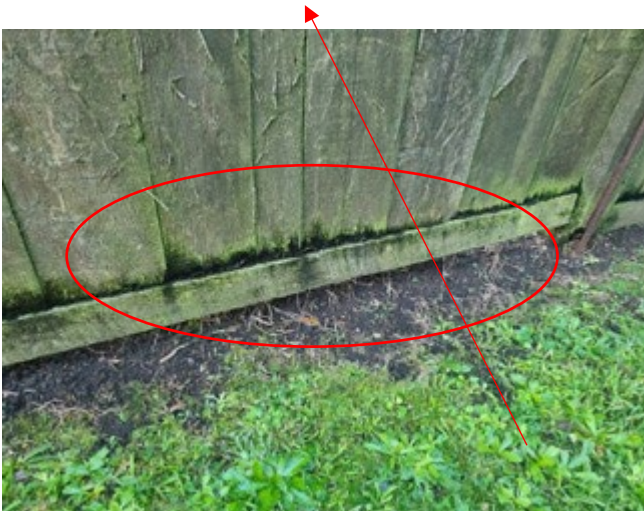
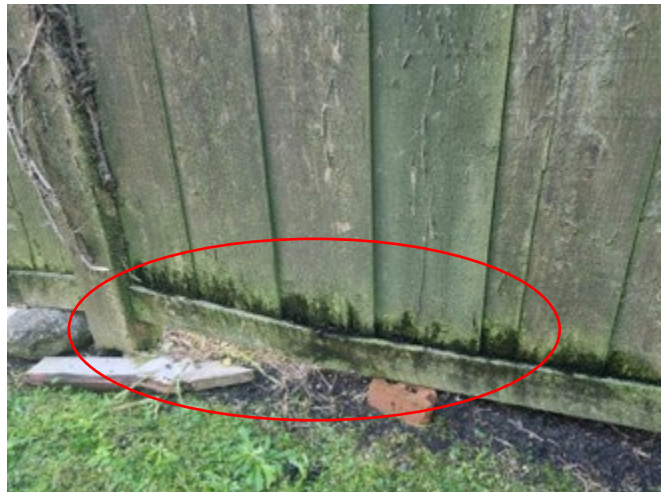
Gate requires maintenance

North side timber fencing in need of repair

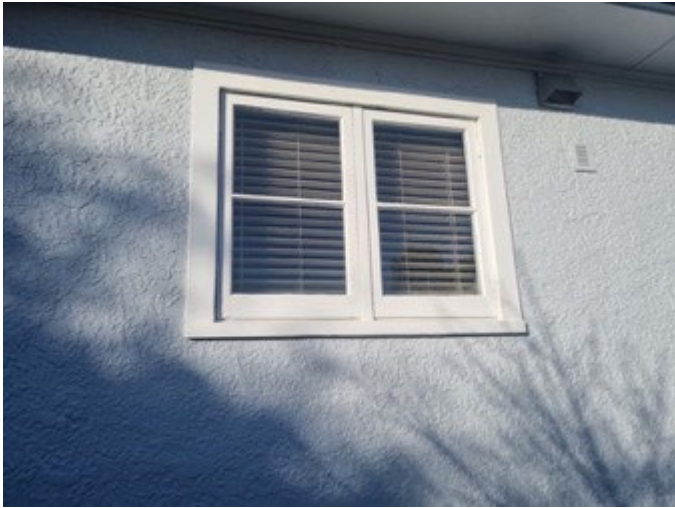
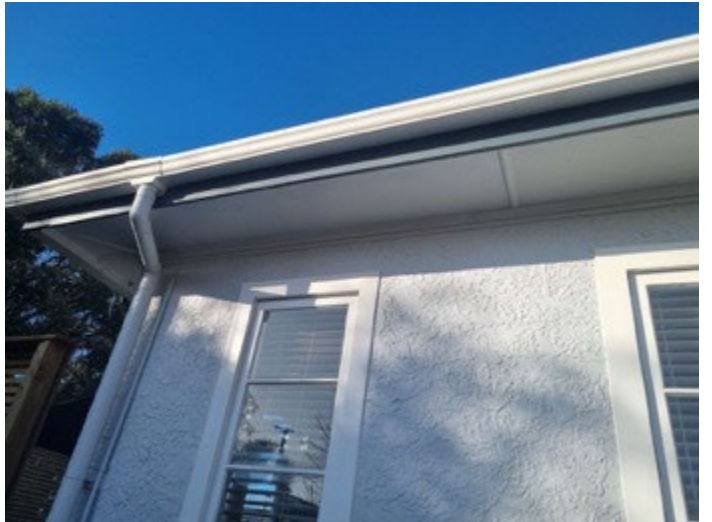
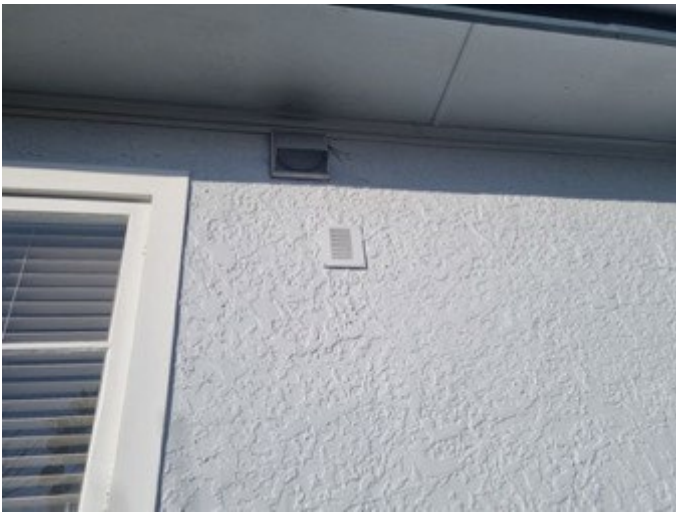
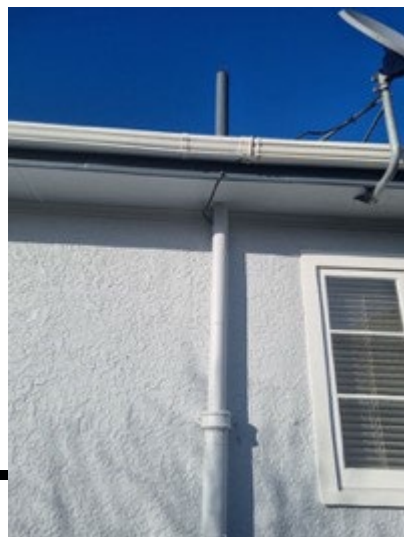
Timber joinery is in satisfactory condition.  
(Recommend regular checks and maintenance)

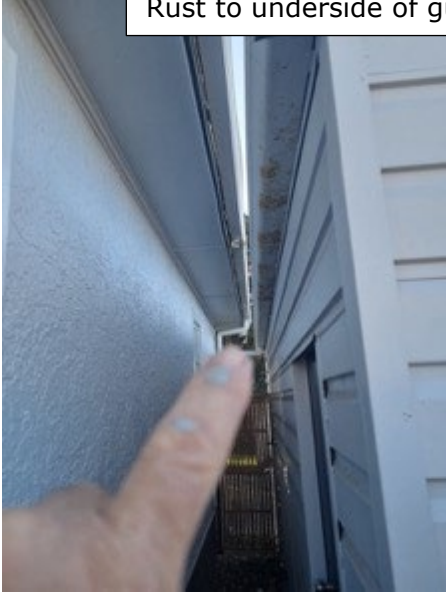
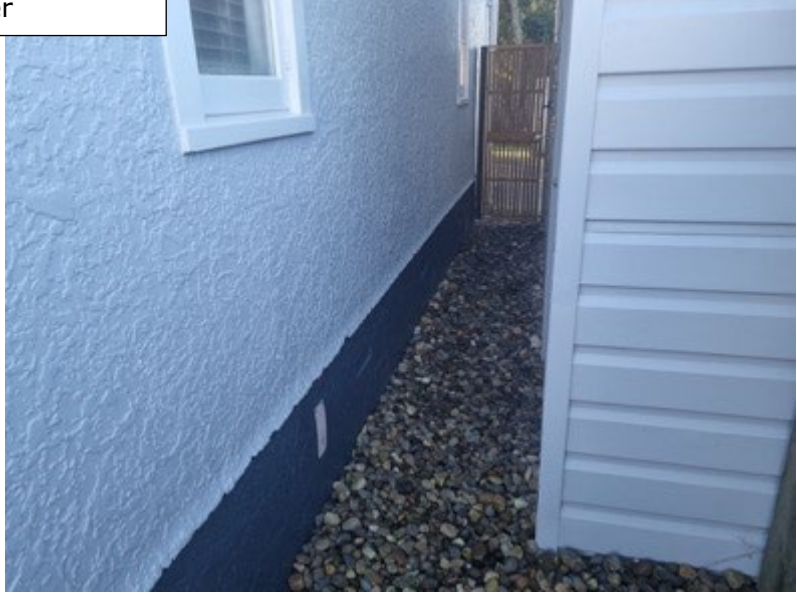
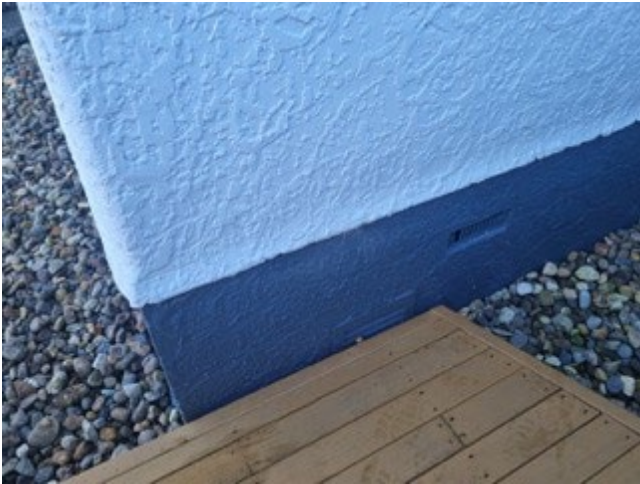
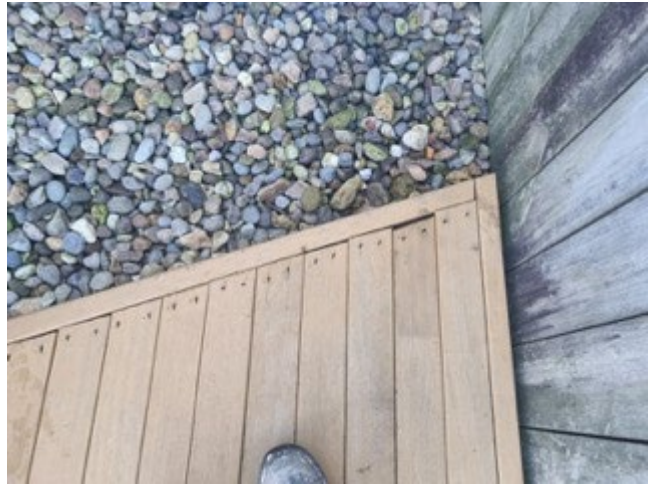
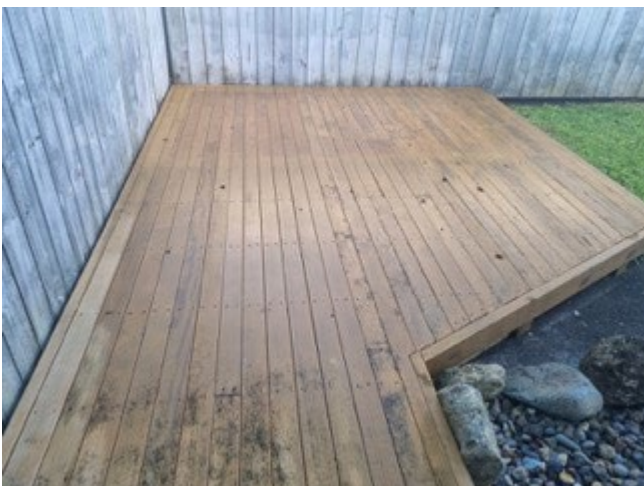
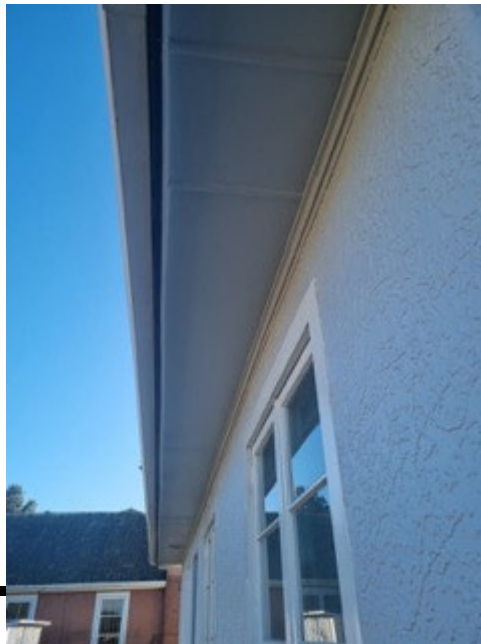
Rust to underside of gutter

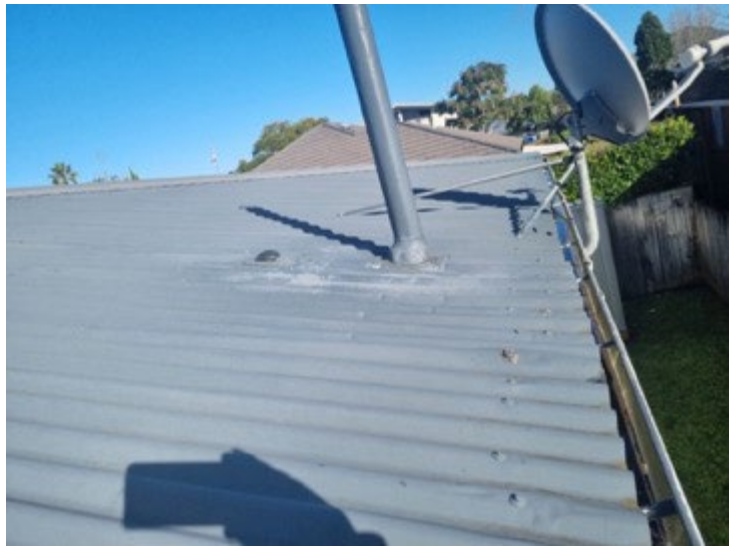
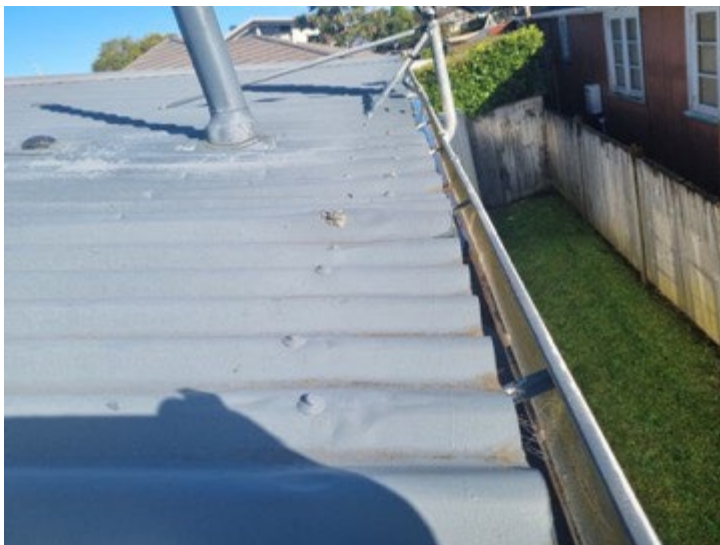
Roof cladding is showing signs of deterioration and has been leaking above the manhole area, and possible other areas. Purlins require replacement to damaged areas. (Further investigation recommended)
