## RED LBP PRE-PURCHASE REPORT

# PRE-PURCHASE BUILDING REPORT

Property Address	19 Stoneybrook Lane, Kamo, Whangarei, Northland, 0112, NZL		
Client	Roz And Richie Fitzpatrick		
Date of Inspection	6th June 2024	Time	1:30 pm
Inspector	Jamie Mackintosh Licensed Building Practitioner Brick & Block		
LBP Number	116085		
Additional Information			
People Present	Inspector, Agent		
House Occupied	Yes

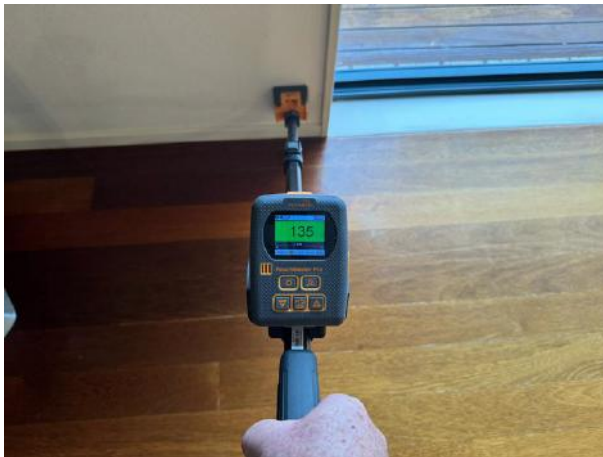
Photo 5

No elevated moisture readings at the time of inspection.

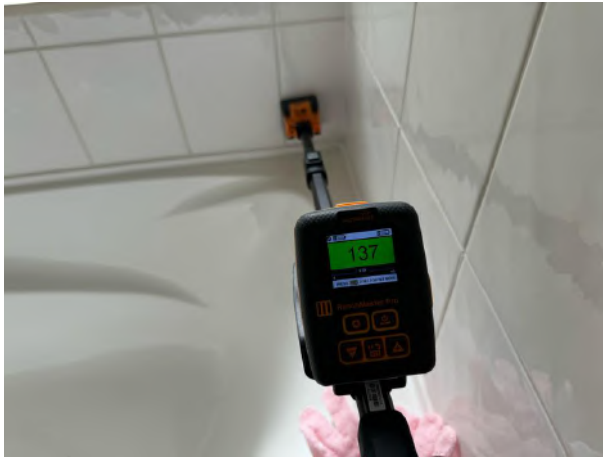
Photo 6

No elevated moisture readings around the wet areas at the time of inspection.

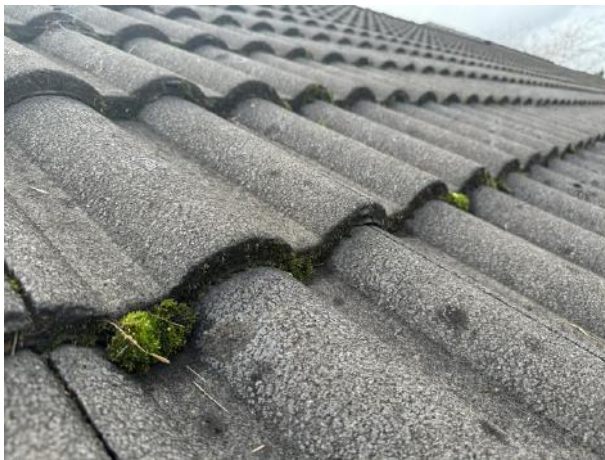
Photo 23

The roof displayed visible signs of moss, mould, or lichen growth in certain areas, and it is advised to address this issue as part of regular maintenance. Failure to do so could cause deterioration of the coating.

Patches of moss/lichen in most areas.

To ensure the longevity and performance of masonry tiles, it is important to adhere to the manufacturer's specifications and perform regular upkeep and maintenance. This typically involves following specific cleaning and sealing procedures on a regular basis. By doing so, you can protect the tiles from deterioration, staining, and other forms of damage.

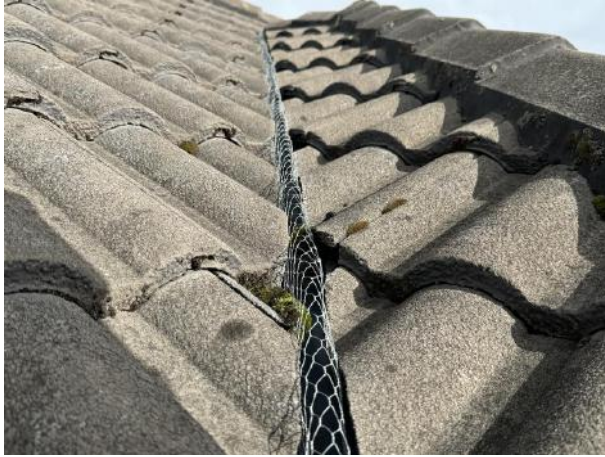
Photo 24

Example of a metal valley flashing with vermin guard. Functional.

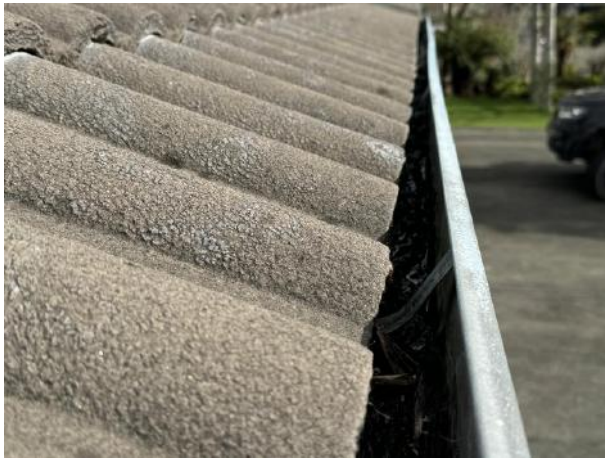
Photo 29

Example of profiled metal guttering. Clear at the time of inspection.

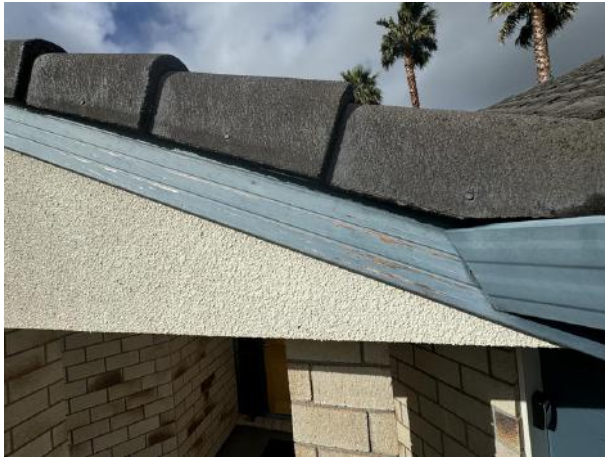
Photo 31

Paint flaking on the front door timber barge boards.

There are areas of the timber fascia that require sanding back any loose flakey paint, apply a sealer coat then redecoration to prevent further deterioration.

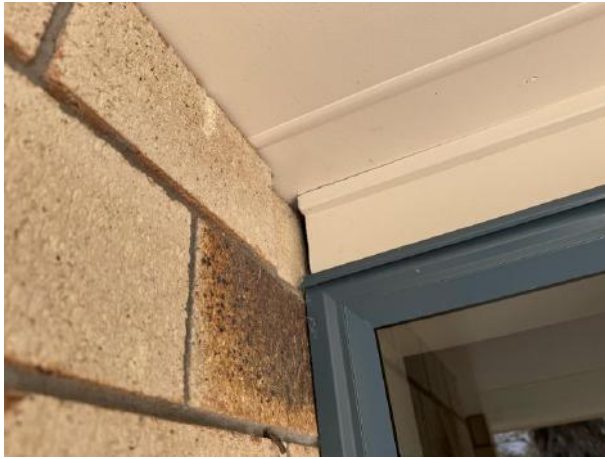
Photo 34

Loose bricks - Refer to photos.

Loose brick at the front door.

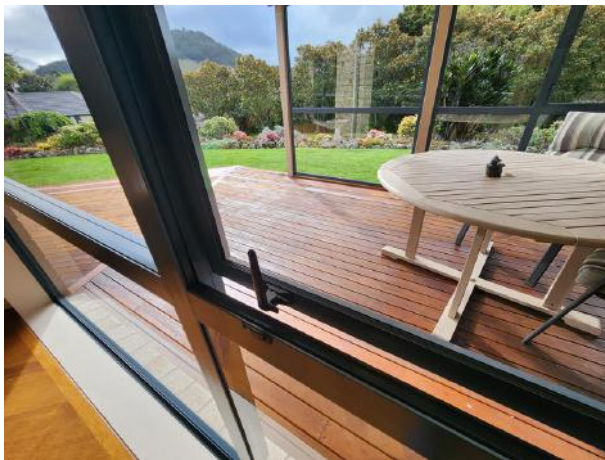
Photo 42

Living room window is out of alignment and catching on the left-hand side.

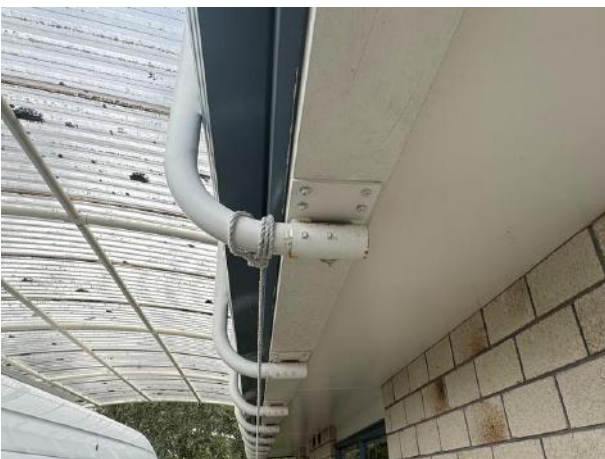
Photo 49

Metal brackets direct fixed to the soffits. Visible surface rusting to some brackets. Recommend cleaning, treating and re-painting.

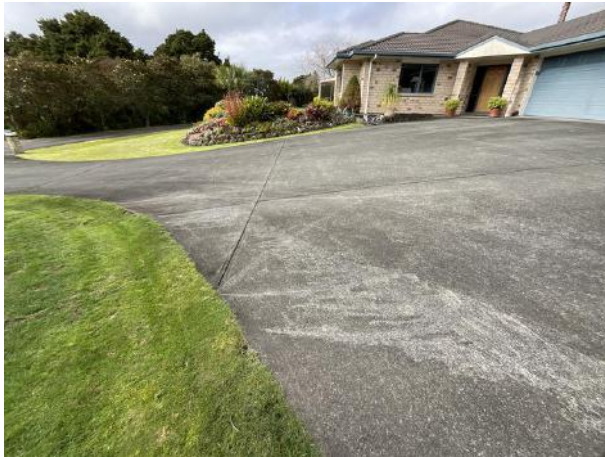
Photo 50

Cracking - Areas of cracking visible.

Concrete driveway.

General upkeep and maintenance of driveway by cleaning and keeping free of debris.

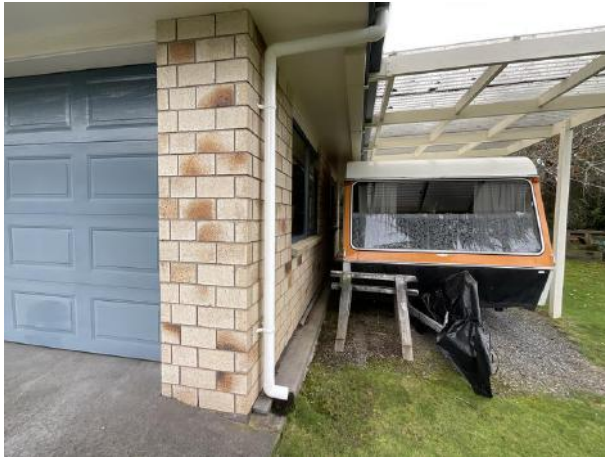
Photo 62

Stormwater from the stand-alone garage is discharging straight to the ground.

It is recommended to connect the downpipes on the garage to an approved stormwater system.

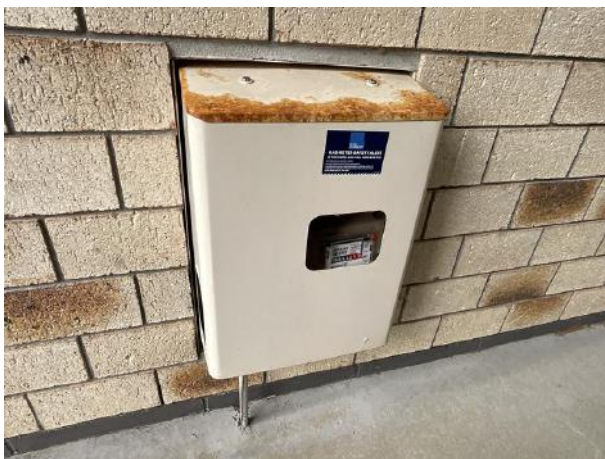
Photo 69

Gas metre located on the west side of the dwelling. Rusting to the top of the cover.
