Building Report

PRE-PURCHASE BUILDING REPORT

Property Address	57A Mill Rd, Kensington, Whangarei, 0112, NZL		
Client	Meyer Real Estate		
Date of Inspection	14th August 2023	Time	10:00 am
Inspector	Jamie Mackintosh Licensed Building Practitioner Brick & Block		
LBP Number	116085		
Inspection Type	Pre-Purchase Report		
People Present	Inspector		
House Occupied	No

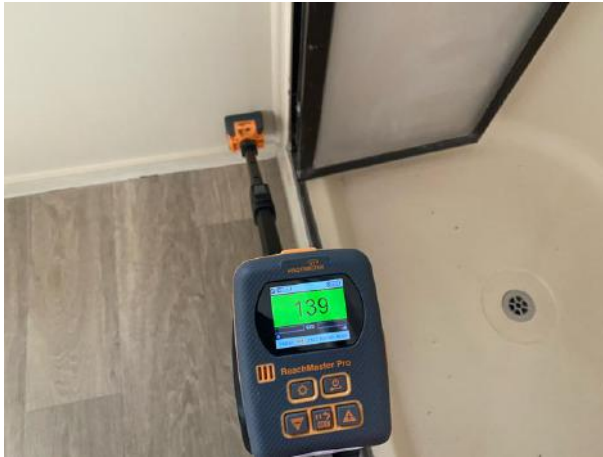
Photo 5

No elevated moisture levels at the time of inspection.

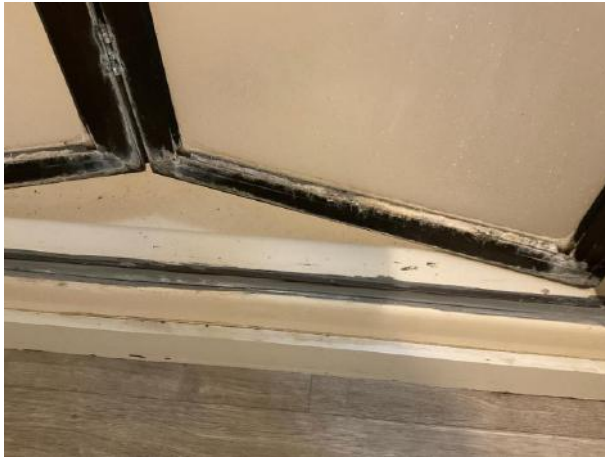
Photo 20

Areas of oxidation visible on the bottom of the shower door.

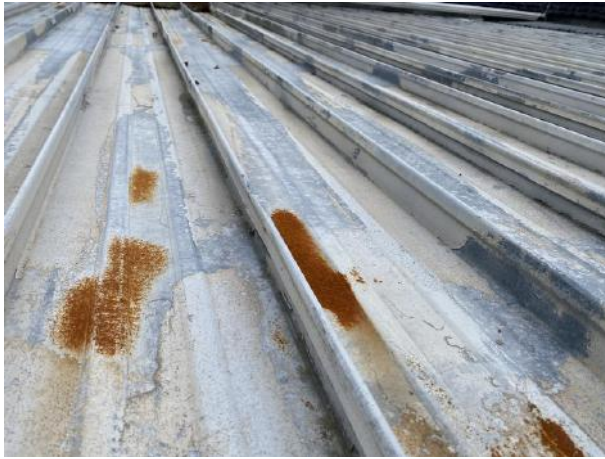
Photo 28

Paint coating has worn in most areas. Visible areas of corrosion on the carport/studio roof. Recommend cleaning and painting.

Recommend cleaning and painting the profiled metal roof over the carport/studio roof.

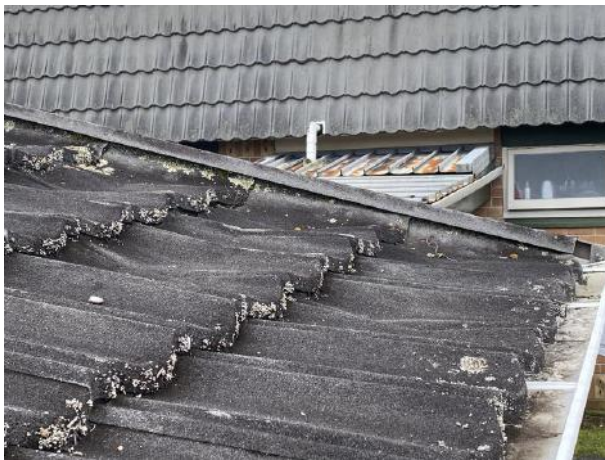
Photo 29

Example of dented tiles throughout the roof.

Dented tin tiles should be repaired or replaced. The dents will deteriorate the tile's coating, which can cause ponding of water and worst case leaks may occur. Have an LBP in roofing undertake any repairs & maintenance outside of the homeowner's skill level.

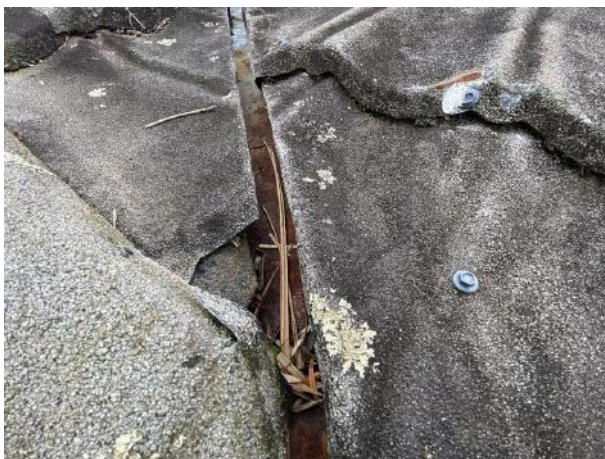
Photo 33

Visible rust in the bottom section of the valley flashing on the west facing roof.

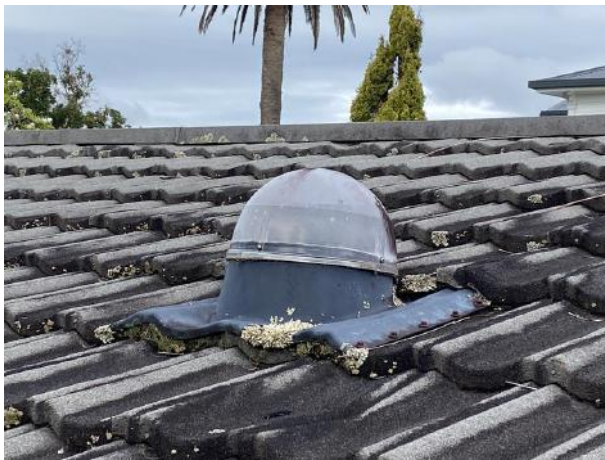
Photo 35

Solartube with metal flashing. Visible rust to the fixings.

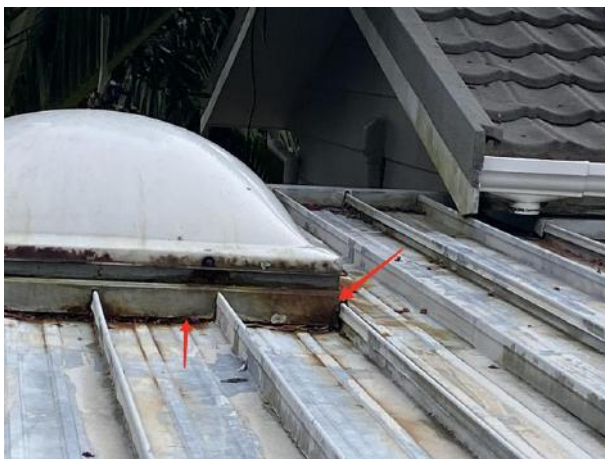
Photo 36

Visible rust on the studio skylight flashings. Recommend having an LBP in roofing report on the repairs/maintenance required.

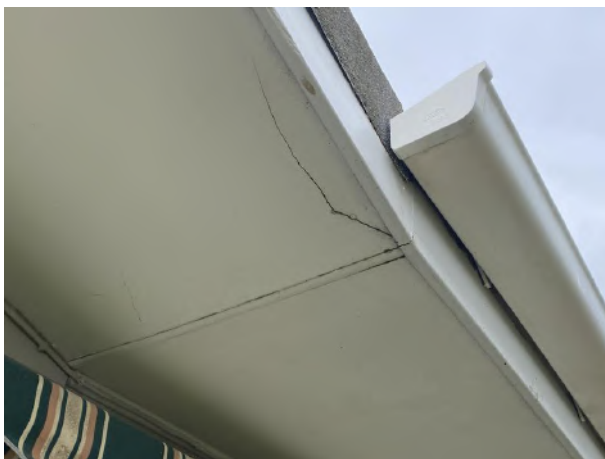
Photo 39

Crack in the soffit board on the west side.

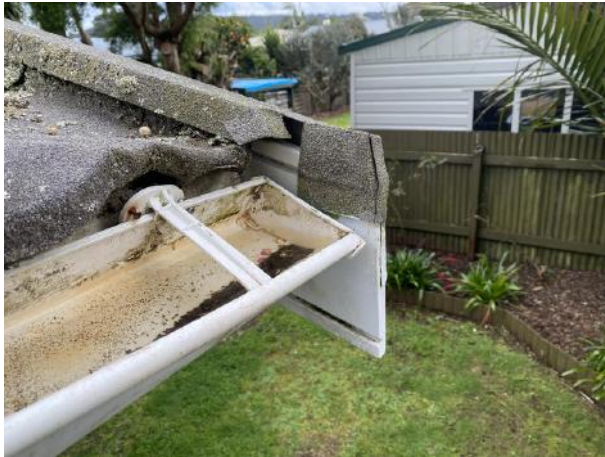
Photo 40

Guttering bracket has pulled out of the soffit on the northwest corner. Visible rot on the fascia board where the bracket was sitting.

Recommend re-fixing the spouting brackets where required.

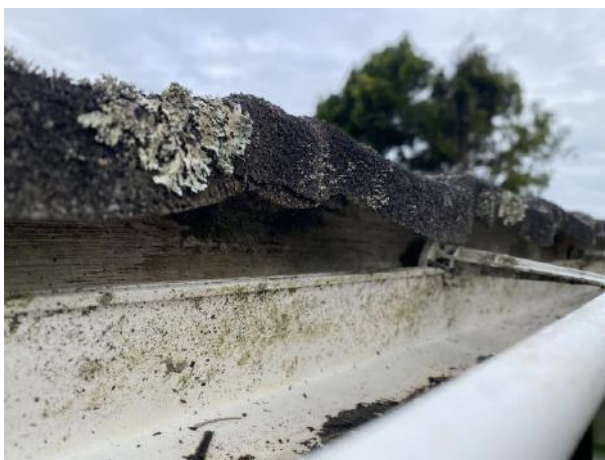
Photo 41

Some brackets on the north side have pulled out. Recommend re-fixing.

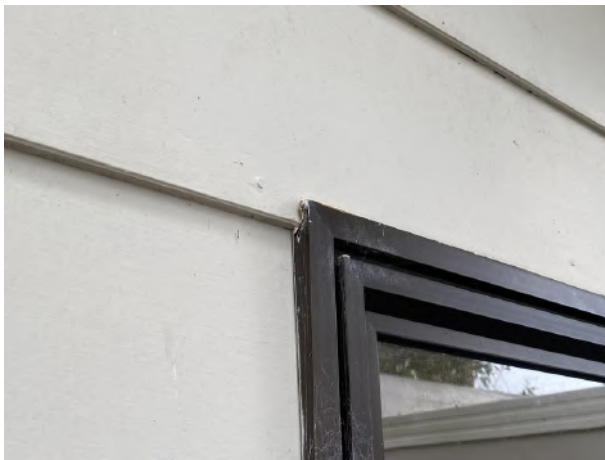
Photo 53

Example of typical aluminium joinery detail. No head flashings.

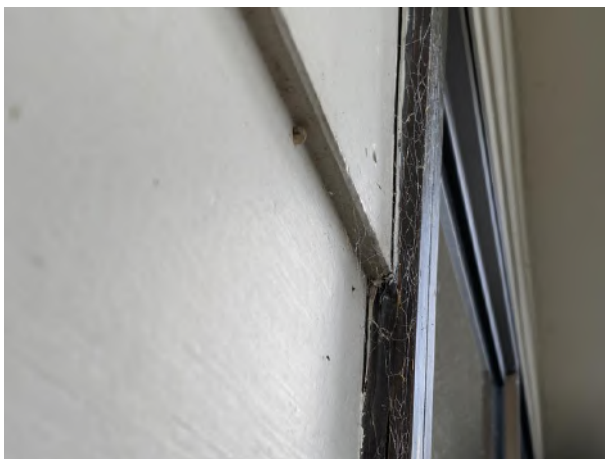
Photo 54

Rubber seal between the window and cladding is showing signs of deterioration. Recommend installing scribes to maintain weather-tightness.

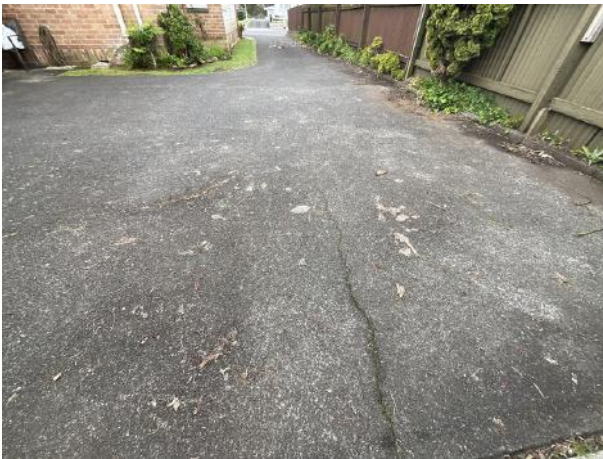
Photo 55

Shared concrete driveway with visible cracking.

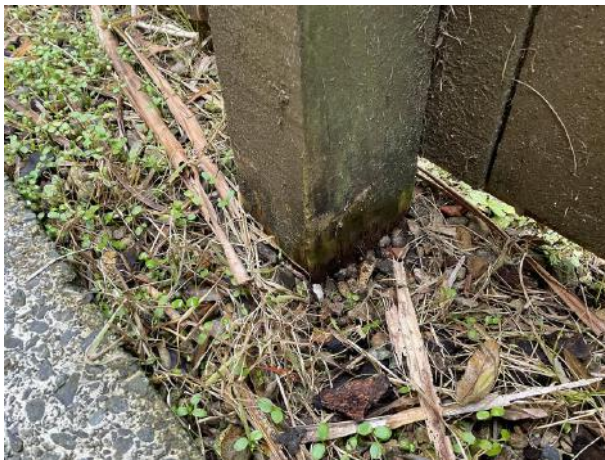
Photo 61

Visible rot on the bottom of the timber posts on the eastern boundary fence.

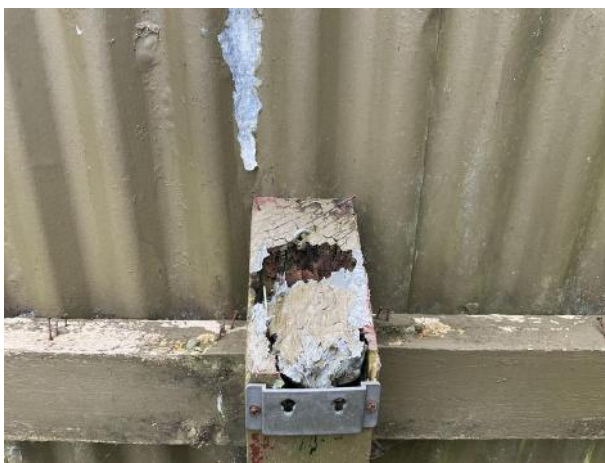
Photo 64

Timber post on the western boundary, has visible rot on the top.

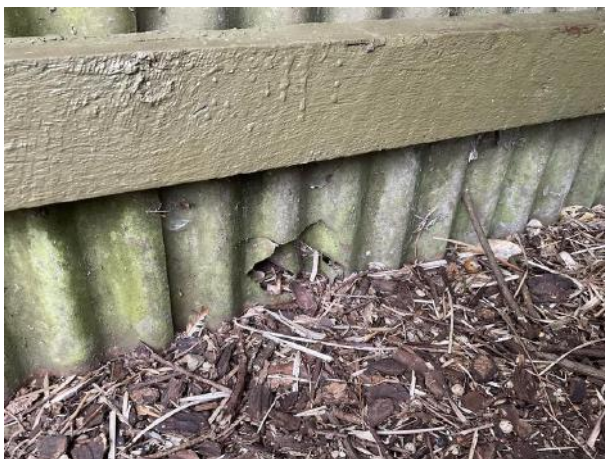
Photo 65

The western boundary fence has a hole in the iron, on the northeast corner.

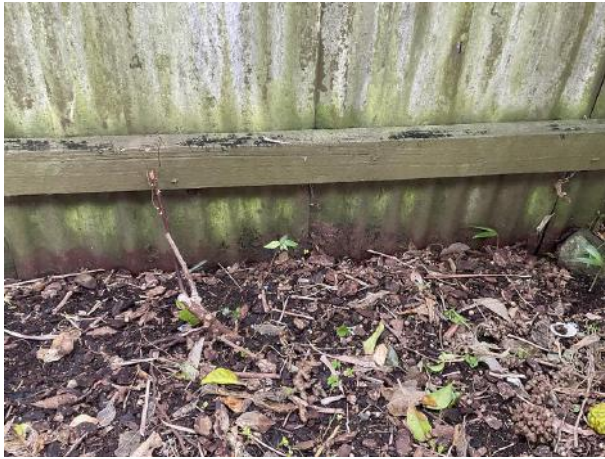
Photo 66

Visible rust along the bottom of the iron on the southern boundary fence.

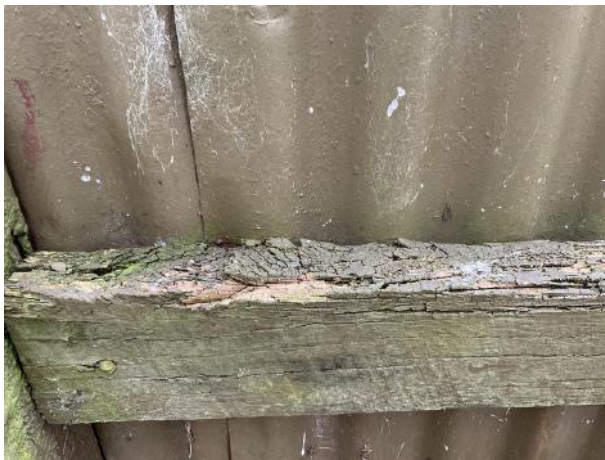
Photo 67

Visible rot in the railing timbers on the southern boundary fence.

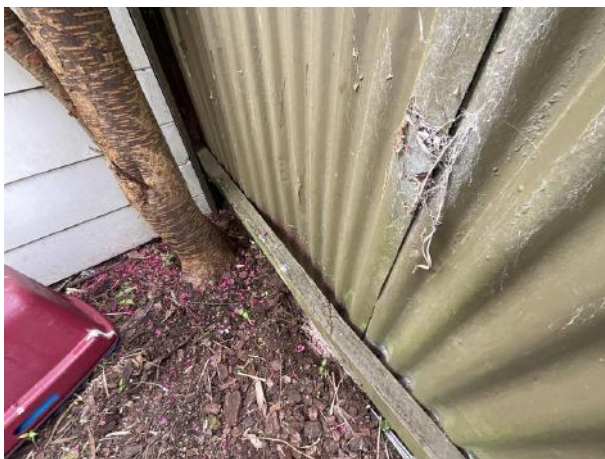
Photo 68

Iron on the southern boundary fence has come away from the bottom timber railing by the carport external door.

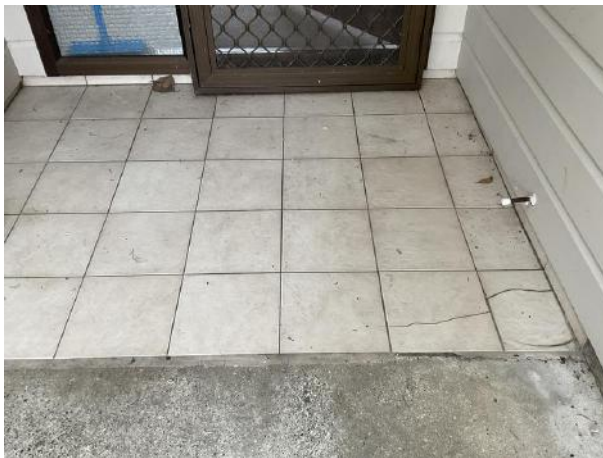
Photo 70

Tiled front door entry. Visible cracking in the tiles.

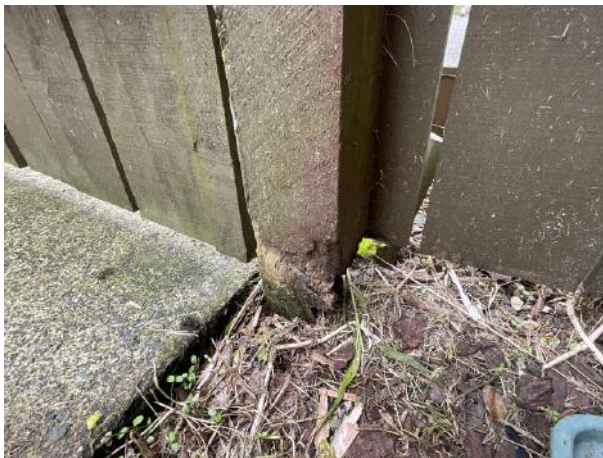
Photo 74

The post the gate latches onto has visible rot at the bottom.

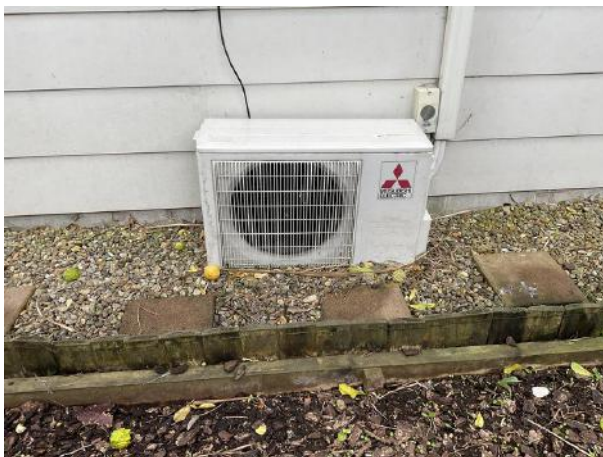
Photo 79

Outdoor heat pump unit located on the south side of the house. Recommend clearing the shingle away from the unit as this will cause deterioration.
