# Building Inspection Report

Client: Paul Sumich - Bayleys  
Location: 74 Cartwright Road  
Onerahi  
Whangarei

Inspection Date: 09/08/2022

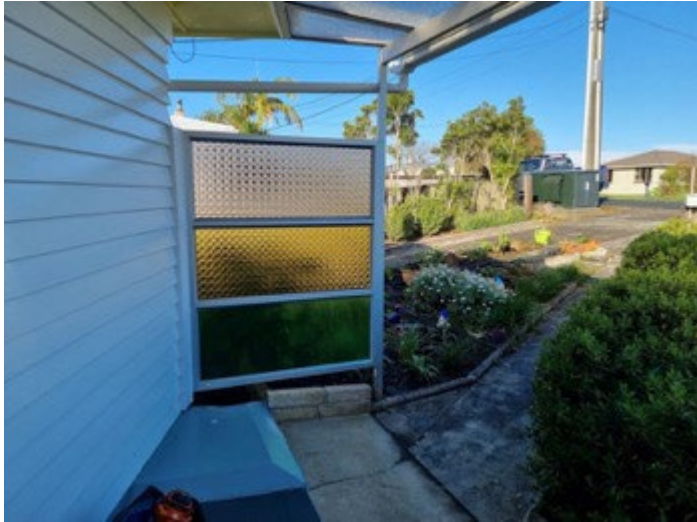
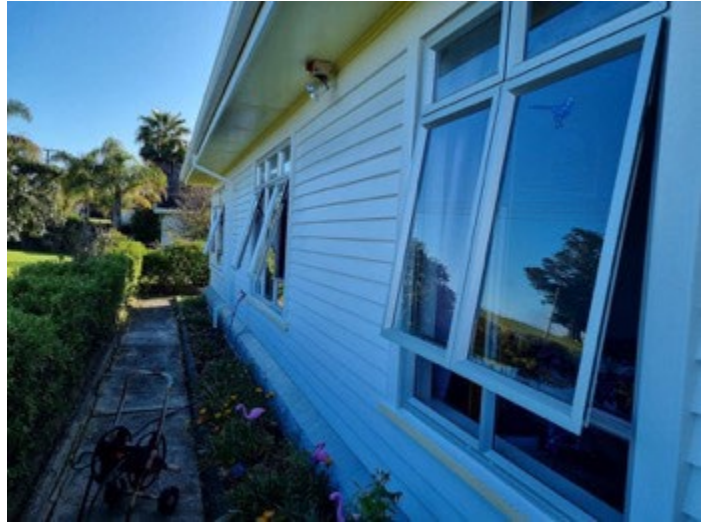
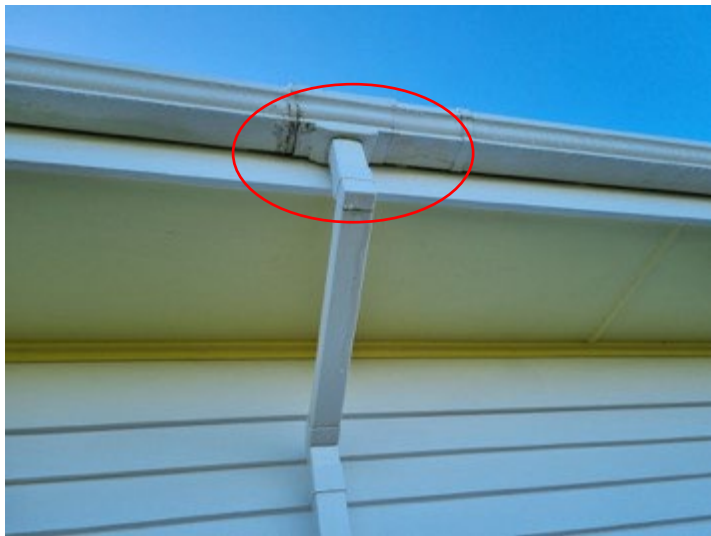
Westside of the house the roof spouting has leaky junction

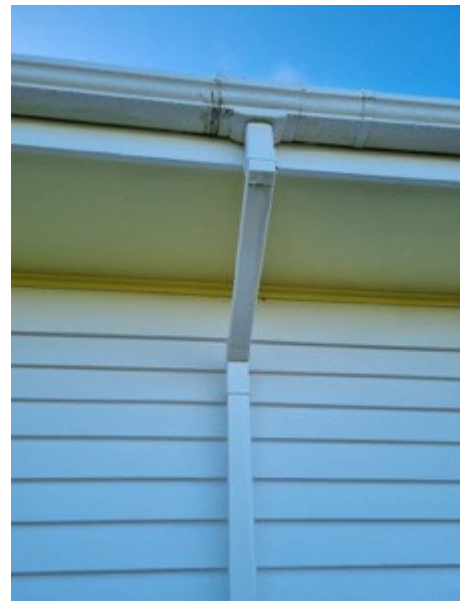
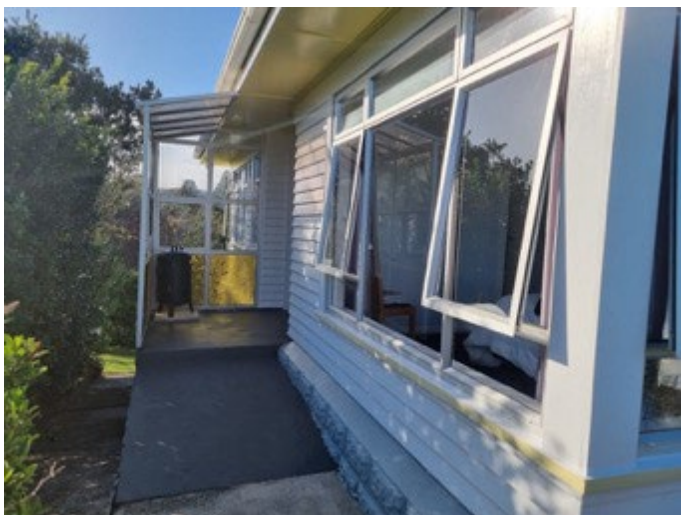
Paint is bubbling in soffit in a couple of areas as per photos

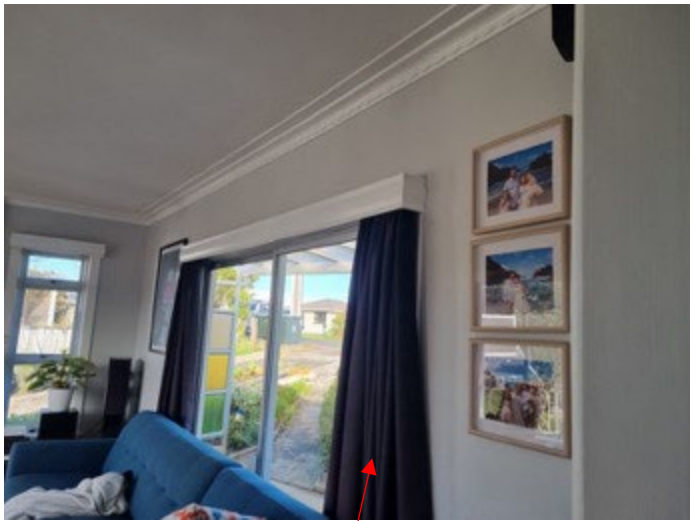
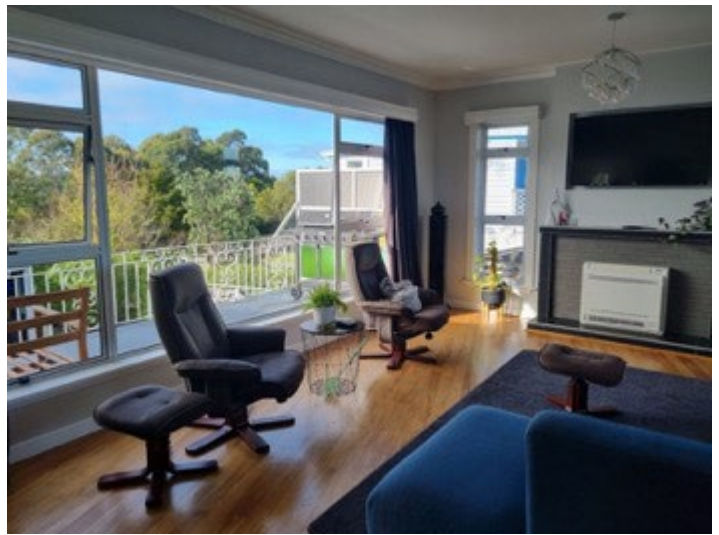
No access on left for moisture reading.

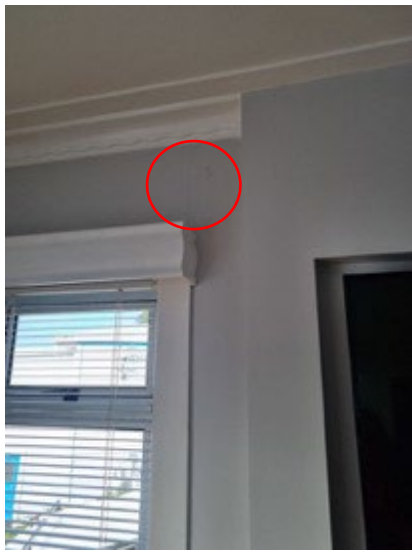
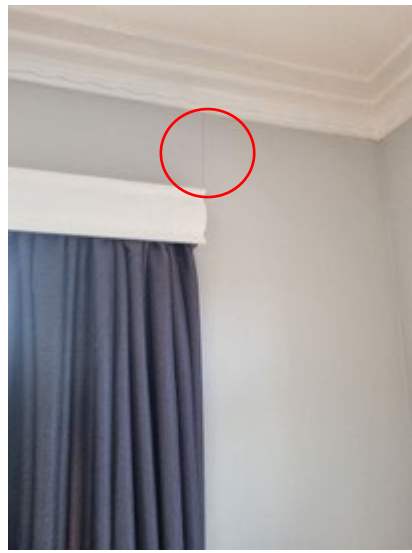
Walls has minor cracks in the gib (or alike) through out

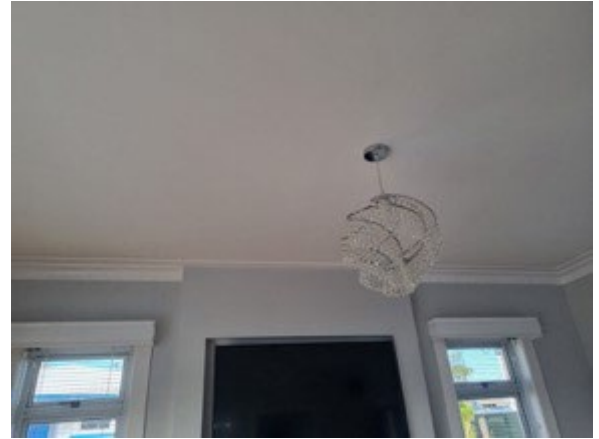
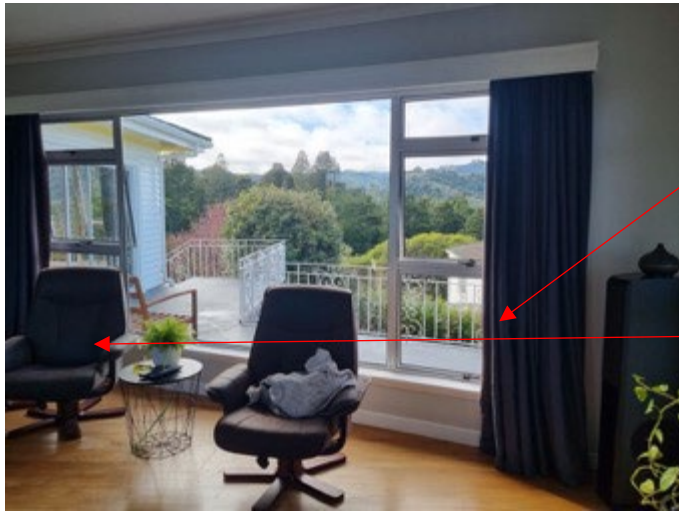
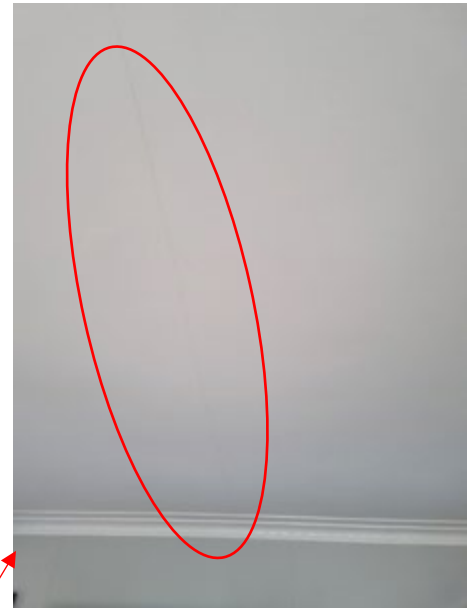
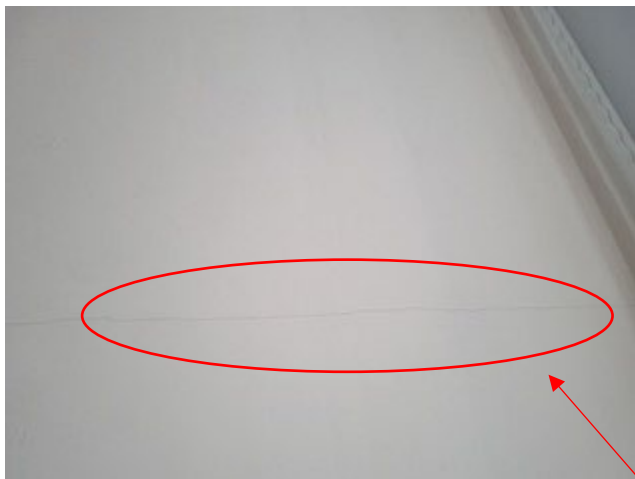
Ceiling has minor cracks in the fibrous plaster throughout due to possible movement over the years

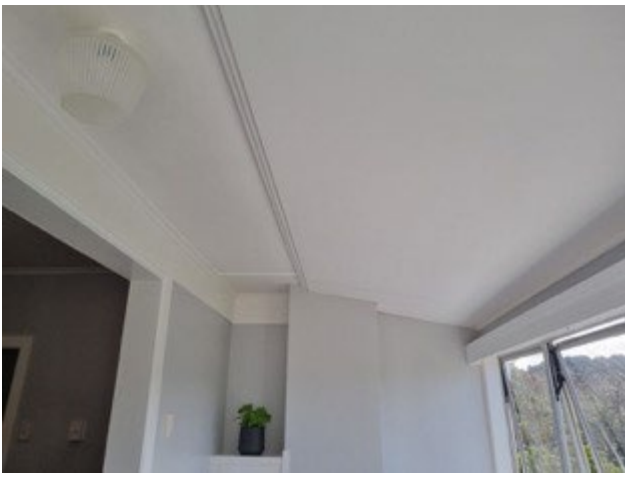
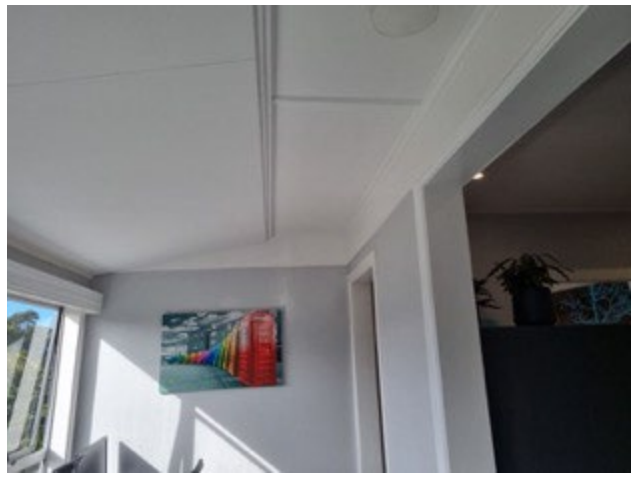
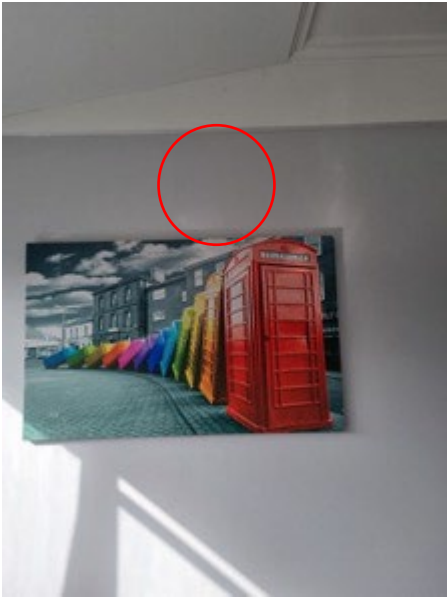
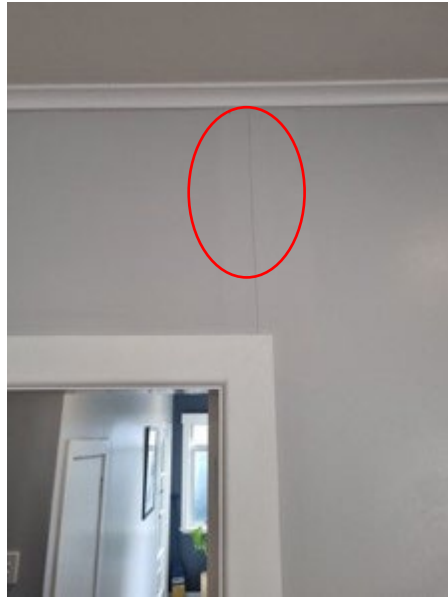
Walls have minor cracks in the gib plaster (or alike) throughout

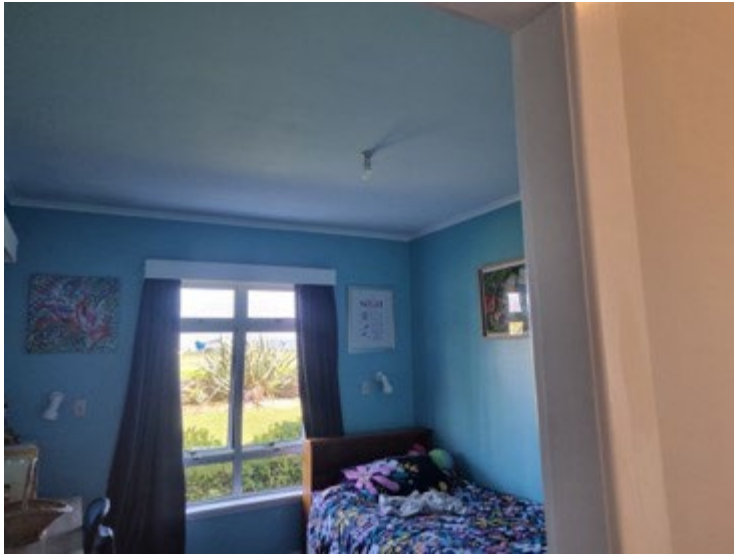
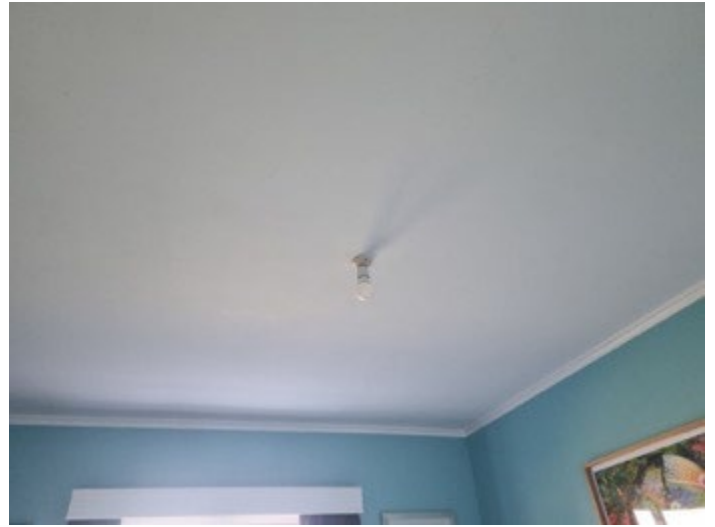
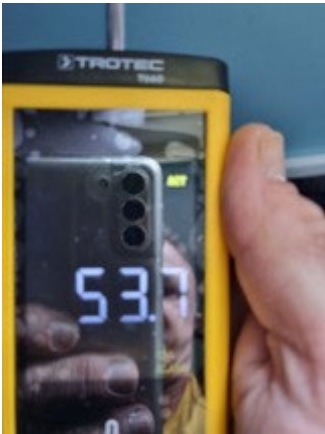
# Bedroom 1

No access on the right for moisture reading.

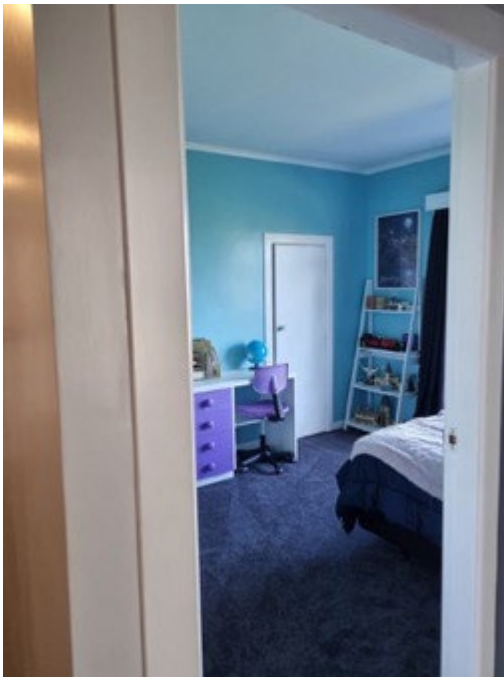
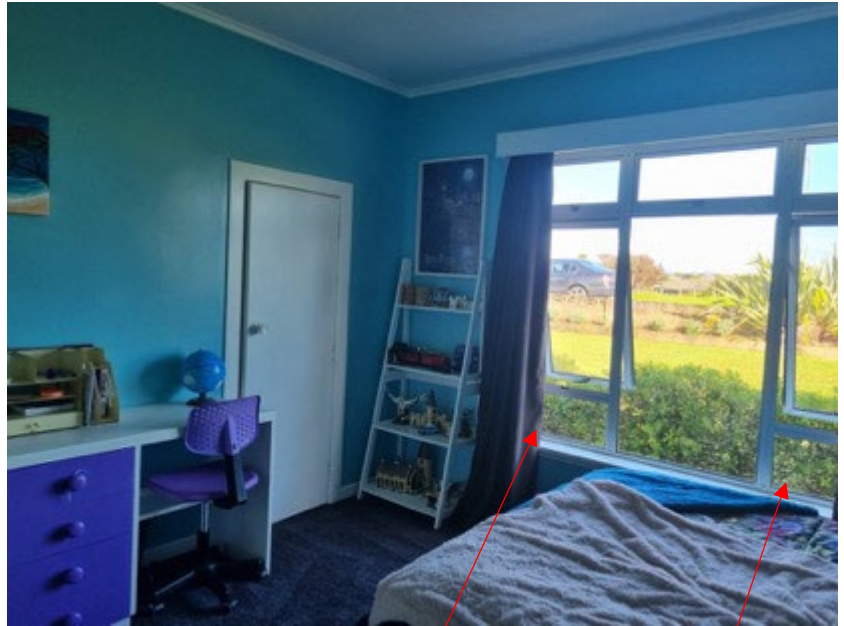
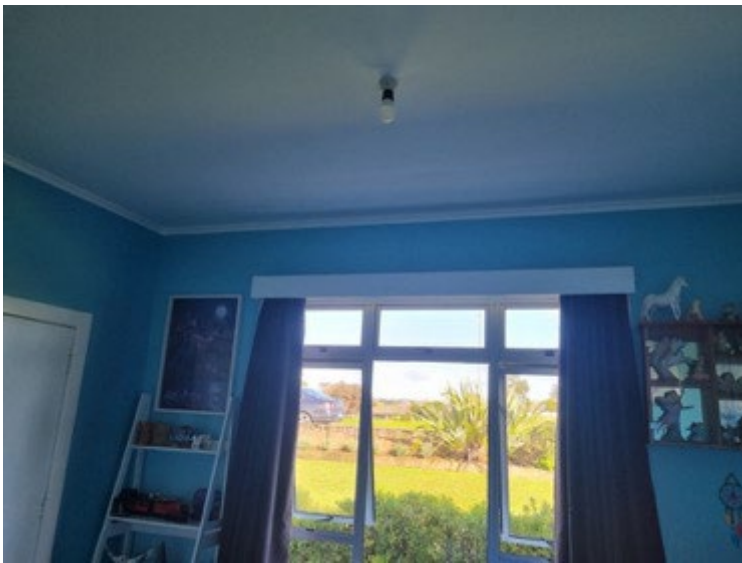
## Bedroom 2

Bedroom 2 has a high moisture meter reading to the right had side. Further investigation recommended

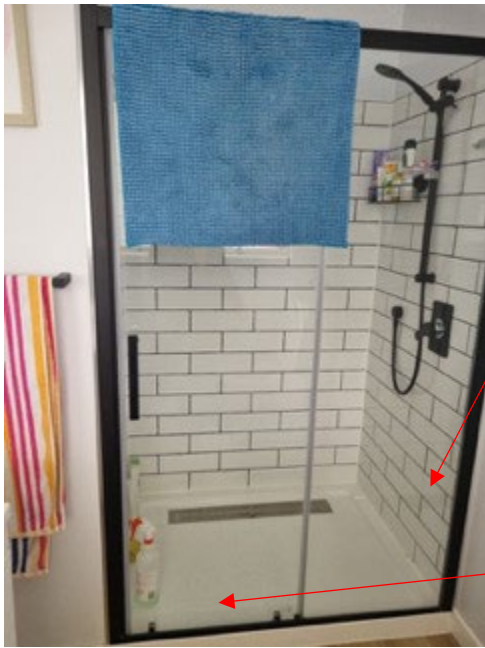
High moisture reading

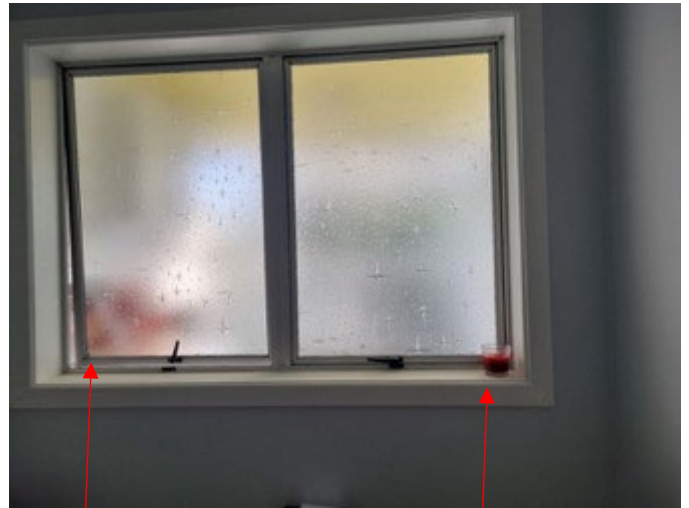
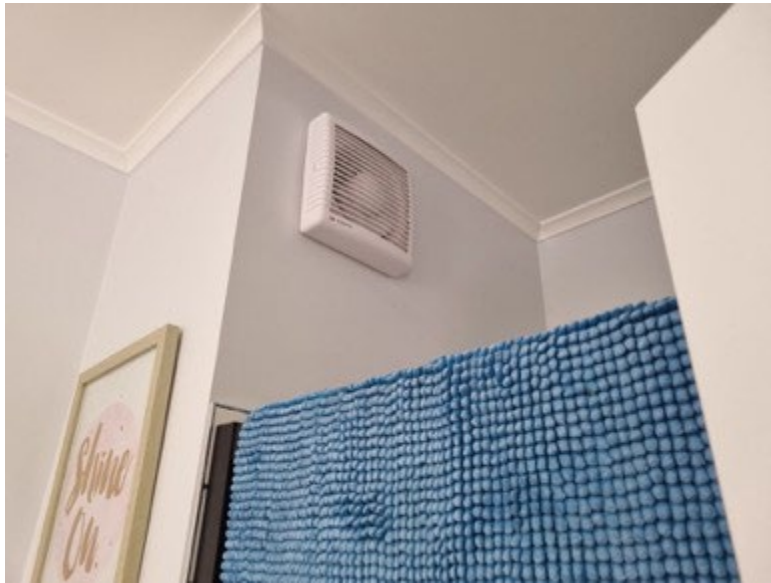
Joinery windows in ensuite & main bathroom are having trouble opening/closing

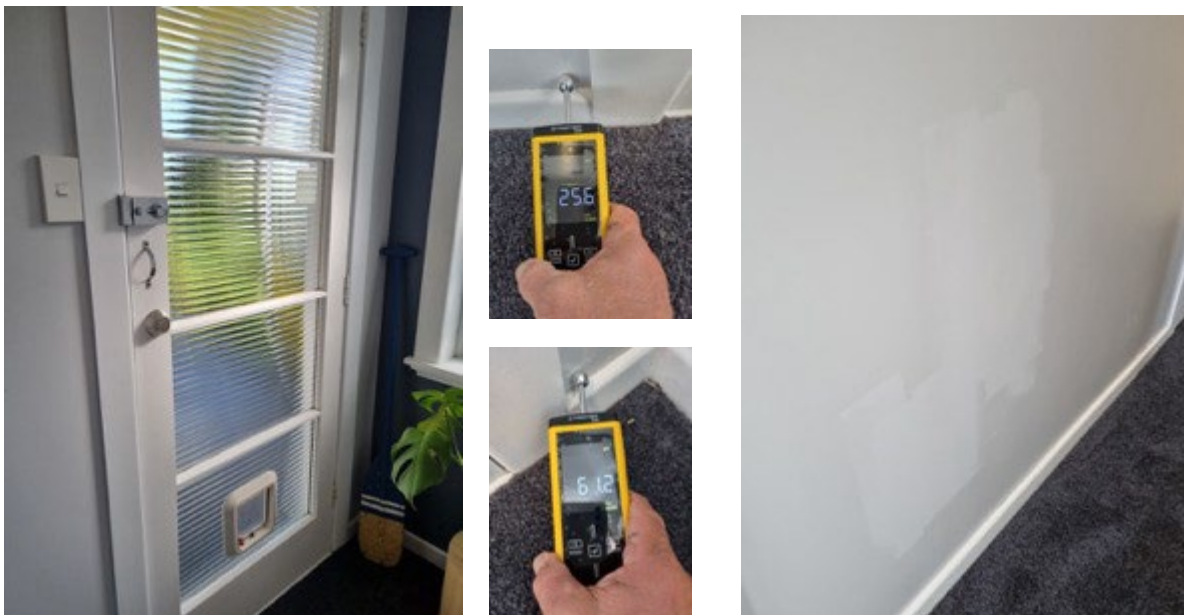
## Backdoor

Hallway back door and hall door need shaving, so they close nicely

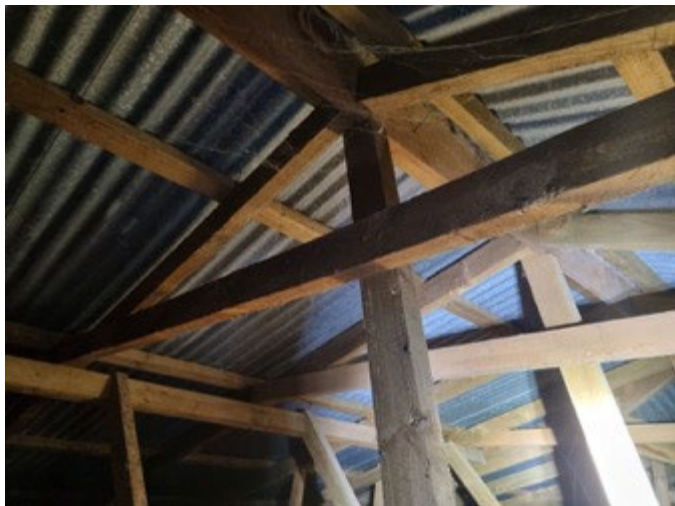
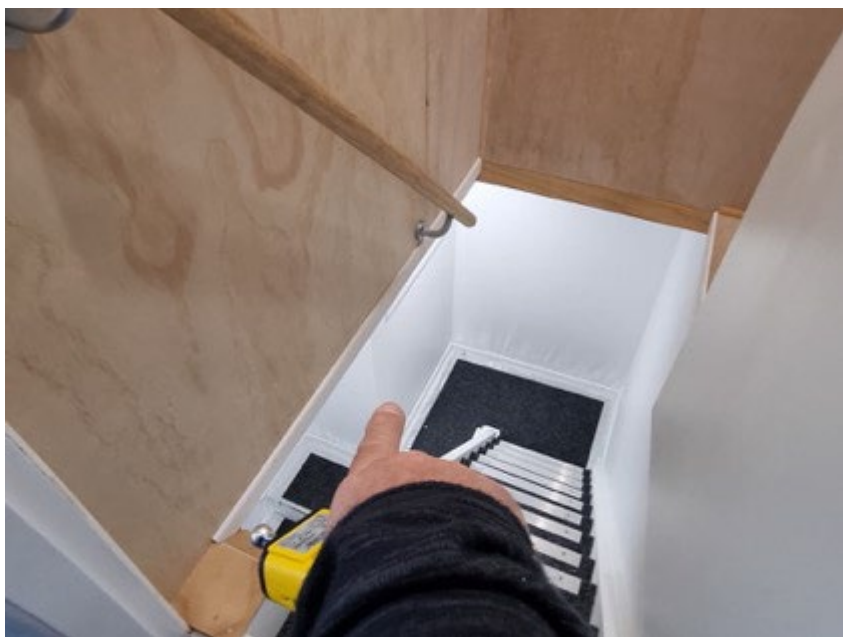
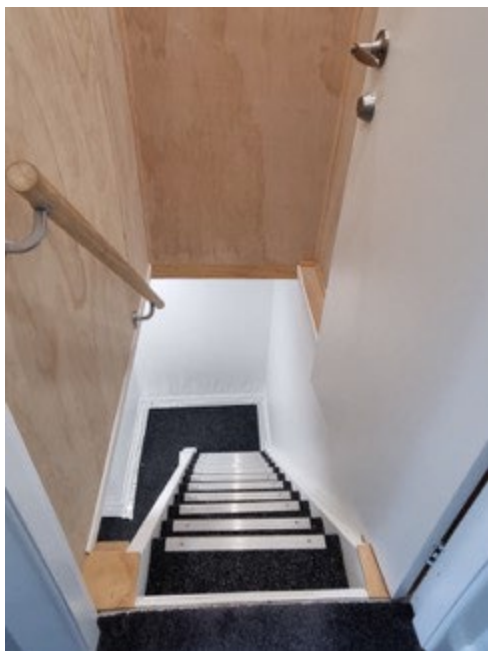
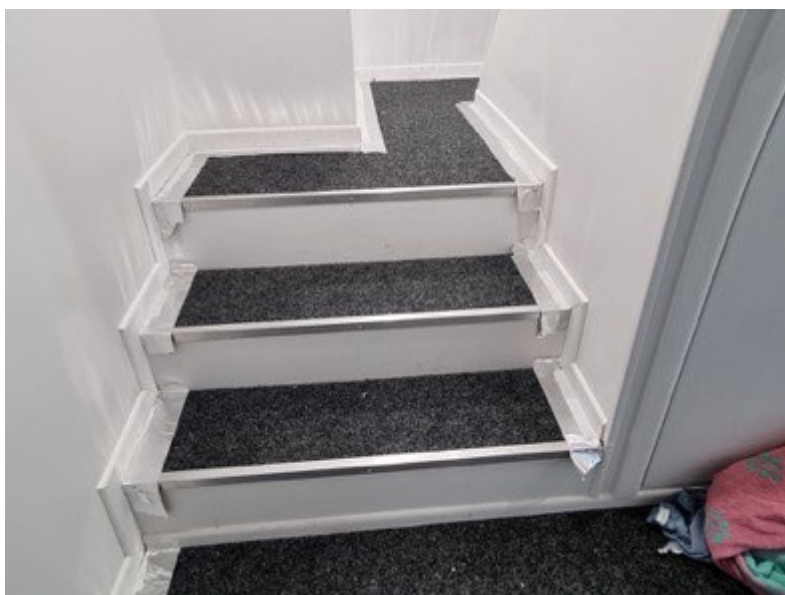
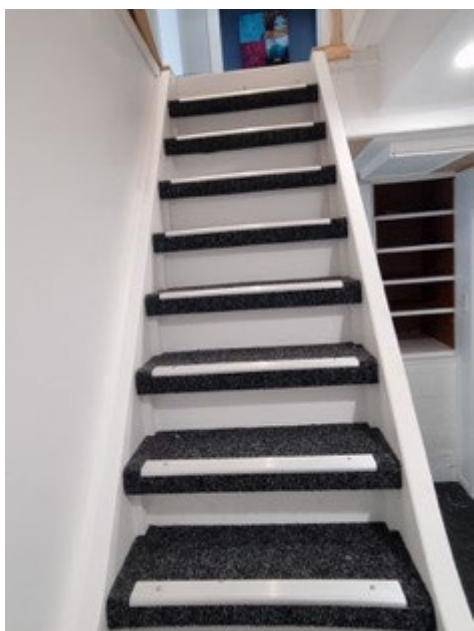
Stairs going down to laundry do not comply, due to tread depth and this is a hazard, also more safety railing required

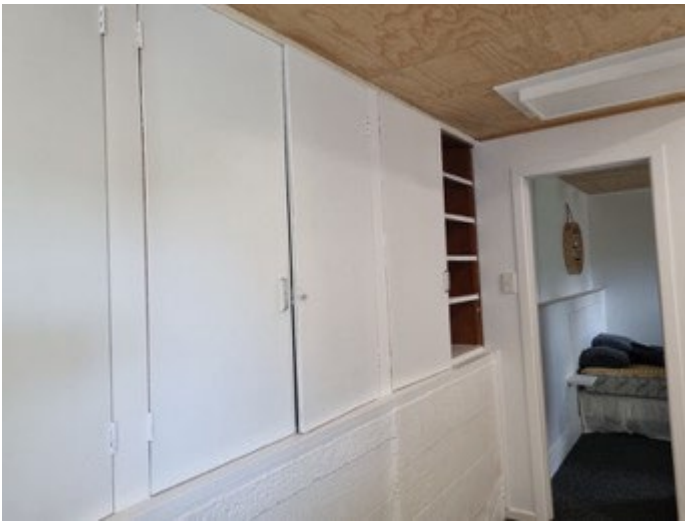
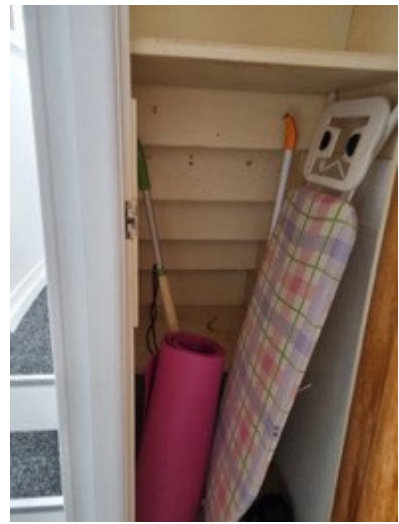
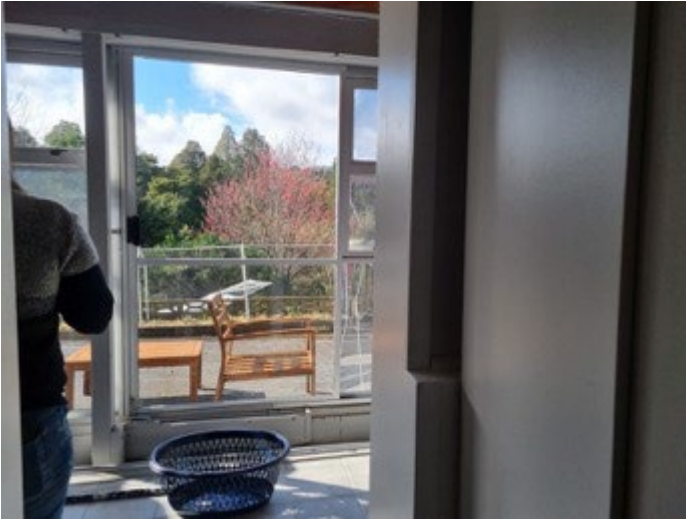
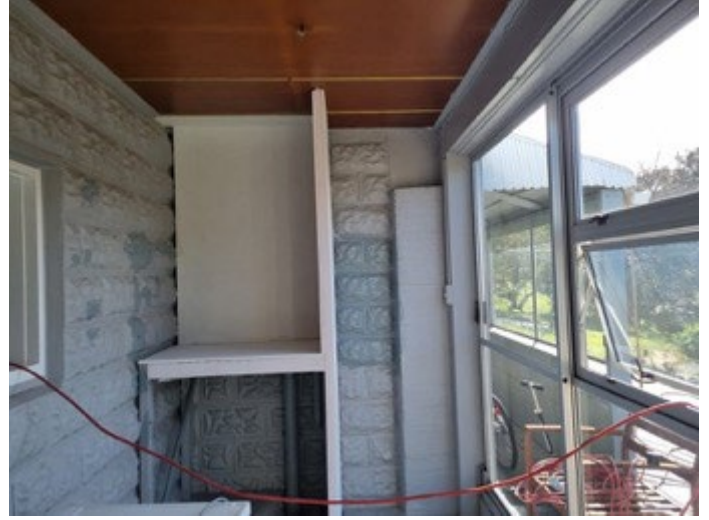
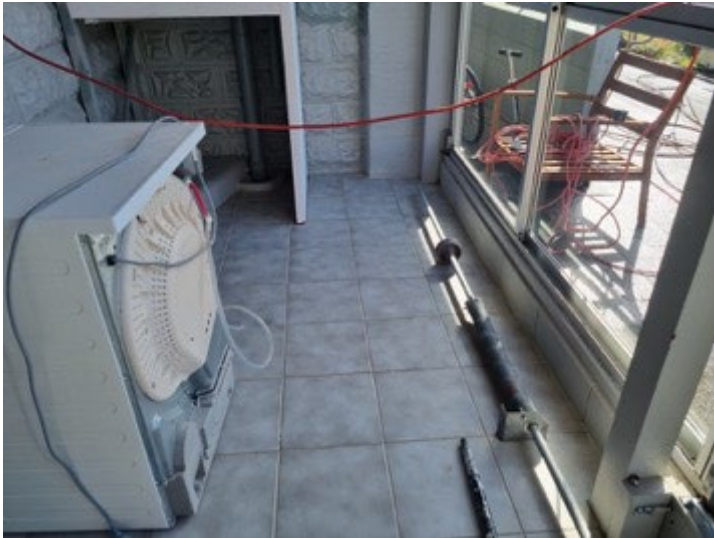
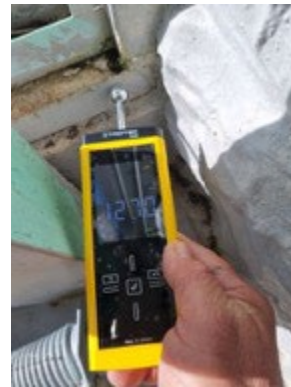
Very High Moisture Reading

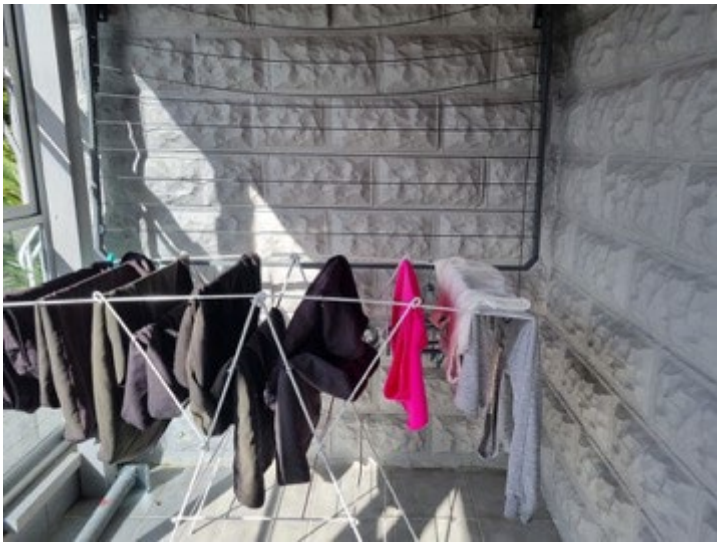
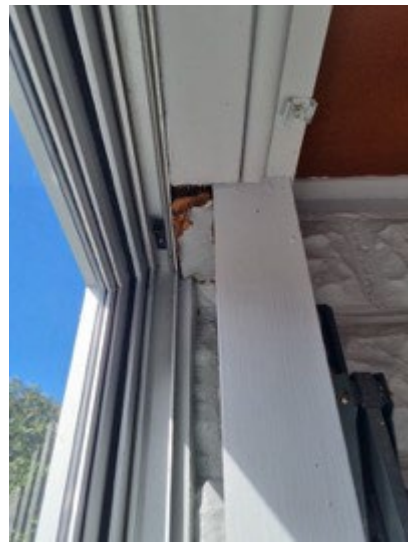
Room off laundry with tiled floor and aluminium joinery, has damaged linings and high moisture meter reading

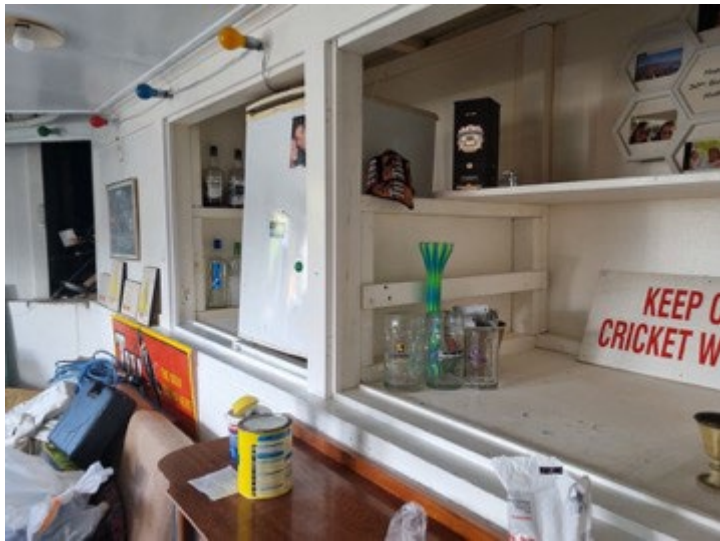
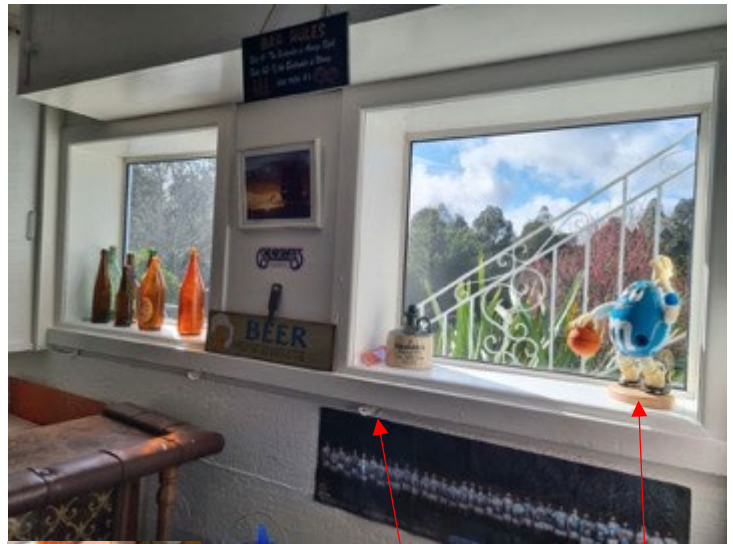
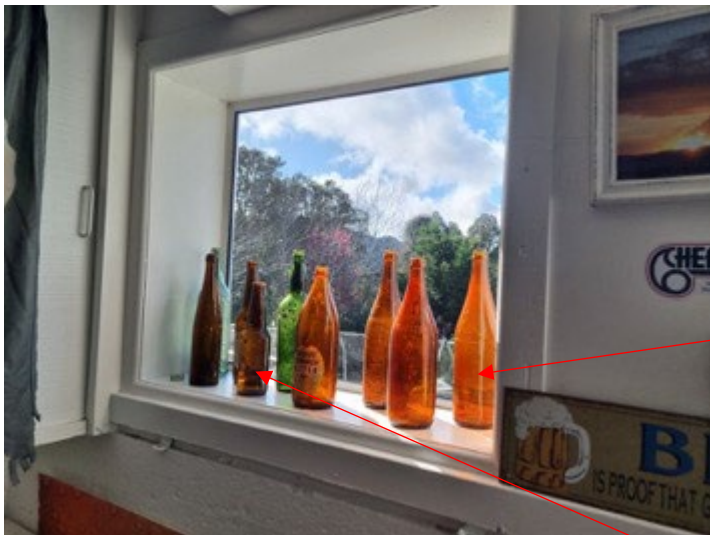
High Moisture reading

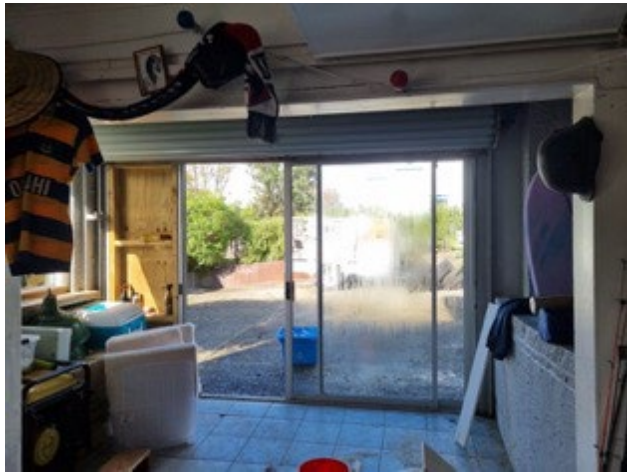
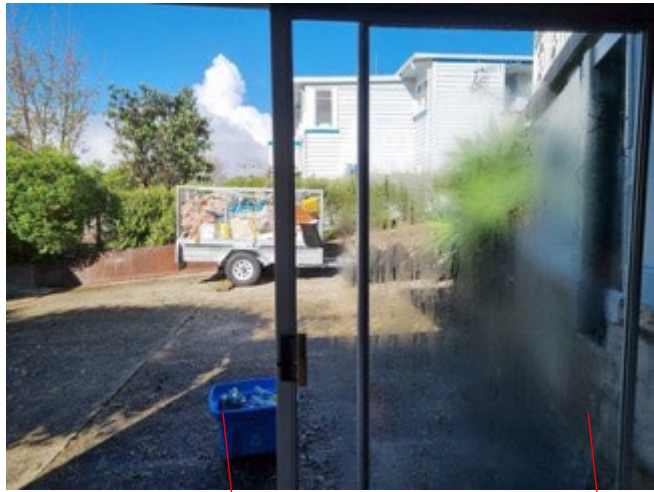
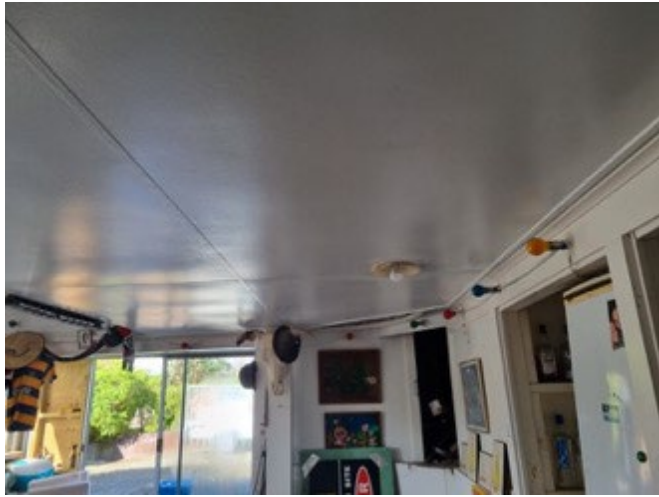
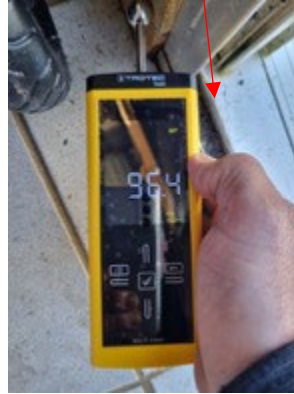
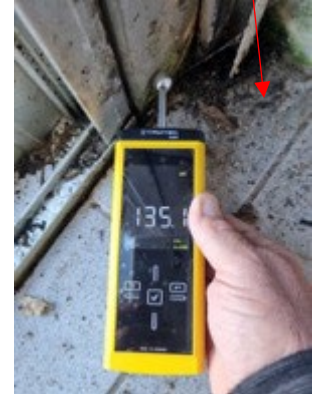
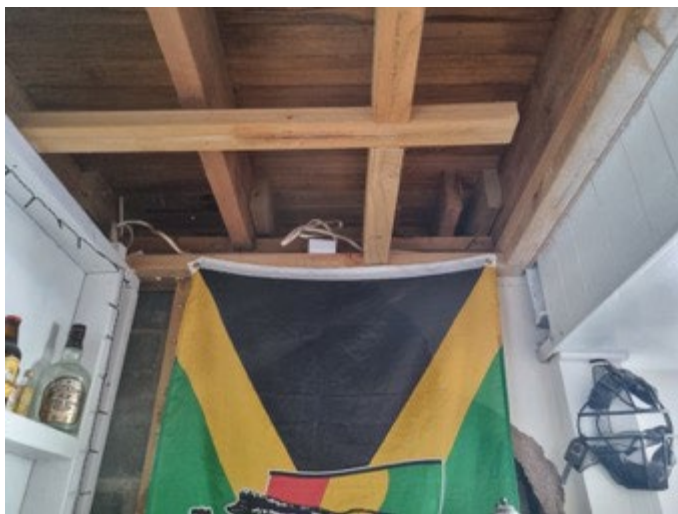
Bar area has high moisture readings and ranch slider has rotting wood bottom right hand side.

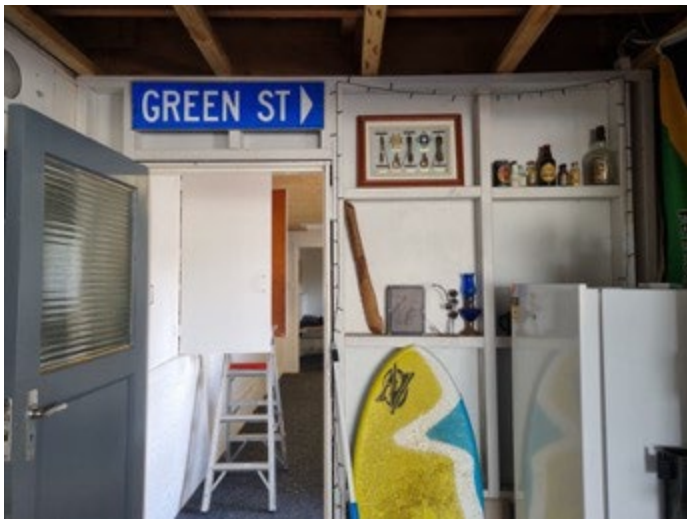
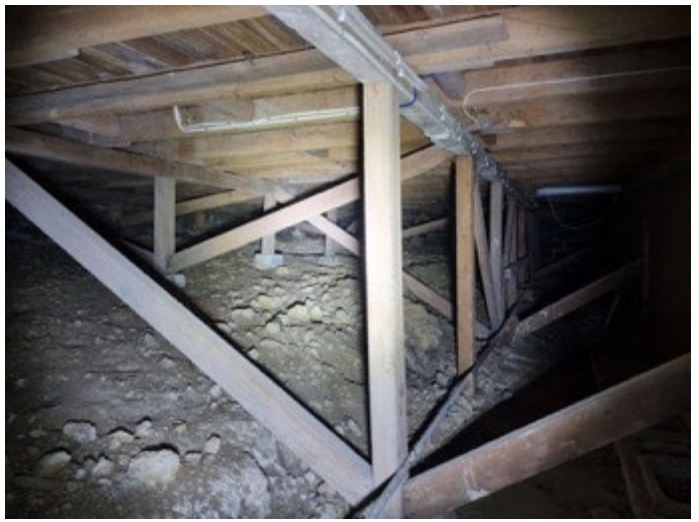
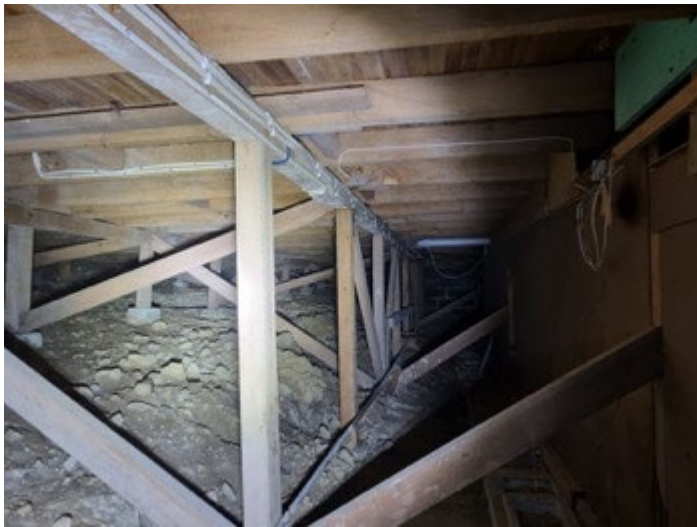
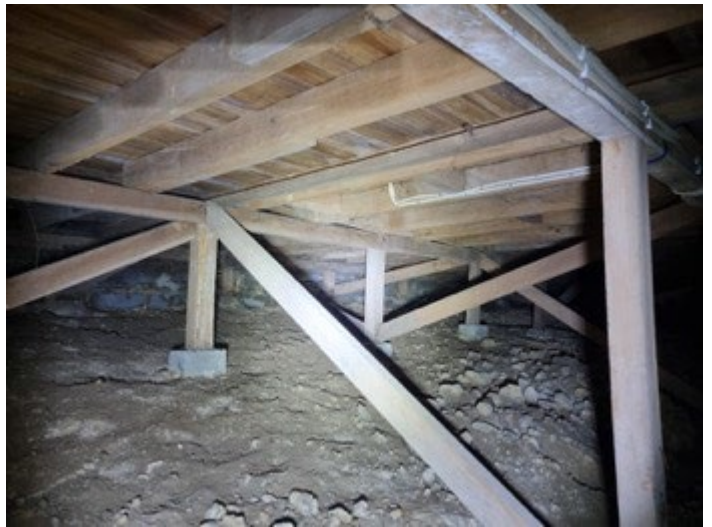
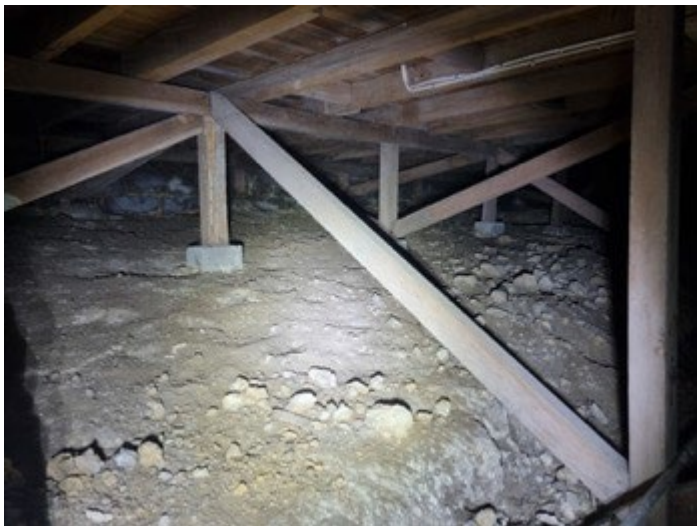
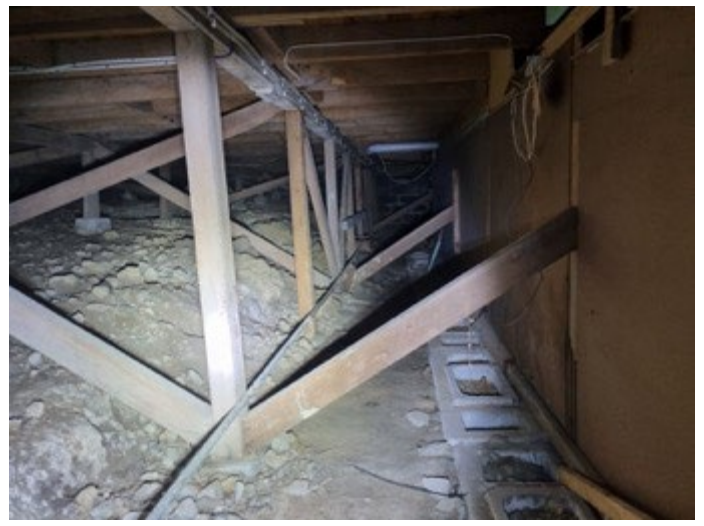
Sub floor structure appears sound and in keeping with its age also no insulation
