# Building Inspection Report

Client: Paul Sumich - Bayleys  
Location: 3 Tullamore Lane  
Maunu  
Whangarei

Inspection Date: 30/08/2022

RE: Building Inspection Report, 3 Tullamore Lane, Maunu, Whangarei.

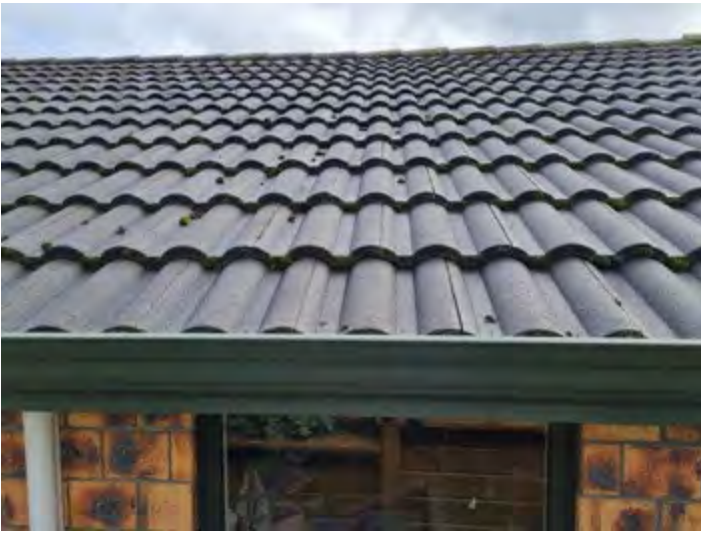
Roof was only inspected from ladder due to Health & Safety

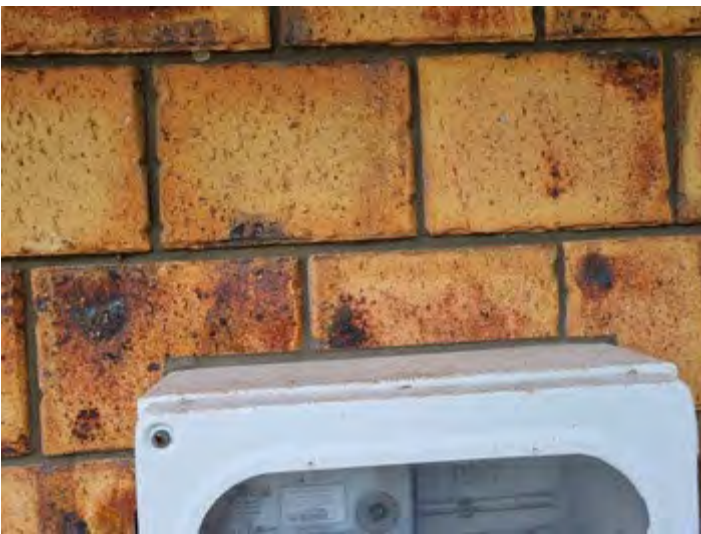
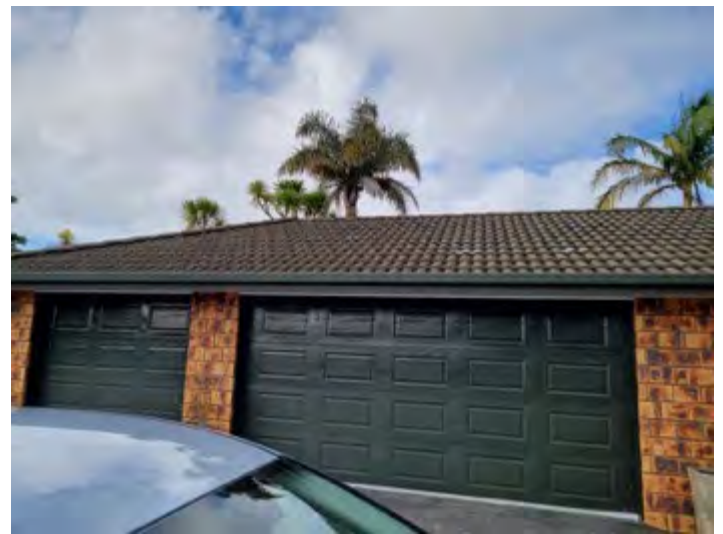
Cladding is brick with Shadow Clad or alike, on garage extension and double-glazed windows with concrete floor. The hip/valley roof consists of concrete tiles and in good condition but does have some moss growing on the south side. Spouting and down pipes are PVC.

Slight bit of moss on the roof on south side

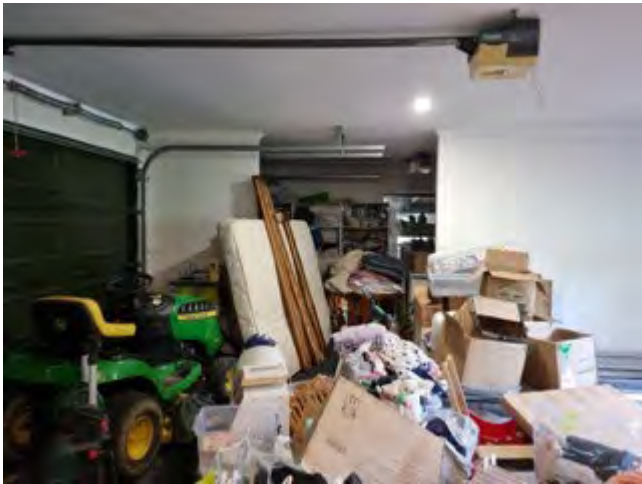
Window in garage workshop area was not moisture tested due to obstacles in the way

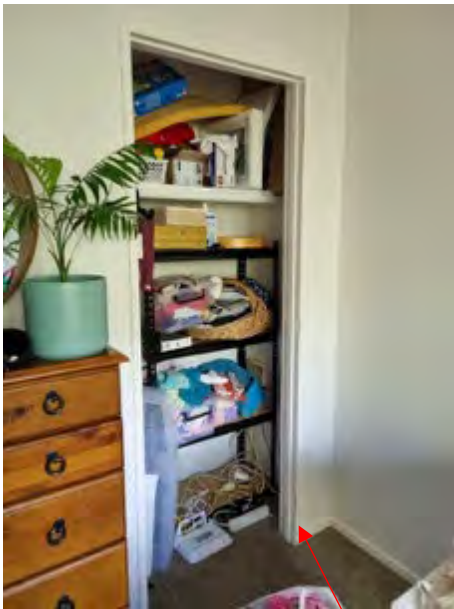
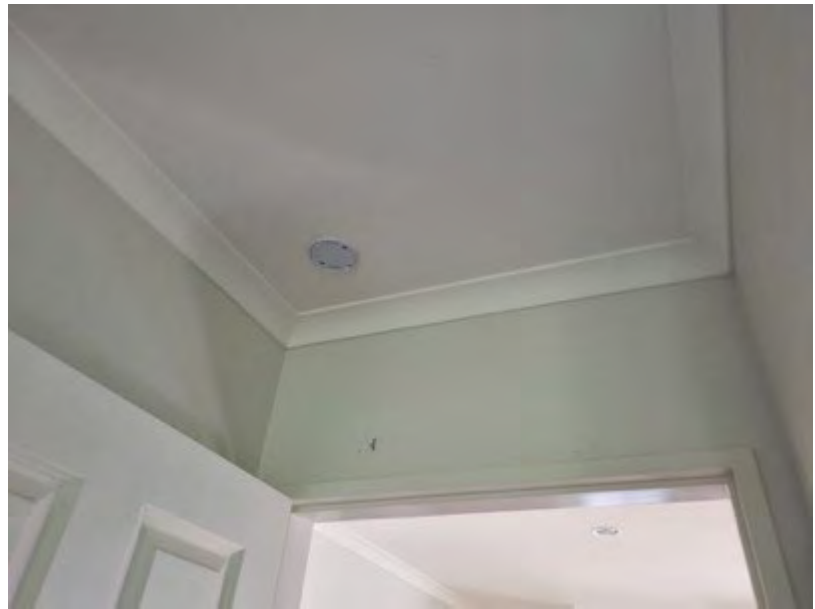
Office/bedroom1 missing wardrobe door

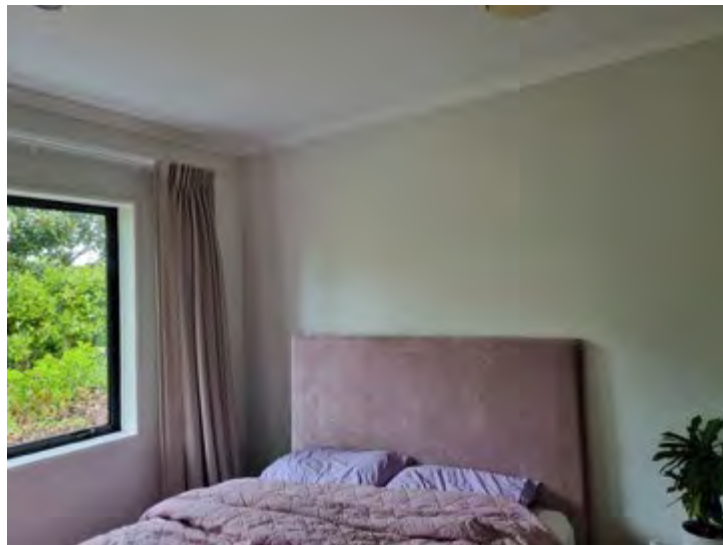
Bedroom 3 door needs planning as it's catching on carpet

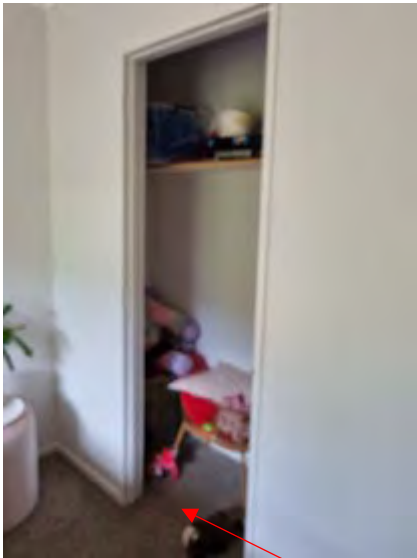
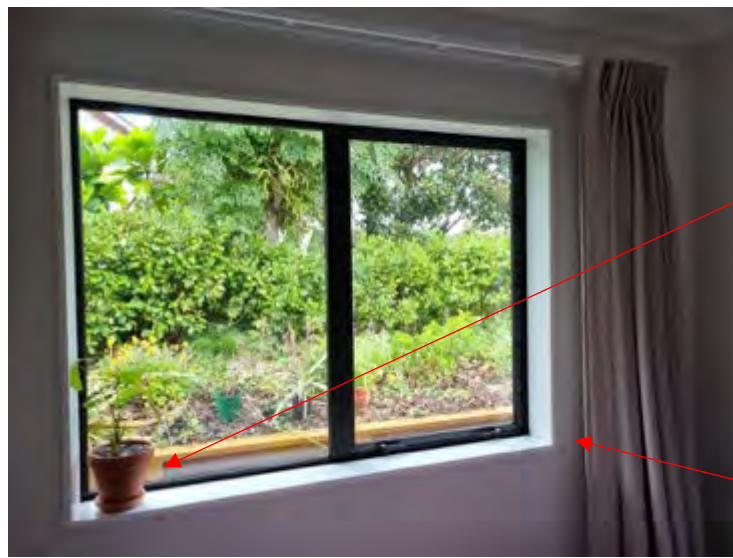
Bedroom 3 missing wardrobe door

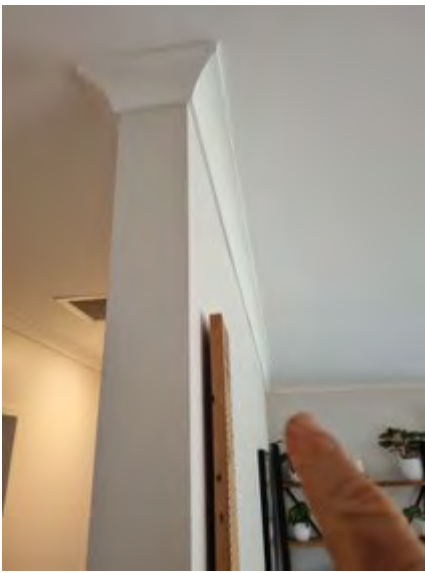
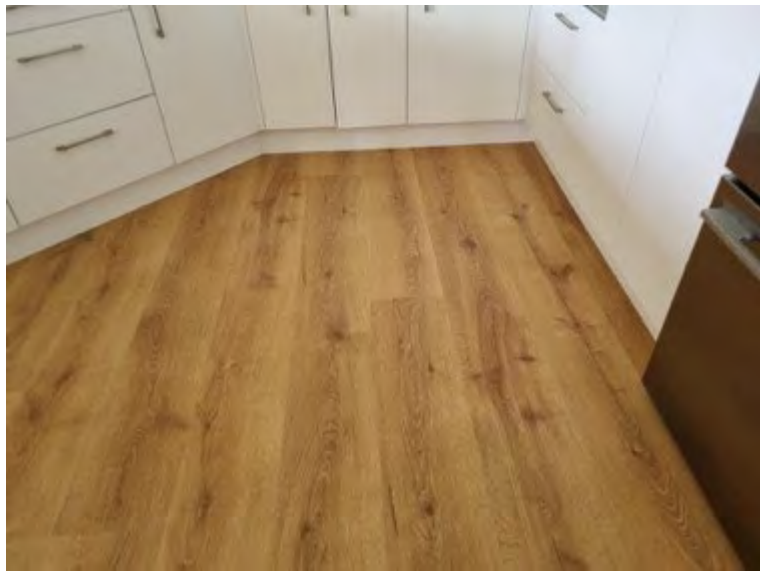
Lounge wall that backs onto hallway has a kink in it and noticeable at the coving line. It looks like this was built like this. No moisture was detected
