# Building Inspection Report

Client: Paul Sumich - Bayleys  
Location: 127 Kiripaka Road  
Tikipunga  
Whangarei

Inspection Date: 22/07/2022

RE: Building Inspection Report, 127 Kiripaka Road, Tikipunga, Whangarei.

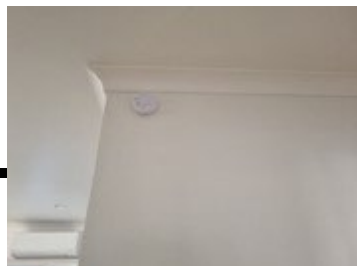
Kitchen, Hallway and Office area

No testing was done on the alarms to check if they are working.  
 We recommend a smoke alarm be present in every sleeping quarter, the room closest to the kitchen, the lounge and in each level of your home.

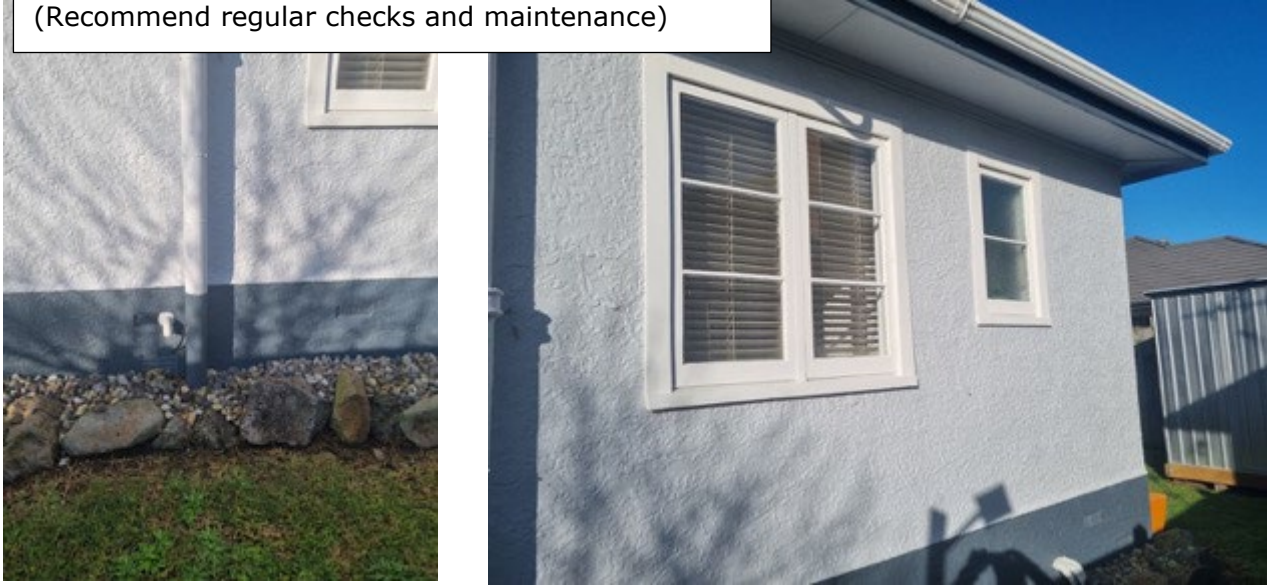
Timber joinery is in satisfactory condition.  
(Recommend regular checks and maintenance)

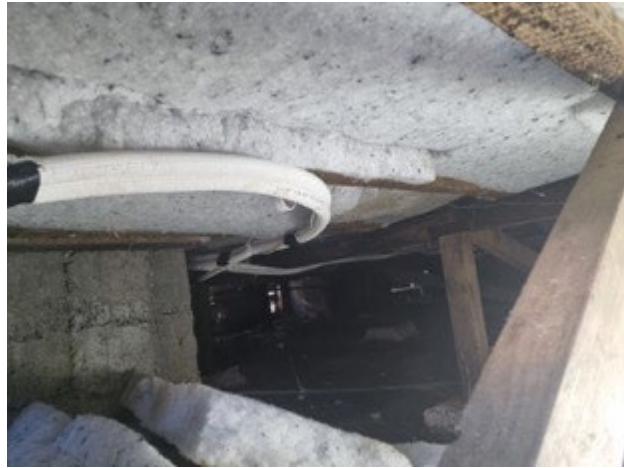
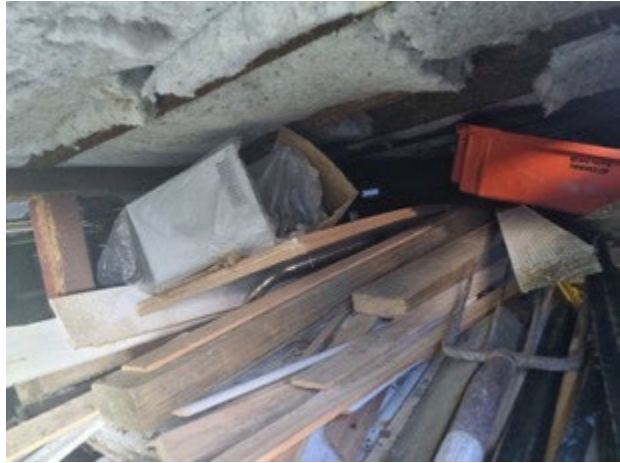
Subfloor inspection made only from Manhole door

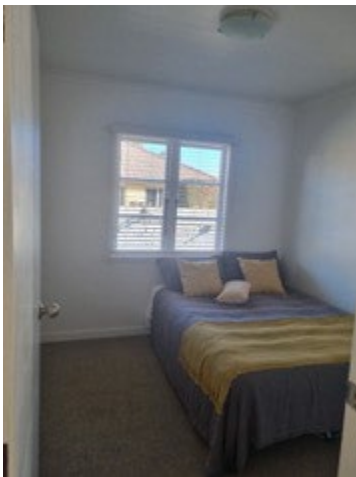
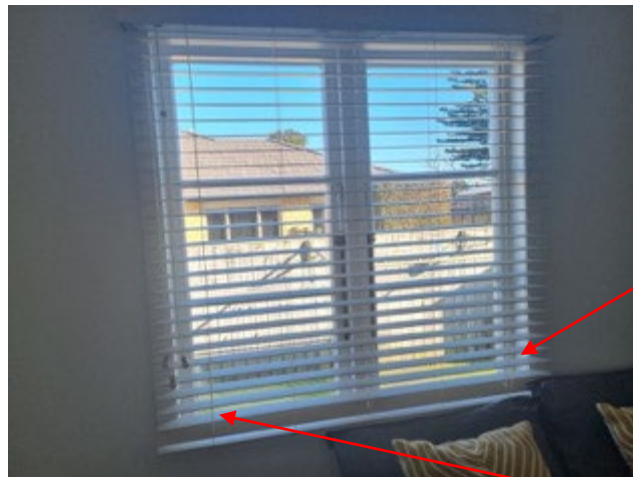
#### Bedroom 1

All bedroom bottom of doors requires planeing as well as HWC door

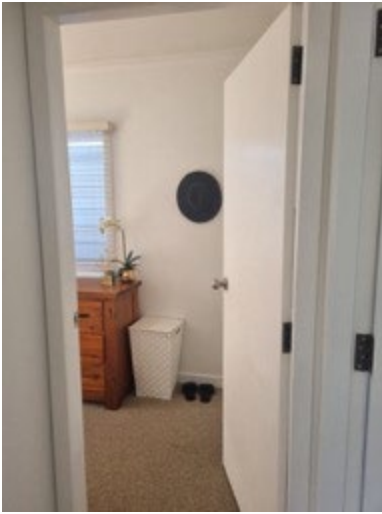
### Bedroom 3 (Master)

No reasonable access to complete the reading to this window behind dresser.

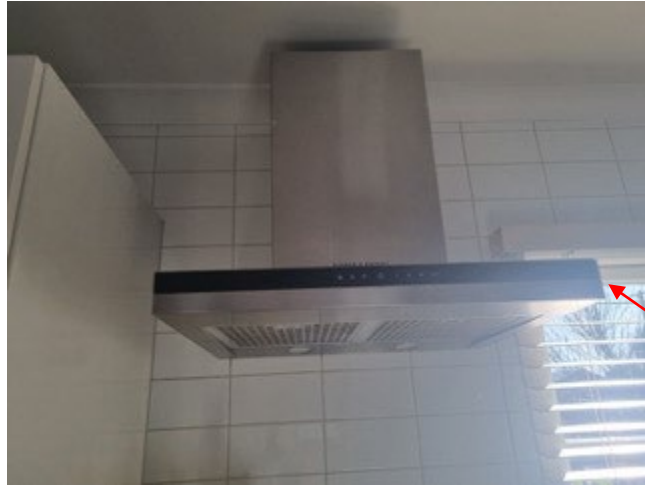
Kitchen extractor fan has a vent visible; we can't confirm it is connected

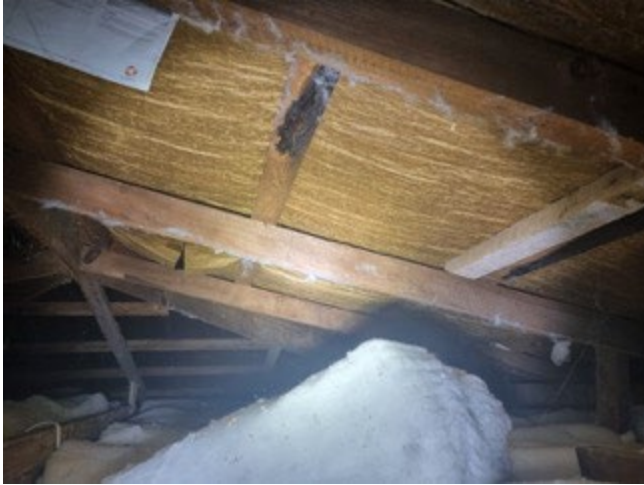
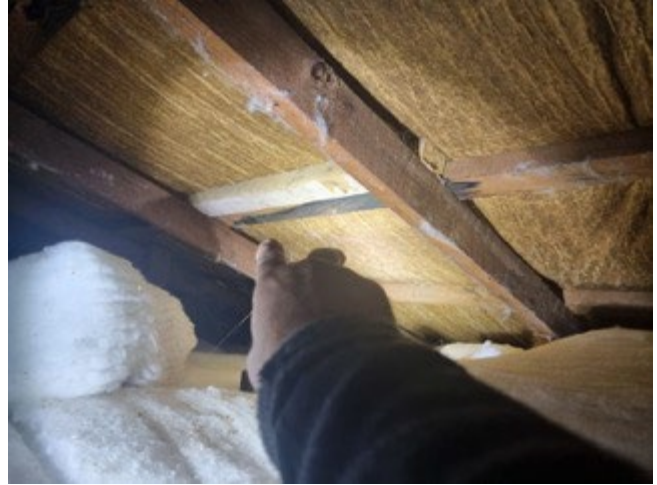
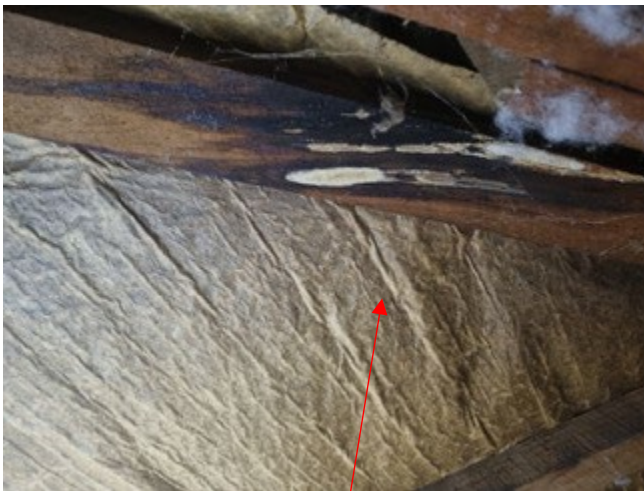
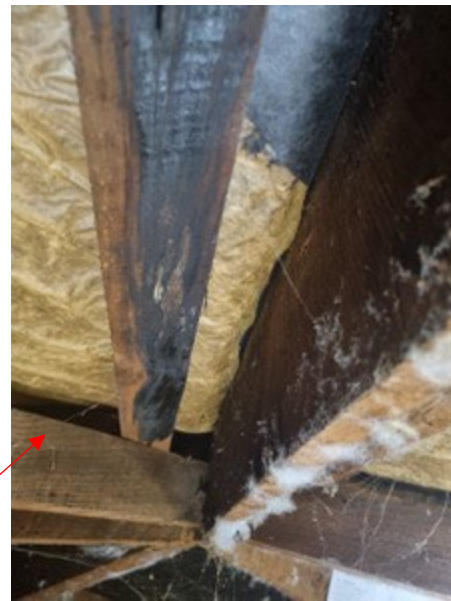
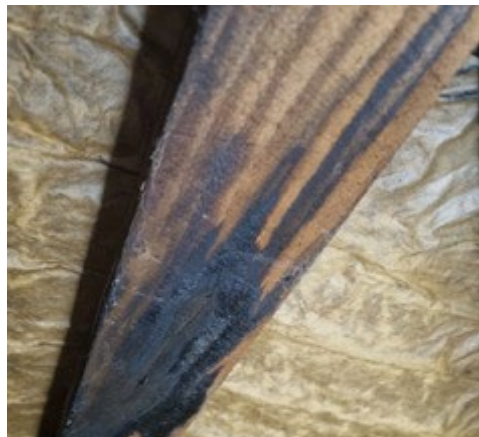
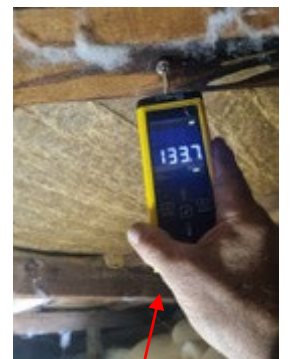
Roof cladding is showing signs of deterioration and has been leaking above the manhole area, and possible other areas. Purlins require replacement to damaged areas. (Further investigation recommended)

Inspection to the ceiling was only done from the manhole door with a torch.

Roofing purlins are showing signs of deterioration, wet and require replacing (further investigation required).

Higher moisture readings present in roof space

Highly recommend a re- roof as overdue.
