## RED LBP PRE-PURCHASE REPORT

# PRE-PURCHASE BUILDING REPORT

Property Address	19 Stoneybrook Lane, Kamo, Whangarei, Northland, 0112, NZL		
Client	Roz And Richie Fitzpatrick		
Date of Inspection	6th June 2024	Time	1:30 pm
Inspector	Jamie Mackintosh Licensed Building Practitioner Brick & Block		
LBP Number	116085		
Additional Information			
People Present	Inspector, Agent		
House Occupied	Yes

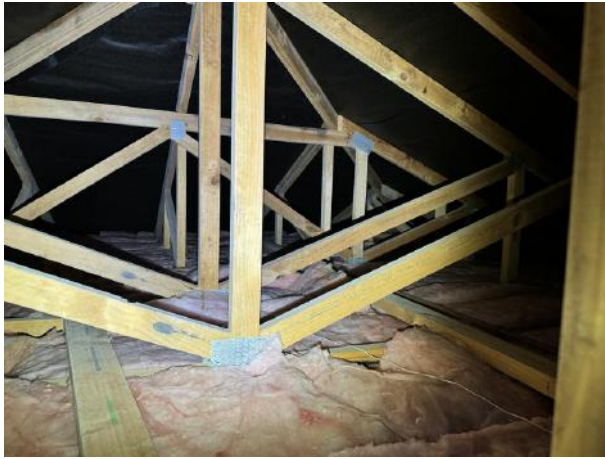
Photo 7

Roof space showing manufactured timber trusses.

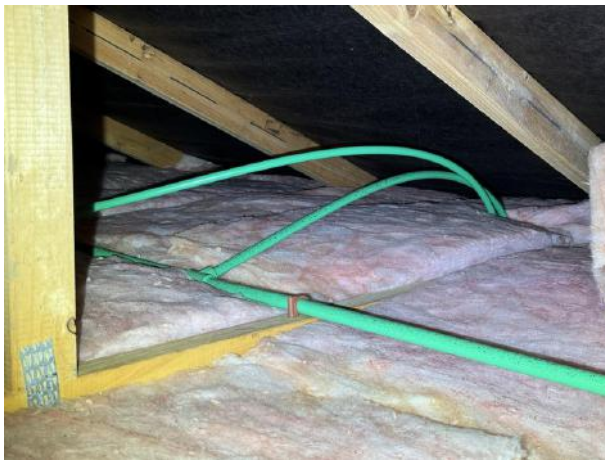
Photo 8

Roof space showing green water pipes and glass wool insulation.

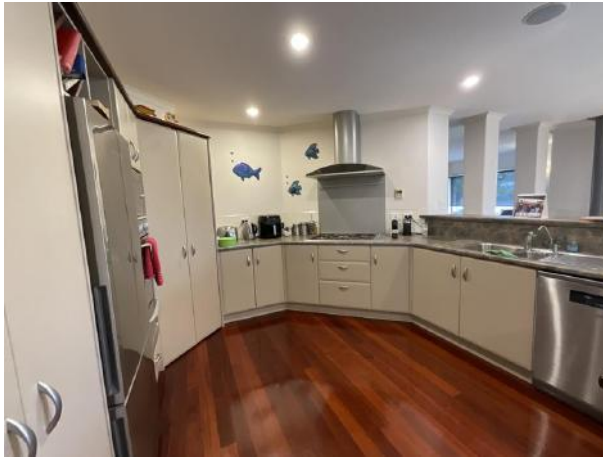
Photo 9

Kitchen.

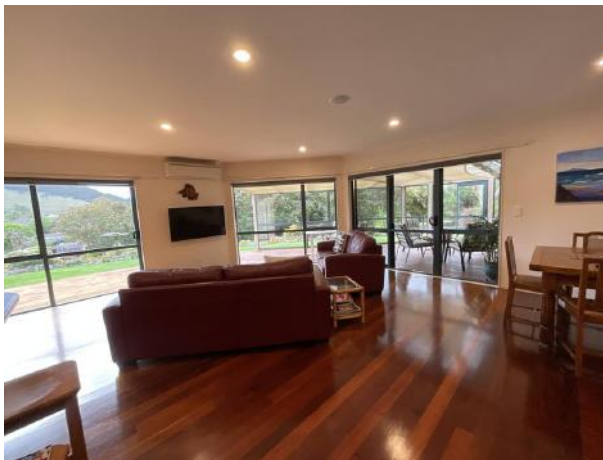
Photo 10

Living area.

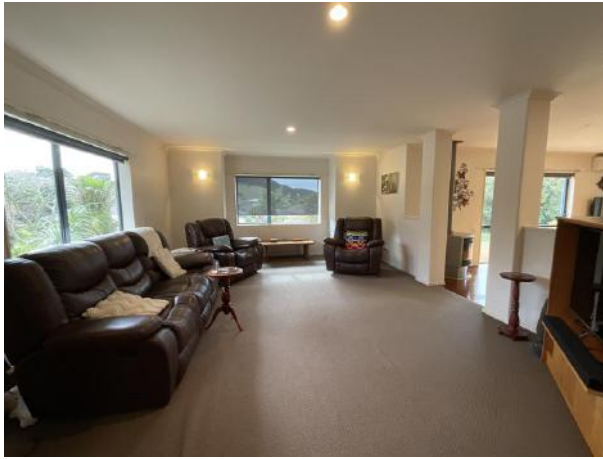
Photo 11

Lounge.

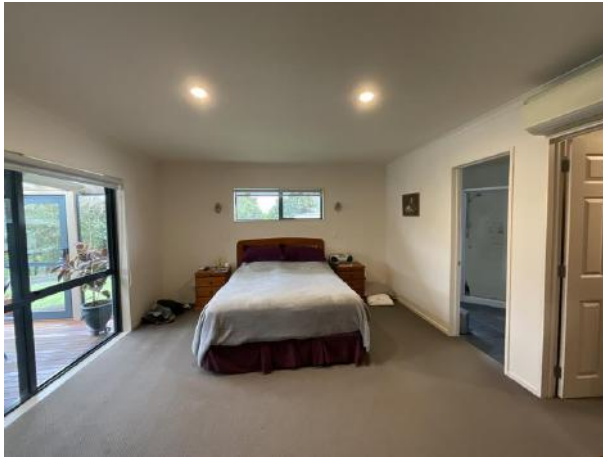
Photo 12

Bedroom one.

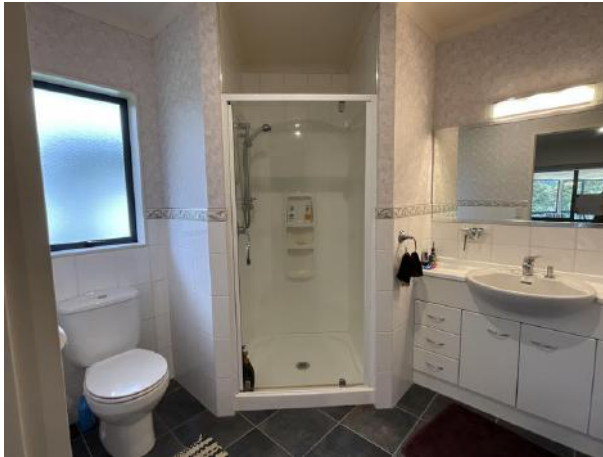
Photo 13

Ensuite.

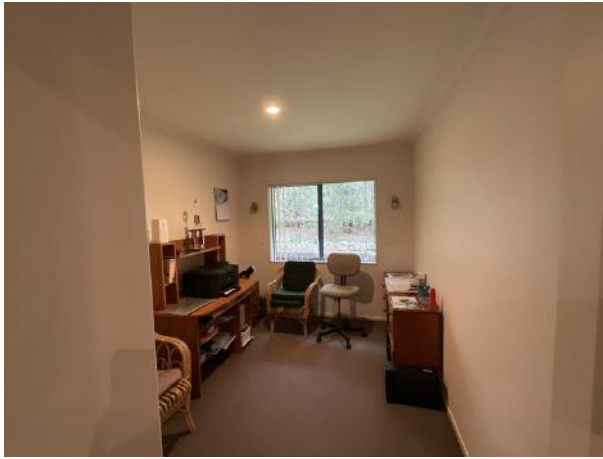
Photo 14

Bedroom two.

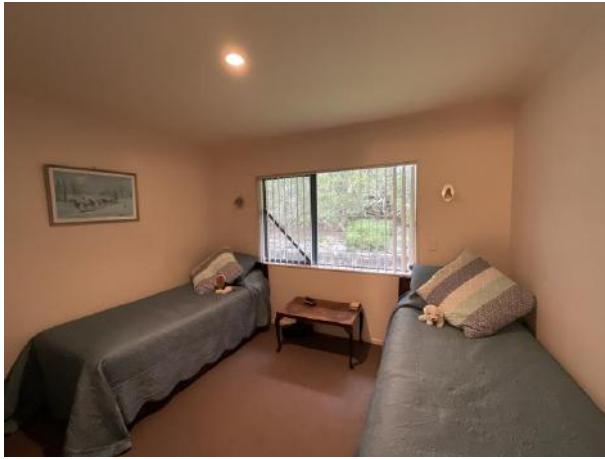
Photo 15

Bedroom three.

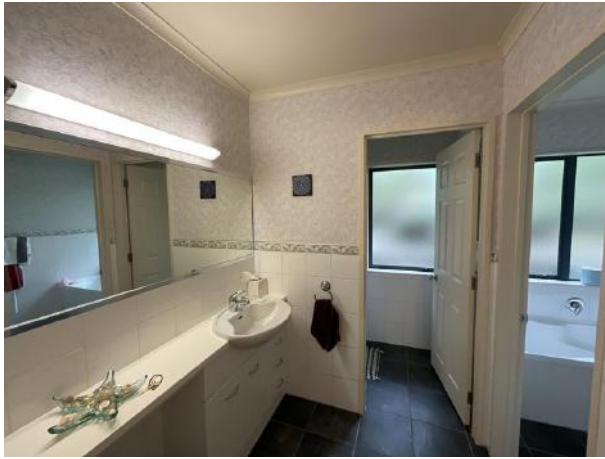
Photo 16

Bathroom.

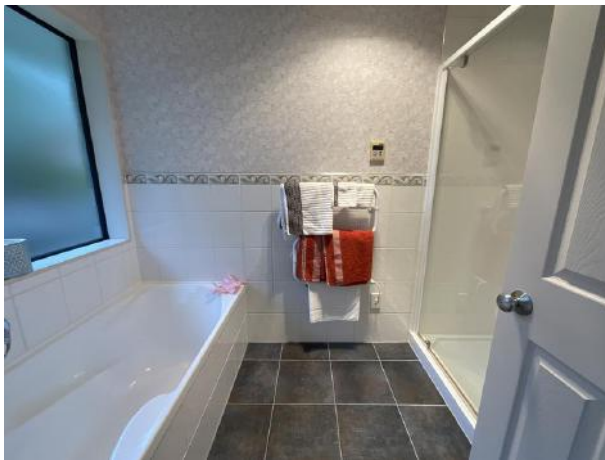
Photo 17

Inbuilt baths can be prone to maintenance issues. Depending on how the bath has been installed and maintained depends on how watertight it remains and how much future maintenance it will require. Typical failure points are where the bath meets the wall and around the tap units.

Bath and shower.

It is recommended you constantly monitor these junctions to ensure damage is not occurring to the adjacent walls. No visible issues were noted during the inspection.

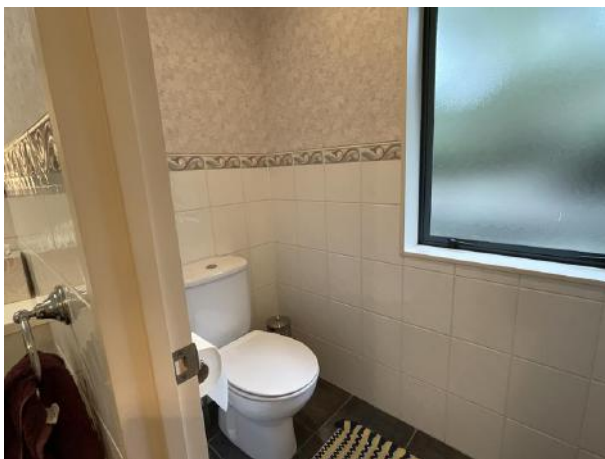
Photo 18

Separate toilet.

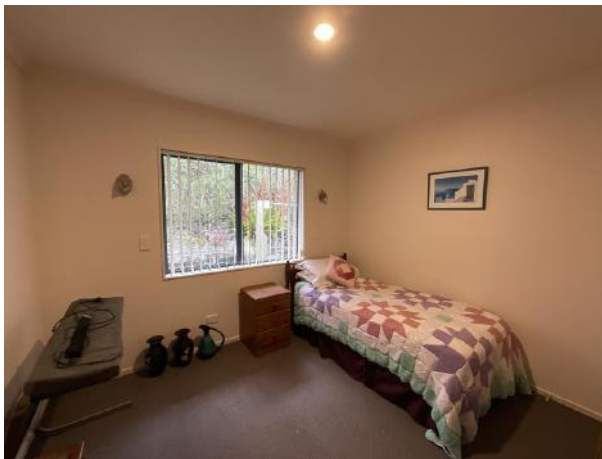
Photo 19

Bedroom four.

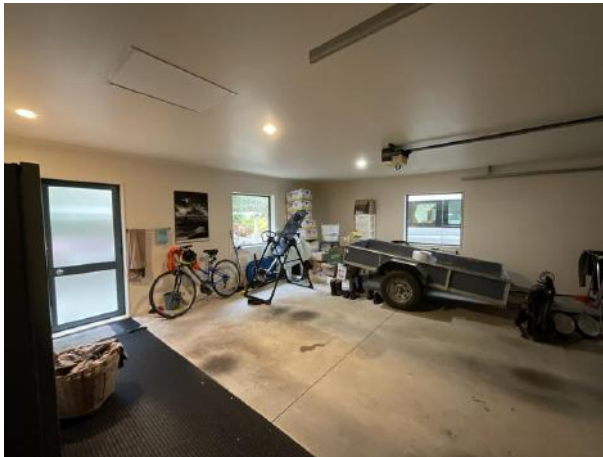
Photo 20

Garage.

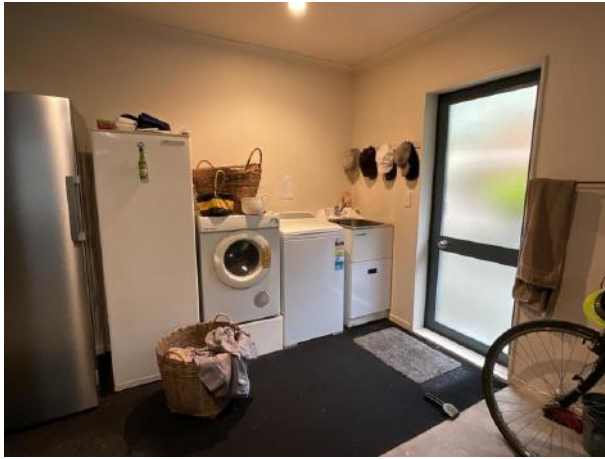
Photo 21

Laundry area.

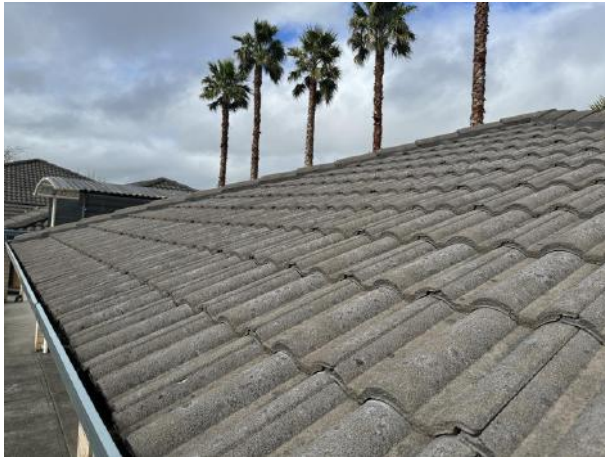
Photo 22

The roof displayed visible signs of moss, mould, or lichen growth in certain areas, and it is advised to address this issue as part of regular maintenance. Failure to do so could cause deterioration of the coating.

Masonry tile roofing.

To ensure the longevity and performance of masonry tiles, it is important to adhere to the manufacturer's specifications and perform regular upkeep and maintenance. This typically involves following specific cleaning and sealing procedures on a regular basis. By doing so, you can protect the tiles from deterioration, staining, and other forms of damage.

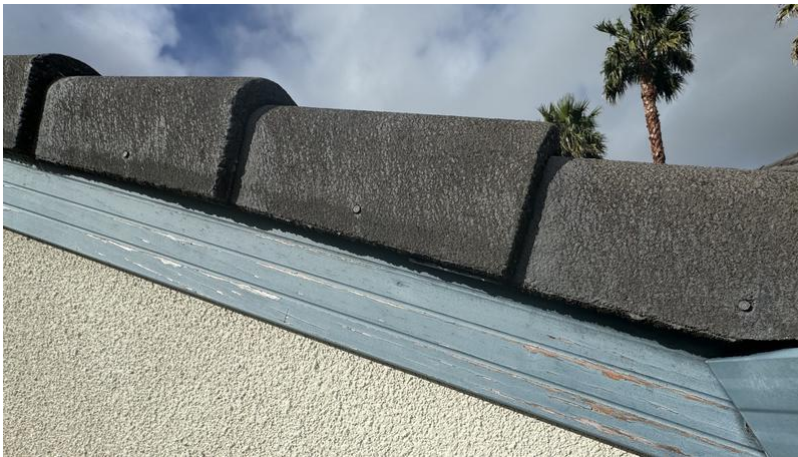
Photo 25

Example of a masonry barge flashing. Functional.

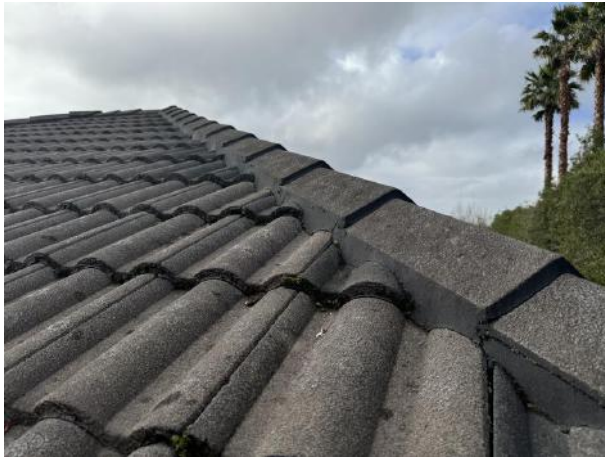
Photo 26

Example of a masonry hip flashing. Functional.

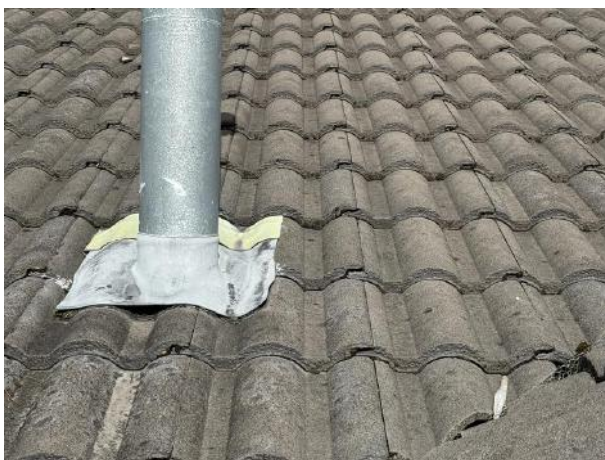
Photo 27

Flue penetration with lead flashing.

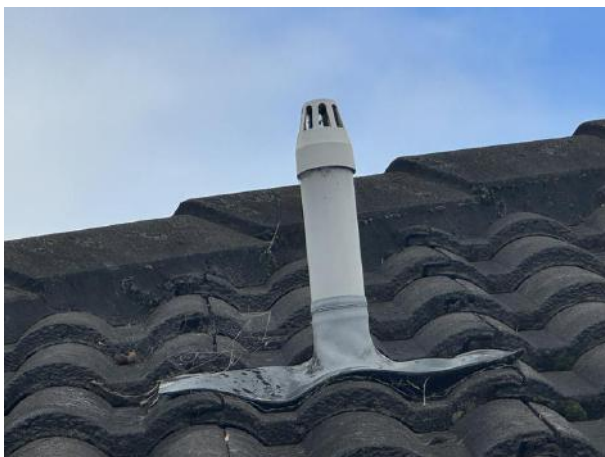
Photo 28

Vent penetration with lead flashing.

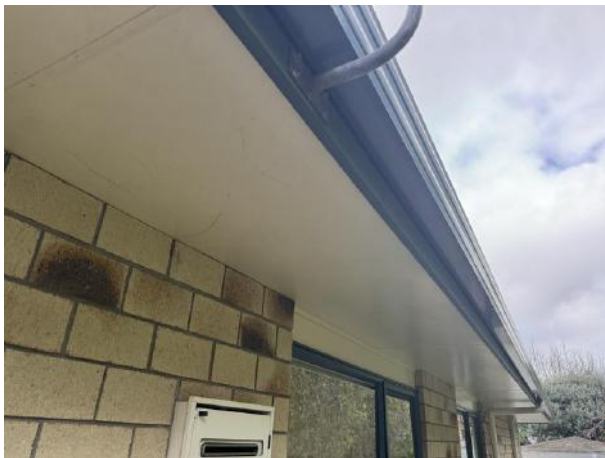
Photo 30

Example of timber fascia boards and fibrous cement soffits.

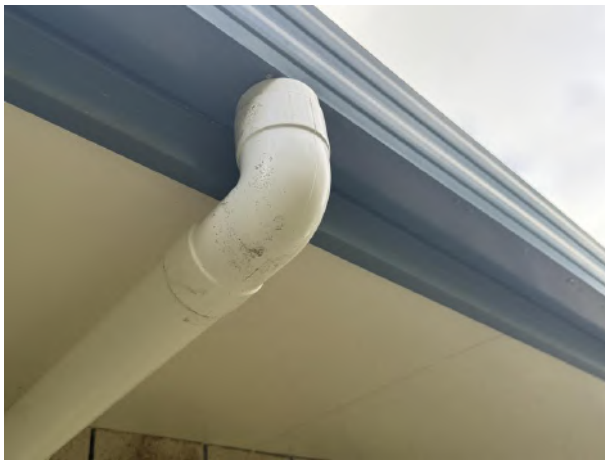
Photo 32

Example of a PVC downpipe.

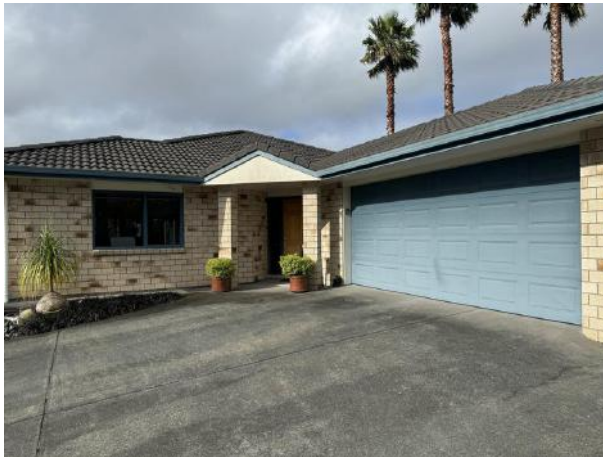
Photo 33

West elevation.

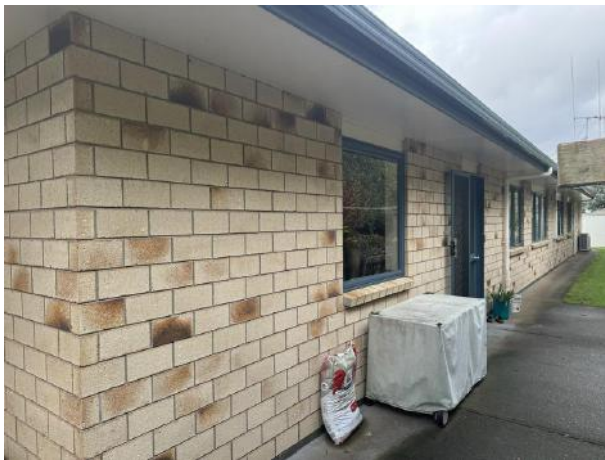
Photo 35

South elevation.

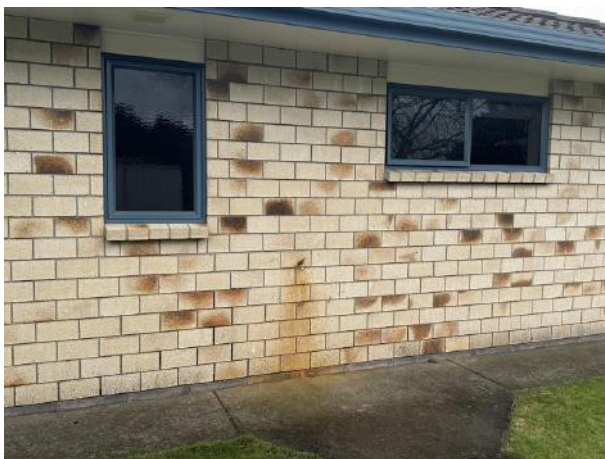
Photo 36

East elevation.

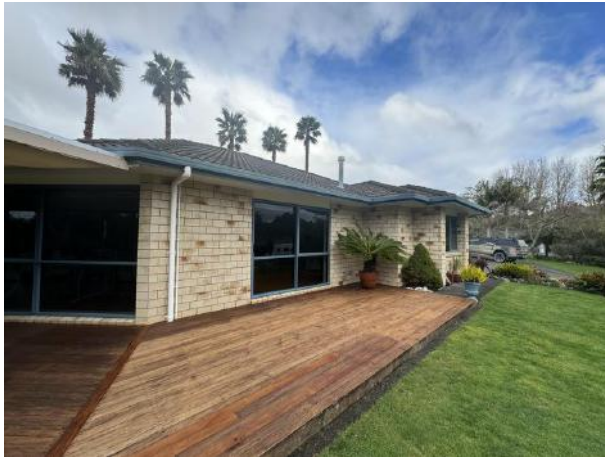
Photo 37

North elevation.

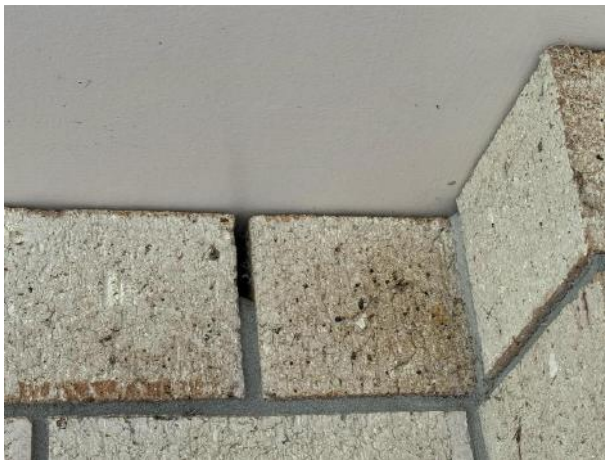
Photo 38

Example of a vent hole. Clear at the time of inspection.

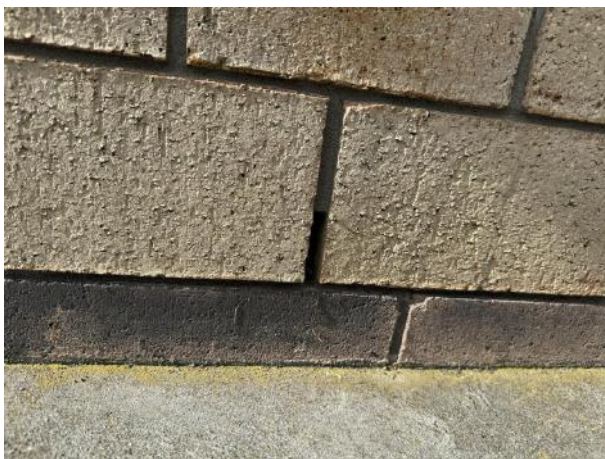
Photo 39

Example of a weep hole. Clear at the time of inspection.

Keep tracks, drainage channels & weep-holes clear of debris.

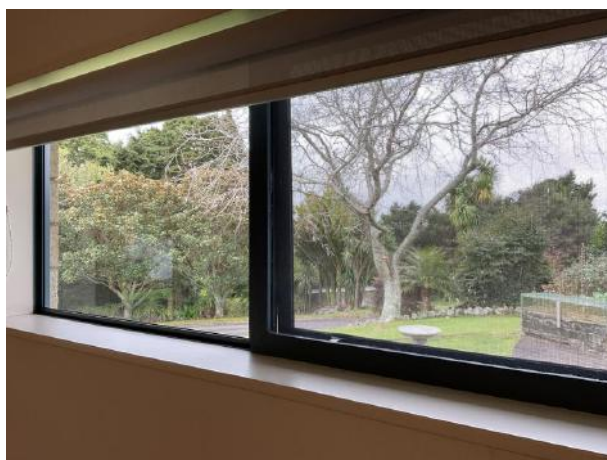
Photo 40

Example of aluminium joinery with timber reveals.

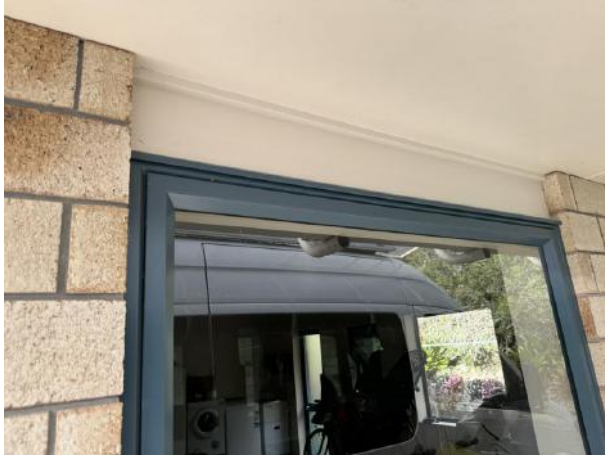
Photo 41

Example of typical joinery to cladding detail. Metal head flashings installed.

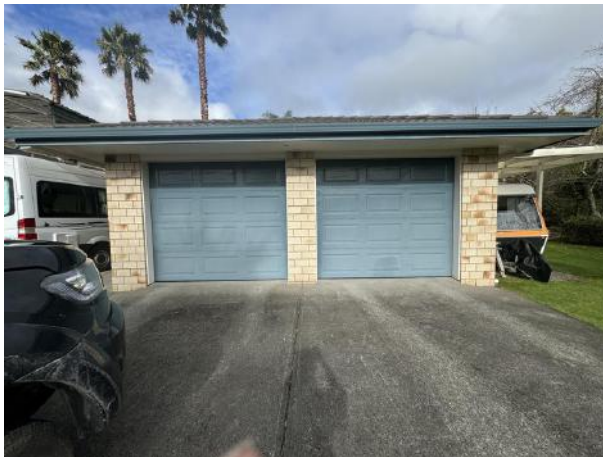
Photo 43

Double garage with brick veneer cladding.

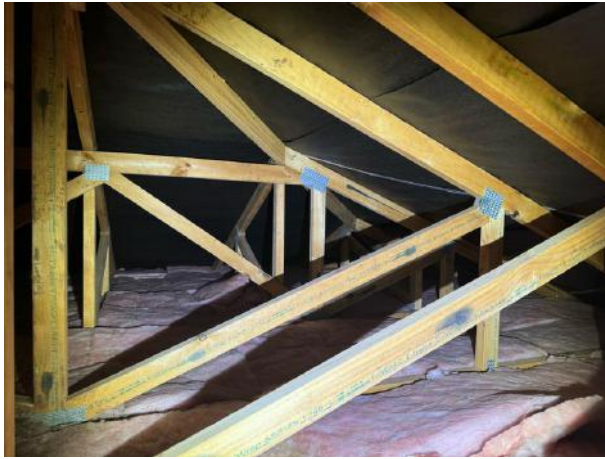
Photo 44

Roof space showing manufactured timber trusses and glass wool insulation.

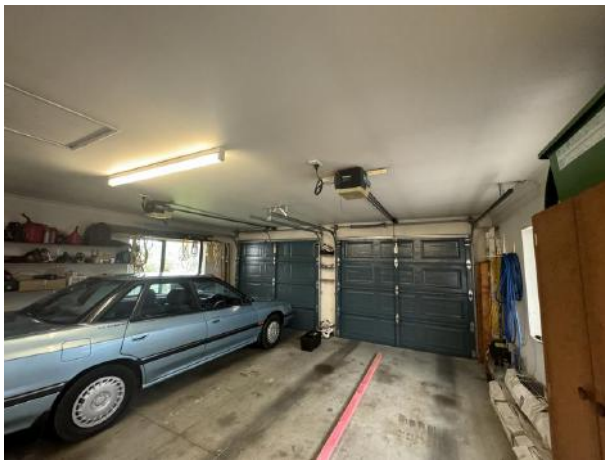
Photo 45

Painted plasterboard linings.

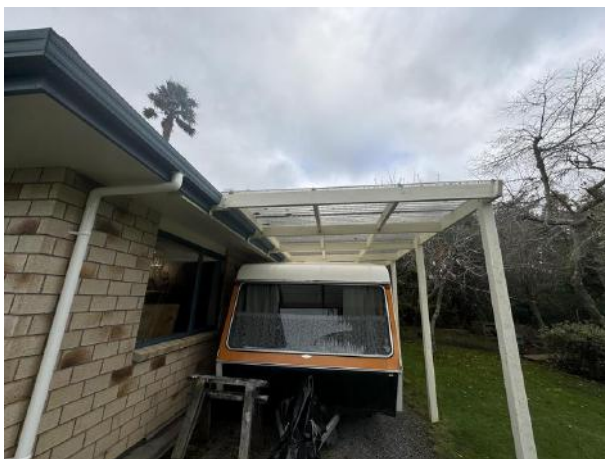
Photo 46

Timber framed carport with polycarbonate roofing on the west side of the garage.

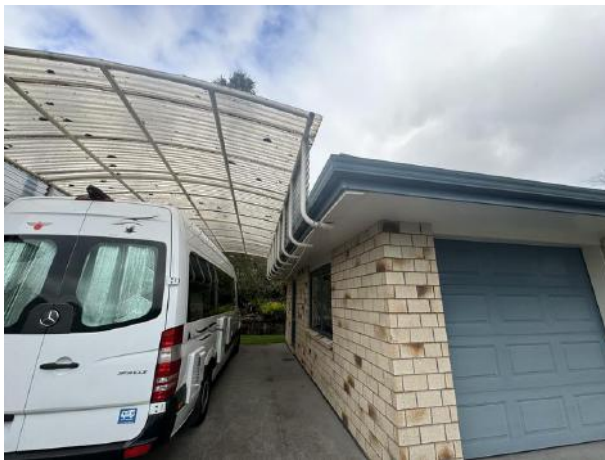
Photo 47

Metal brackets direct fixed to the soffit.

Metal brackets direct fixed to the soffits. Visible surface rusting to some brackets. Recommend cleaning, treating and re-painting.

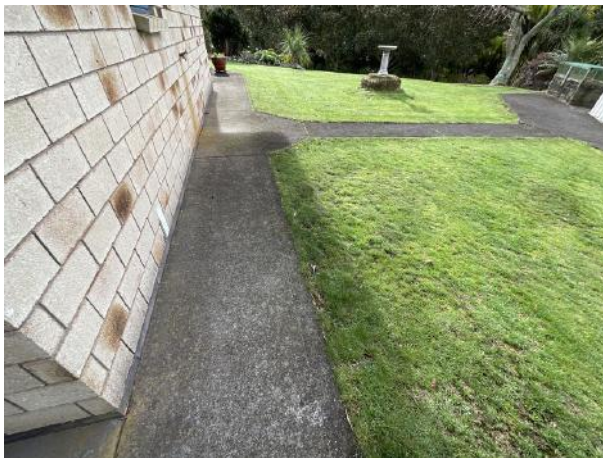
Photo 52

Concrete path running along the east side of the dwelling.

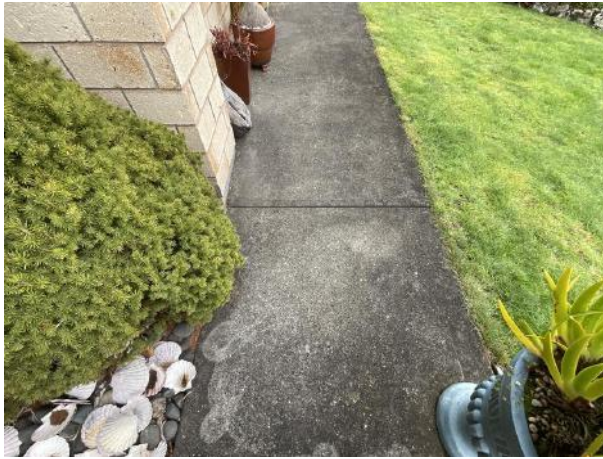
Photo 53

Concrete path running from the northern deck to the driveway.

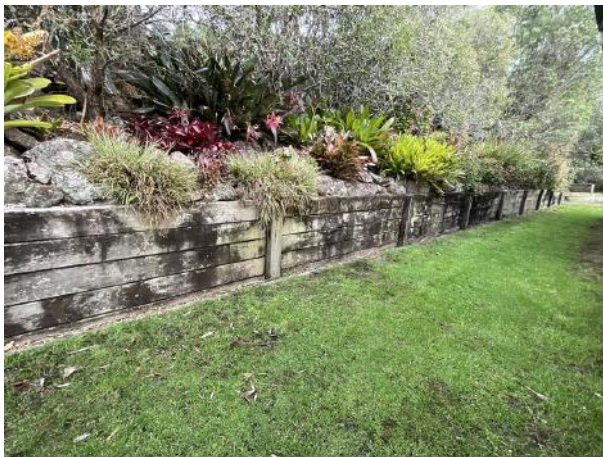
Photo 54

Timber retaining wall located along the south side of the property.

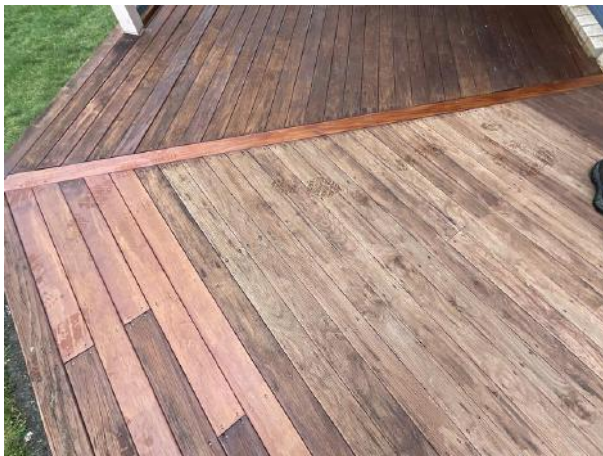
Photo 55

Timber deck off the living and bedroom one, on the north side of the dwelling.

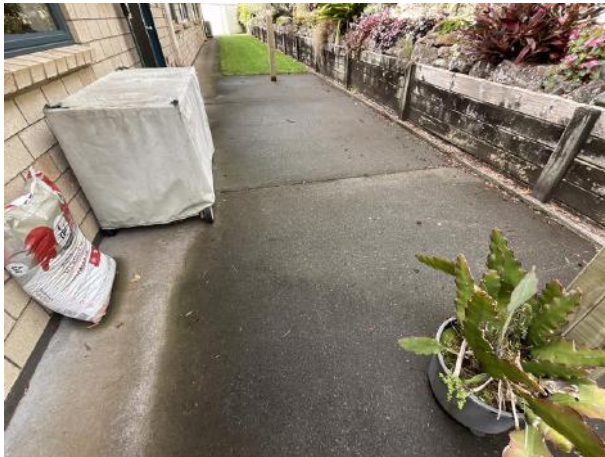
Photo 56

Concrete patio off the laundry on the south side of the dwelling.

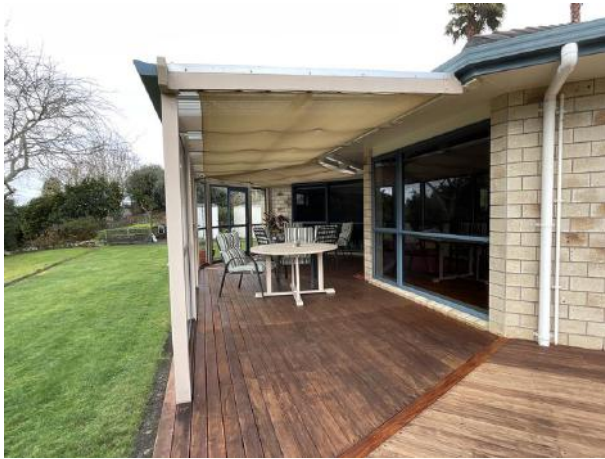
Photo 57

Timber framed verandah with polycarbonate roofing and aluminium joinery off the living room and bedroom one, on the north side of the dwelling.

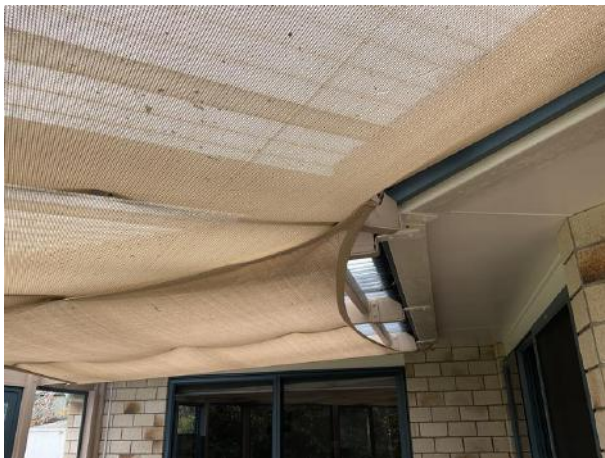
Photo 58

Timber and polycarbonate roofing with fabric sunshade.

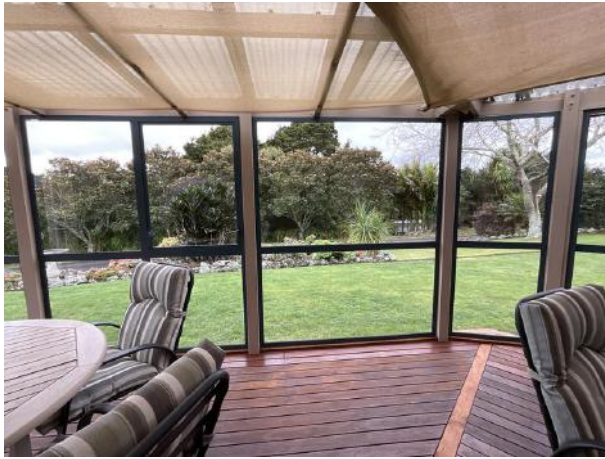
Photo 59

Aluminium glass panels,  
window and ranch slider.

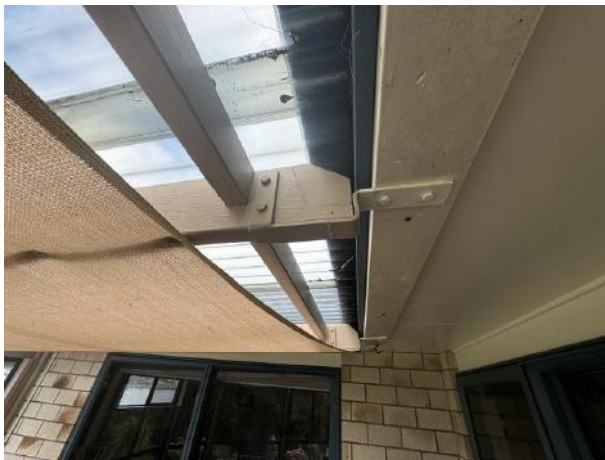
Photo 60

Metal brackets supporting the  
rafters.

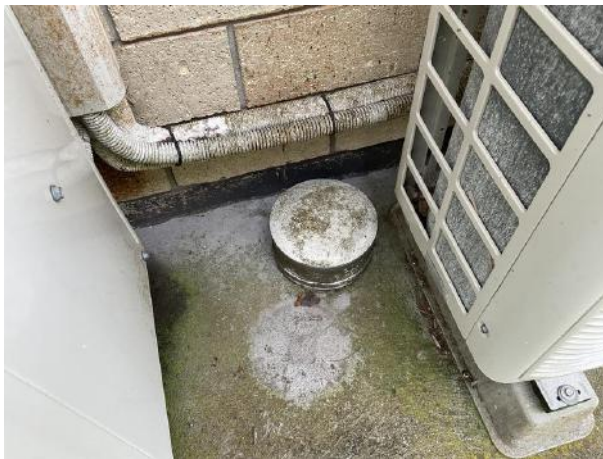
Photo 61

Pop-up inspection cover located on the south side of the dwelling.

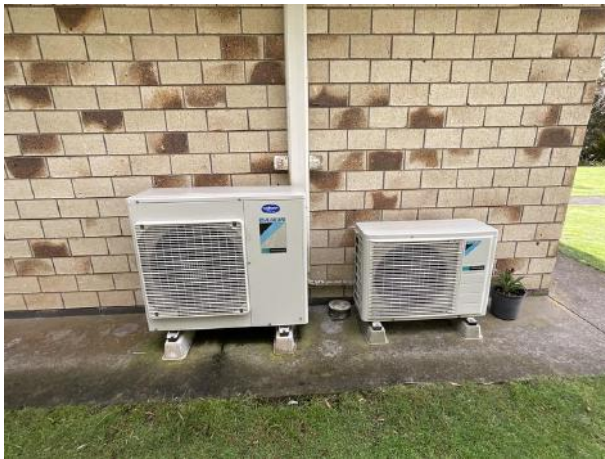
Photo 63

Exterior heat pump units located on the south side of the dwelling.

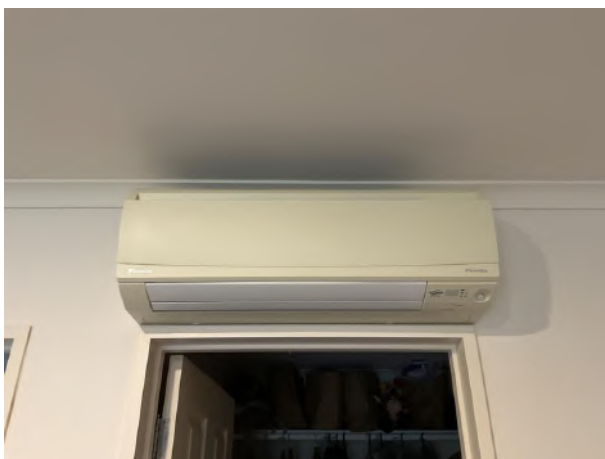
Photo 64

Daikin inverter heat pump located in bedroom one.

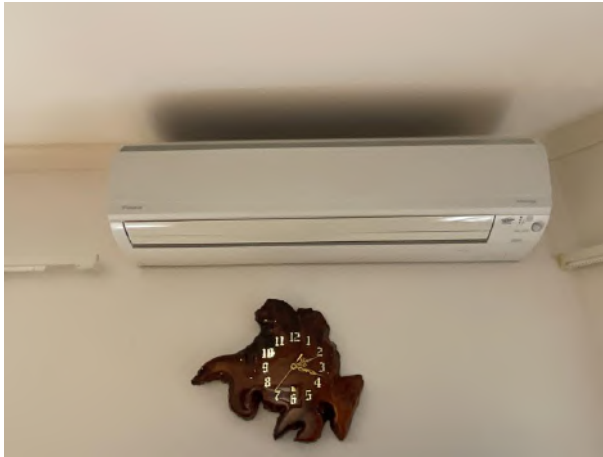
Photo 65

Daikin inverter heat pump located in the living room.

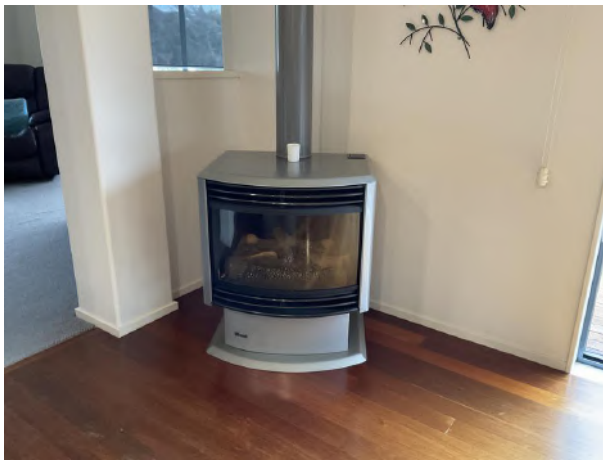
Photo 66

Rinnai freestanding gas burner located in the living room.

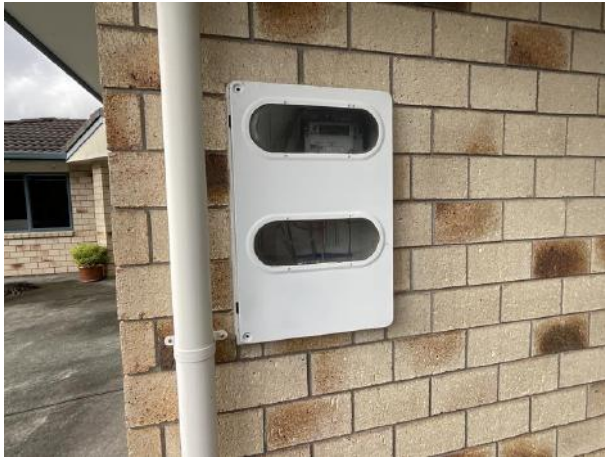
Photo 67

Metre box located on the west side of the dwelling.

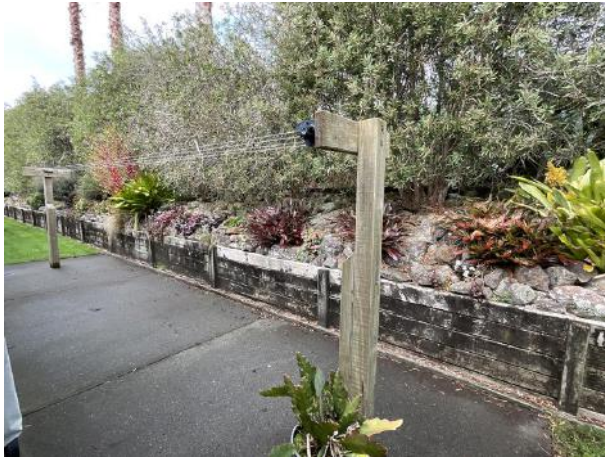
Photo 70

Clothes line located on the south side of the dwelling.

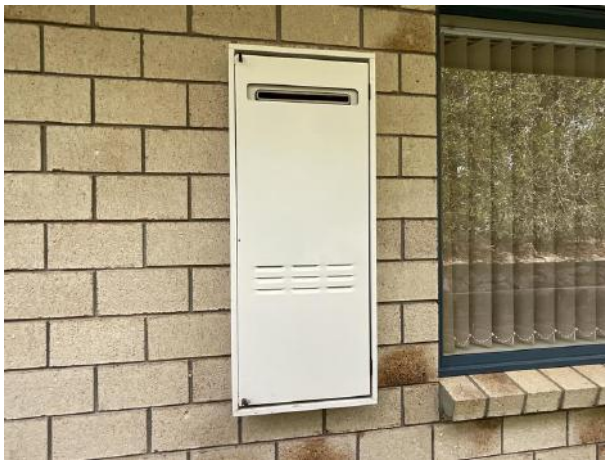
Photo 71

Gas Califont located on the south side of the dwelling.

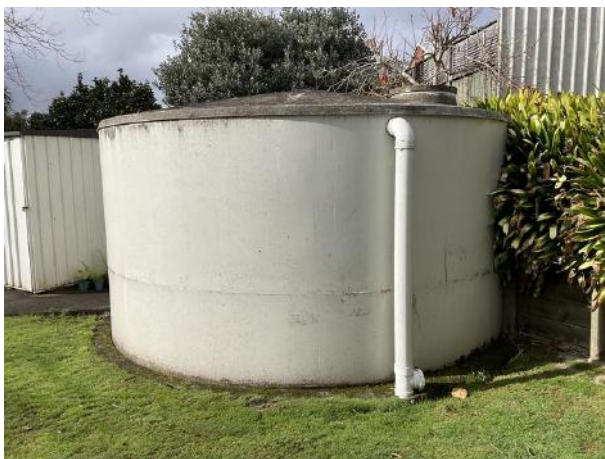
Photo 72

Concrete water tank located on the east side of the dwelling.

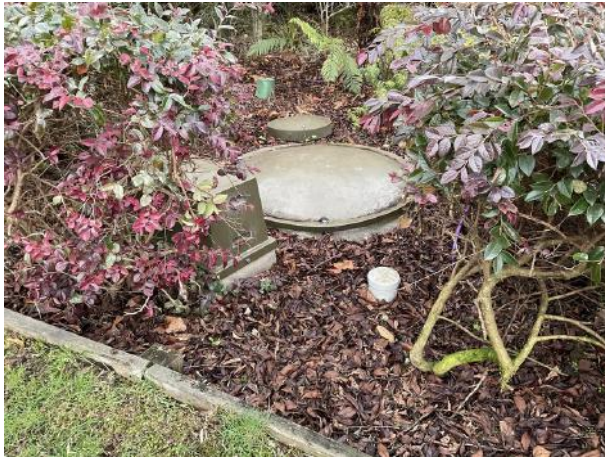
Photo 73

Septic tank system is located on the west side of the property.

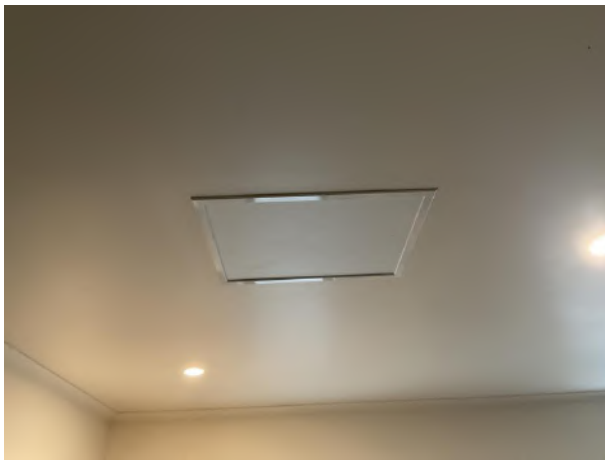
Photo 74

Roof space access located in the garage.

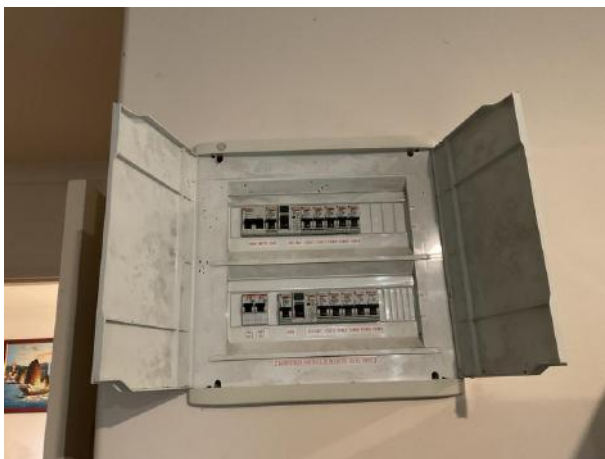
Photo 75

Distribution board located in the garage.

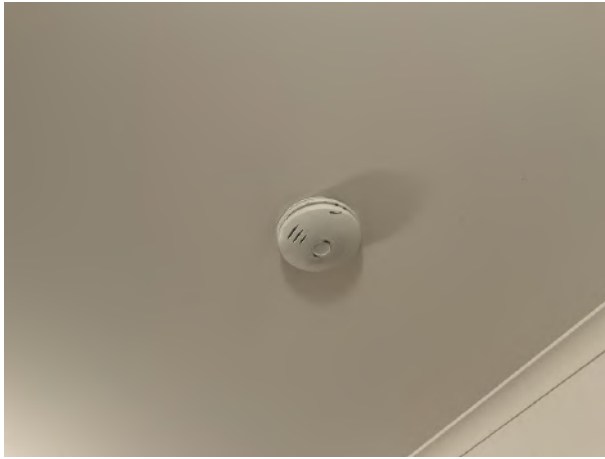
Photo 76

Smoke alarms located in the hallway.

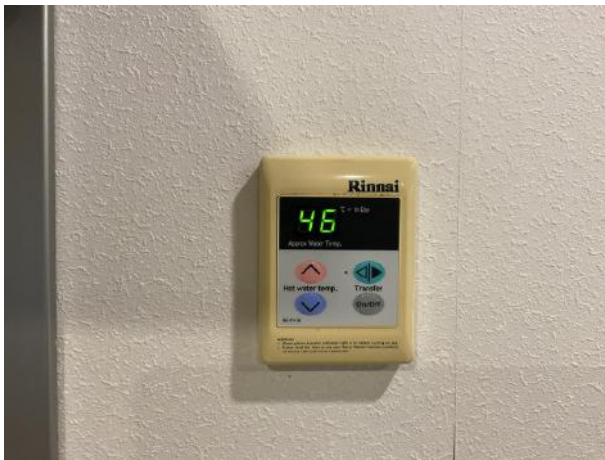
Photo 77

Rinnai Hotwater control panel located in the kitchen and bathrooms.

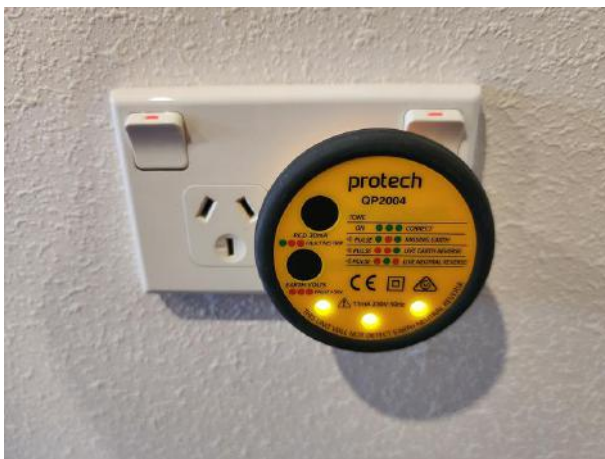
Photo 78

Example of electrical sockets tested throughout the dwelling.
