Building Report

PRE-PURCHASE BUILDING REPORT

Property Address	57A Mill Rd, Kensington, Whangarei, 0112, NZL		
Client	Meyer Real Estate		
Date of Inspection	14th August 2023	Time	10:00 am
Inspector	Jamie Mackintosh Licensed Building Practitioner Brick & Block		
LBP Number	116085		
Inspection Type	Pre-Purchase Report		
People Present	Inspector		
House Occupied	No

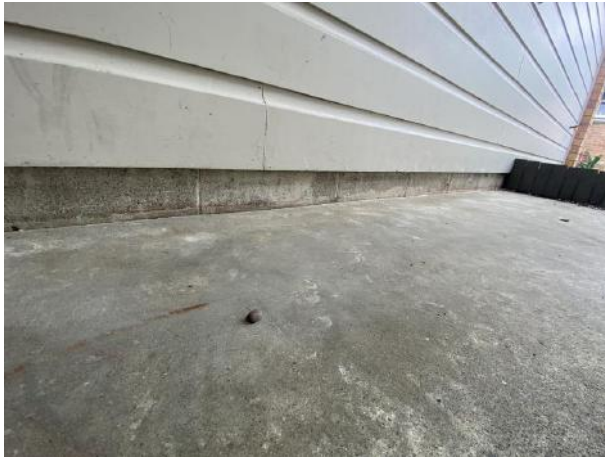
Photo 2

Masonry block foundation.

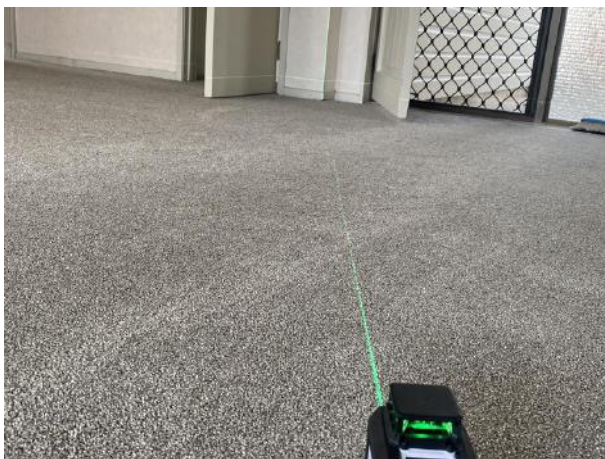
Photo 4

Floor levels checked using a self levelling laser level.

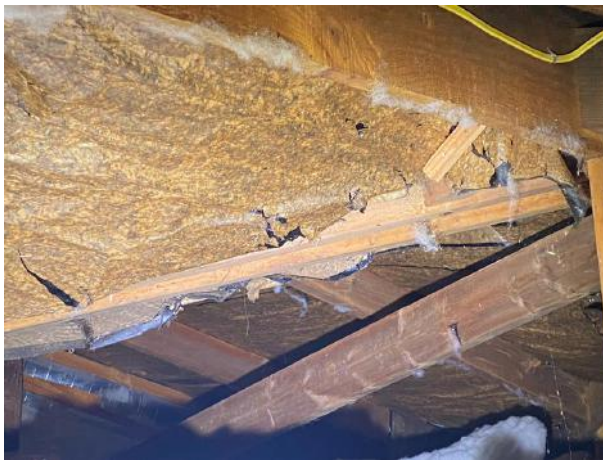
Photo 10

Roofing underlay - Bituminous self-supporting paper. Condition - Torn - Areas requiring re-fixing.

Areas of torn roofing paper throughout the roof space.

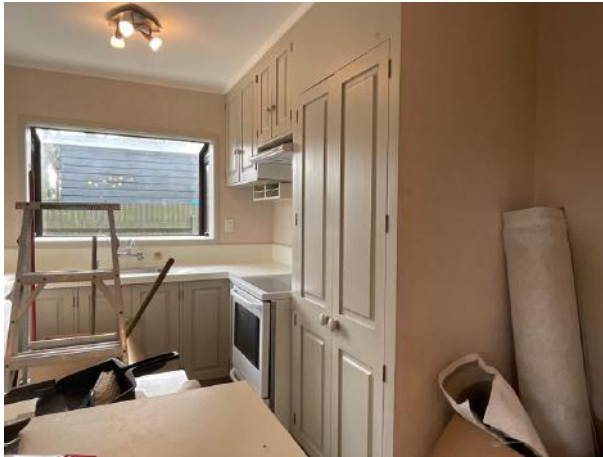
Photo 11

Kitchen.

Recommend having a registered electrician check for live wires and cover the open electrical socket under the bench.

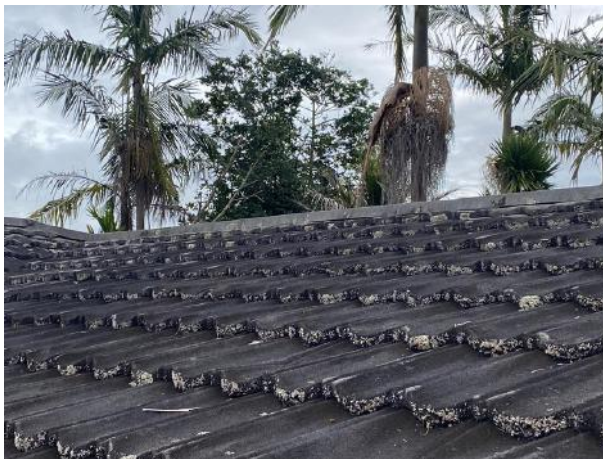
Photo 26

Pressed metal tin tile with a decramastic coating.

Dented tin tiles should be repaired or replaced. The dents will deteriorate the tile's coating, which can cause ponding of water and worst case leaks may occur. Have an LBP in roofing undertake any repairs & maintenance outside of the homeowner's skill level.

It is recommended to obtain a thorough assessment of the roof's condition by engaging a Licensed Building Practitioner (LBP) specialising in roofing to conduct a comprehensive inspection and prepare a detailed report.

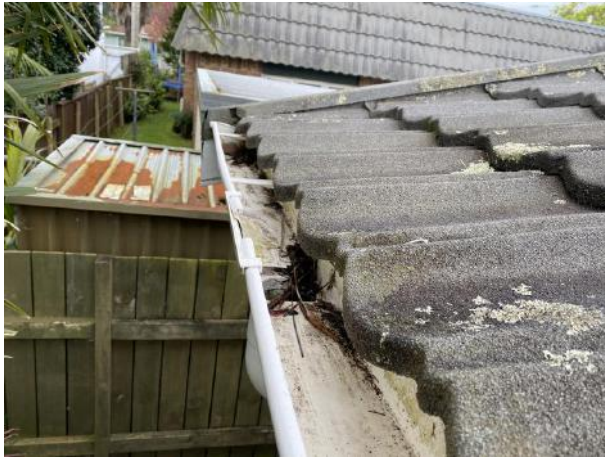
Photo 37

Example of PVC guttering. Clear at the time of inspection.

Recommend re-fixing the spouting brackets where required.

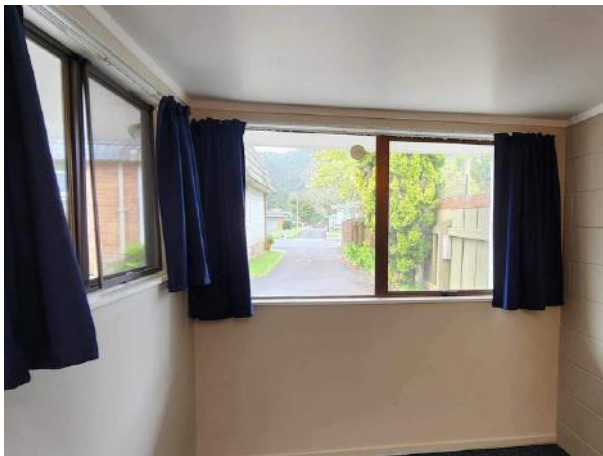
Photo 51

Example of aluminium windows with timber reveals.

The joinery needs to have any condensation/moisture addressed daily. To prevent the condensation from forming, the installation of a positive airflow ventilation system such as an HRV, DVS, I-Vent or similar should be considered. These greatly reduce any moisture in the home.

It is recommended to install suitable flashings to the exterior joinery.

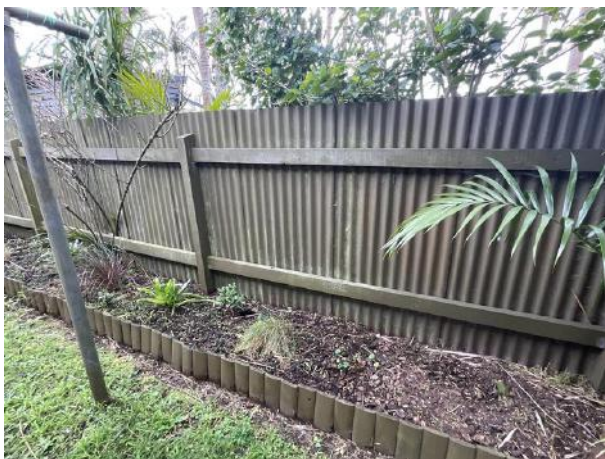
Photo 62

Timber framed profiled metal fence located on the northern boundary.

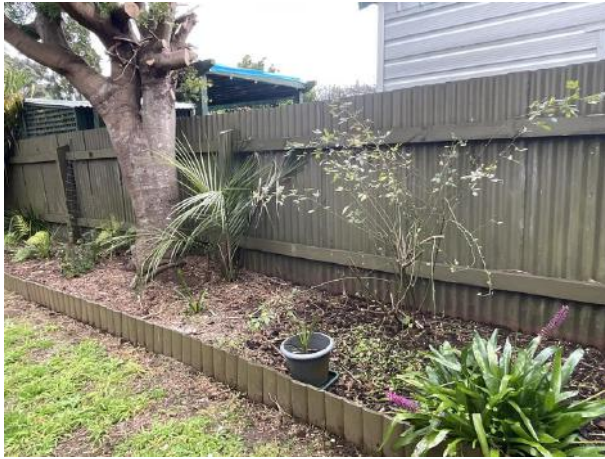
Photo 63

Timber framed profiled metal fence located on the western boundary.

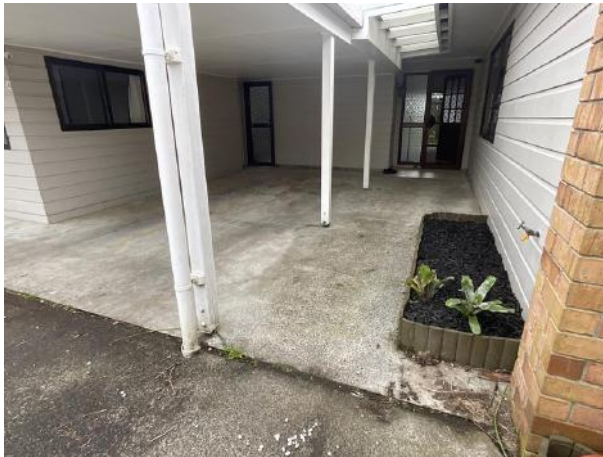
Photo 69

Covered concrete path leading to the front entrance, located on the east side of the house.

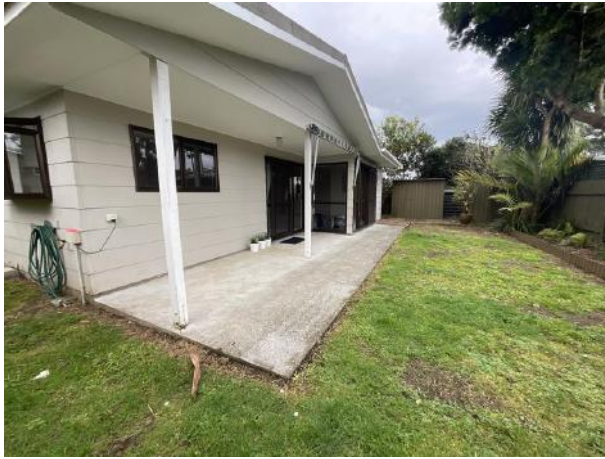
Photo 71

Concrete patio area off the dining and lounge, located on the west side of the house.

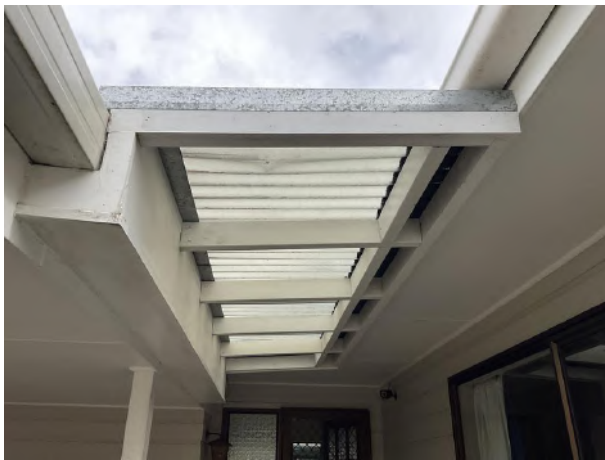
Photo 72

Timber framed roof with polycarbonate roofing over the front entrance.

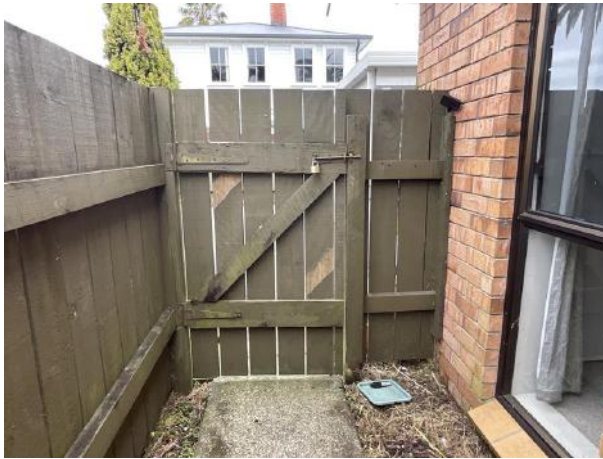
Photo 73

Timber gate located on the east side of the house. Gate is locked and unable to be tested.

Recommend regular lubrication of the hinges and latch to maintain full function.

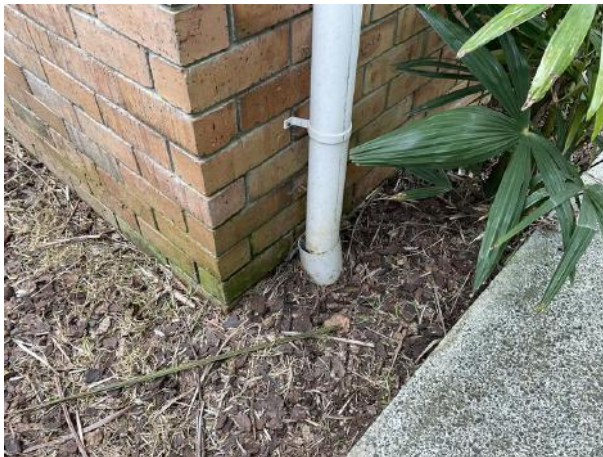
Photo 75

Example of a stormwater riser.

Keep vegetation and soils clear of drainage.

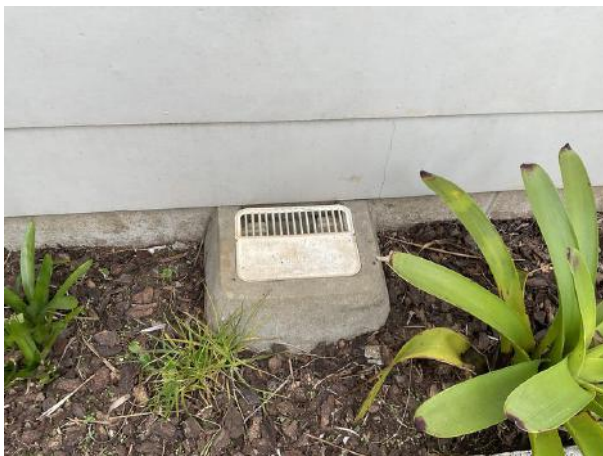
Photo 76

Gully trap located on the north side of the house.

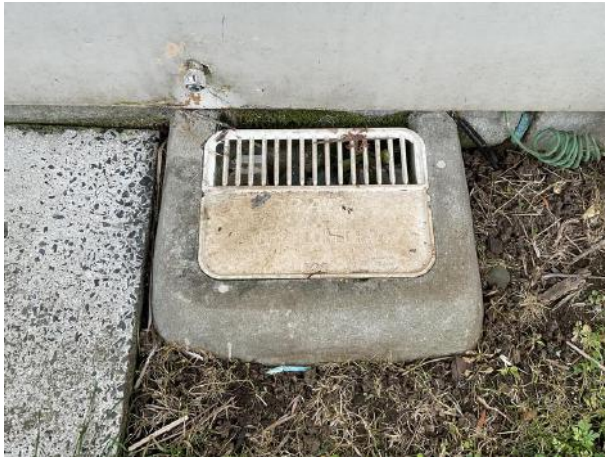
Photo 77

Gully trap located on the north side of the house.

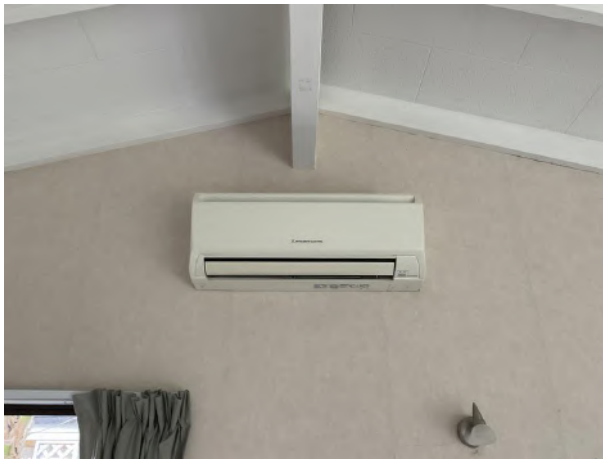
Photo 78

Mitsubishi electric heat pump located in the lounge.

Service as per manufacturer's recommendations. Clean heatpump filters every 4 - 12 weeks depending on the placement of the unit.

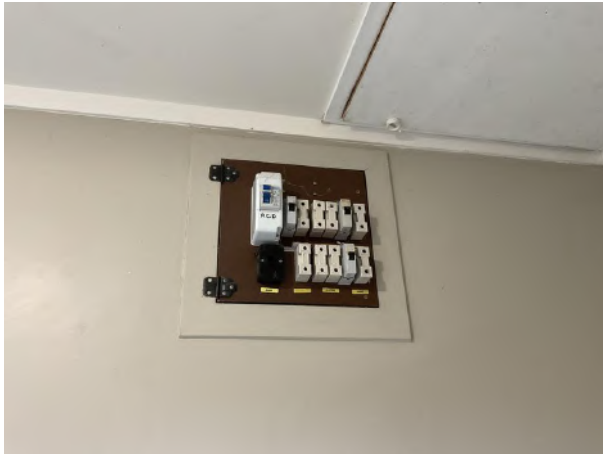
Photo 80

Distribution board located in the laundry.

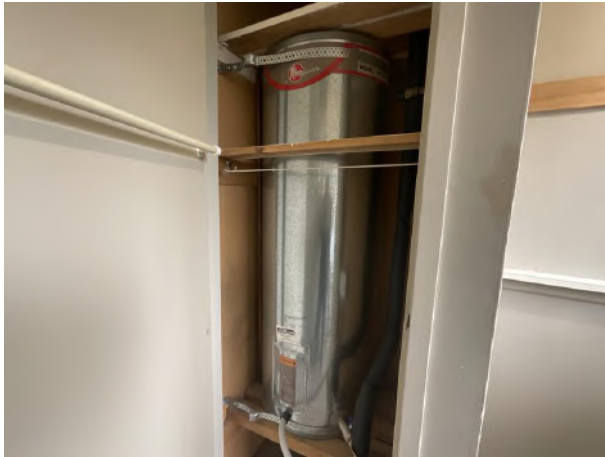
Photo 82

Hot water cylinder located in the laundry cupboard.

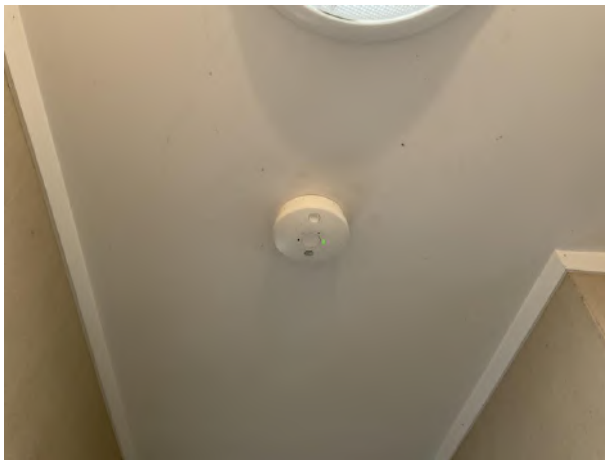
Photo 83

Example of a smoke alarm located in the hallway, bedroom two and lounge.

Fire and Emergency New Zealand recommend installing a smoke alarm in every bedroom, hallway, and living area and a minimum of one smoke detector fitted to every level of two-storey homes. You may also choose to install a heat alarm in the kitchen, laundry, bathroom or garage.

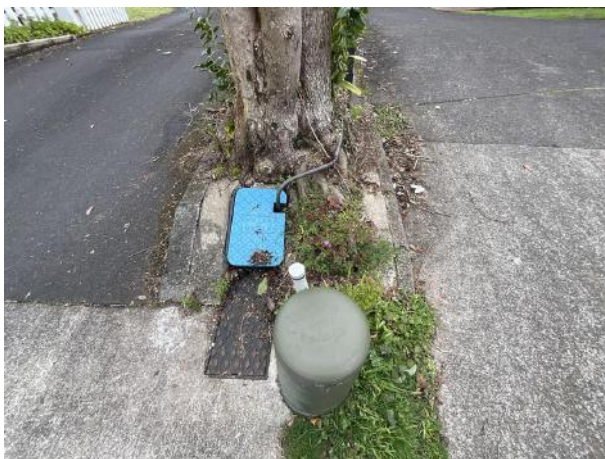
Photo 84

Water toby located on the southeast boundary.

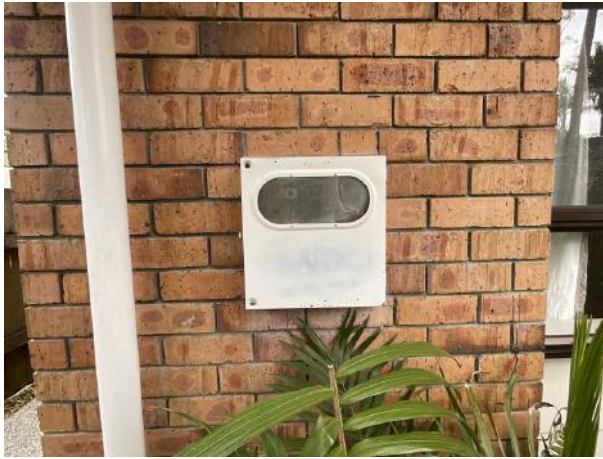
Photo 85

Metre board located on the north side of the house.

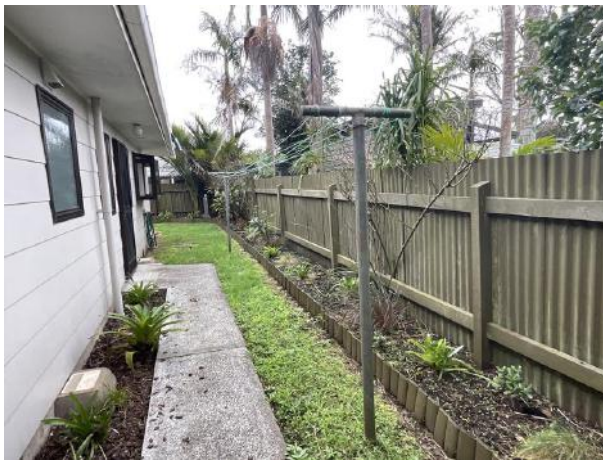
Photo 86

Clothesline located on the north side of the house.

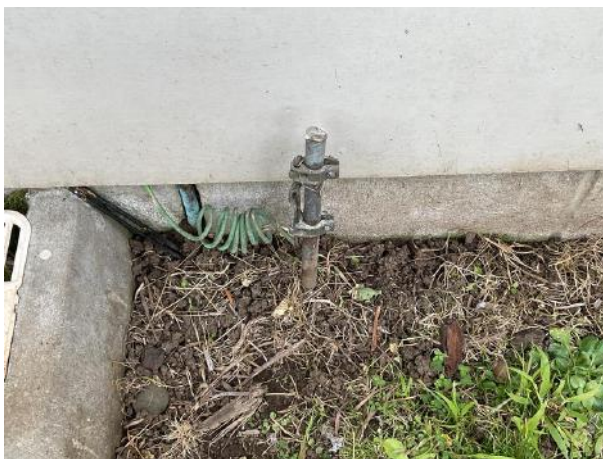
Photo 87

Earth Peg located on the north side of the house.

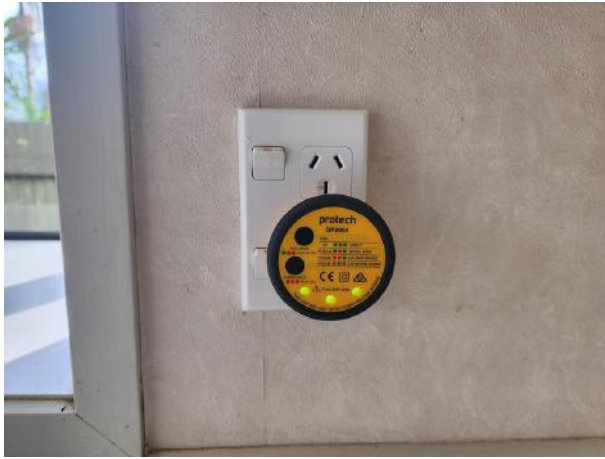
Photo 88

Example of electrical sockets tested throughout the house.
