# Building Inspection Report

Client: Paul Sumich - Bayleys  
Location: 74 Cartwright Road  
Onerahi  
Whangarei

Inspection Date: 09/08/2022

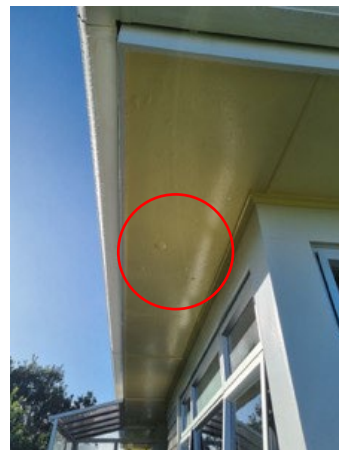
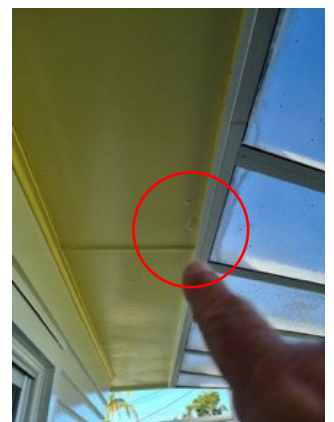
Paint is bubbling in soffit in a couple of areas as per photos

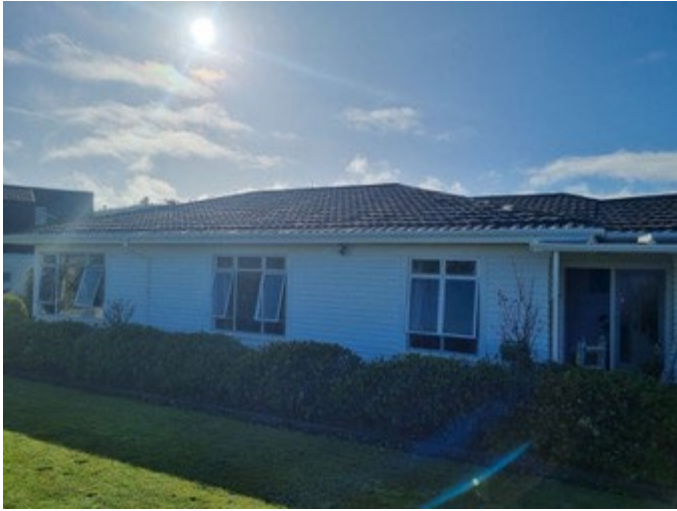
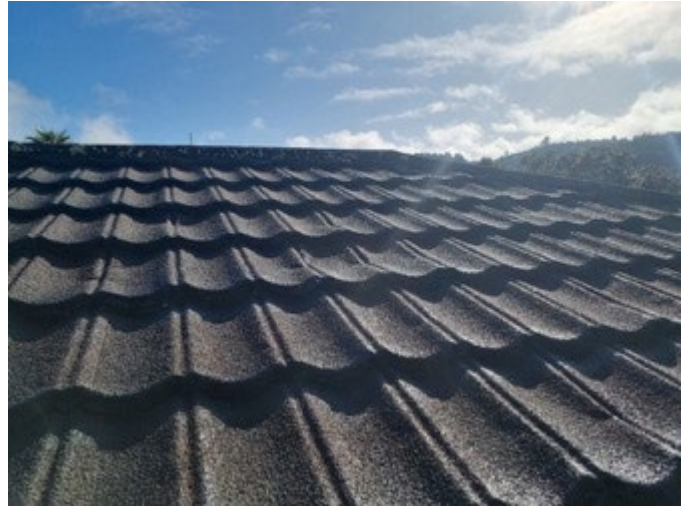
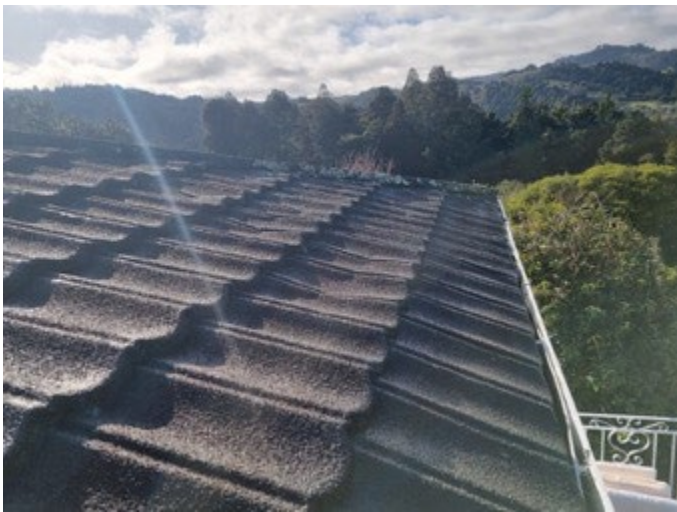
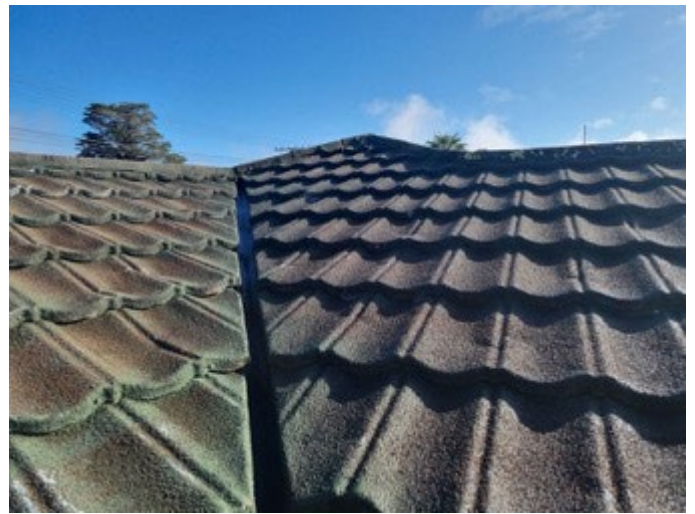
The decramastic roof tiles are due for maintenance (recoating)

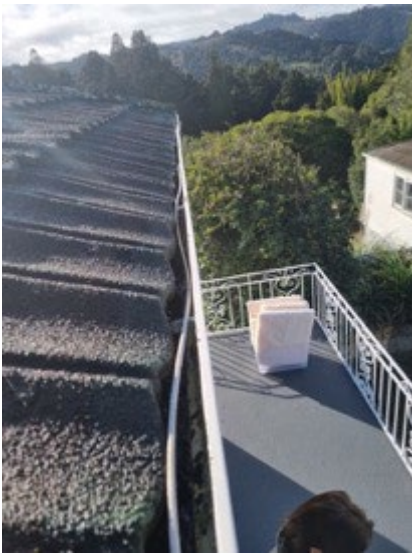
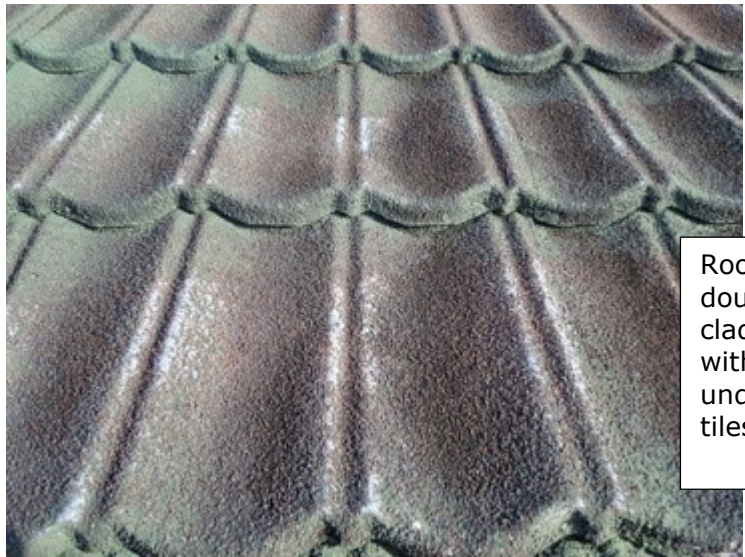
Roof has double cladding with iron under the tiles

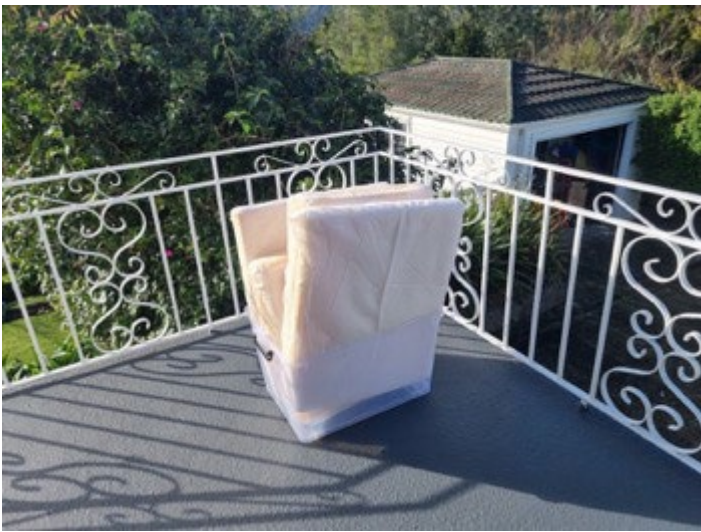
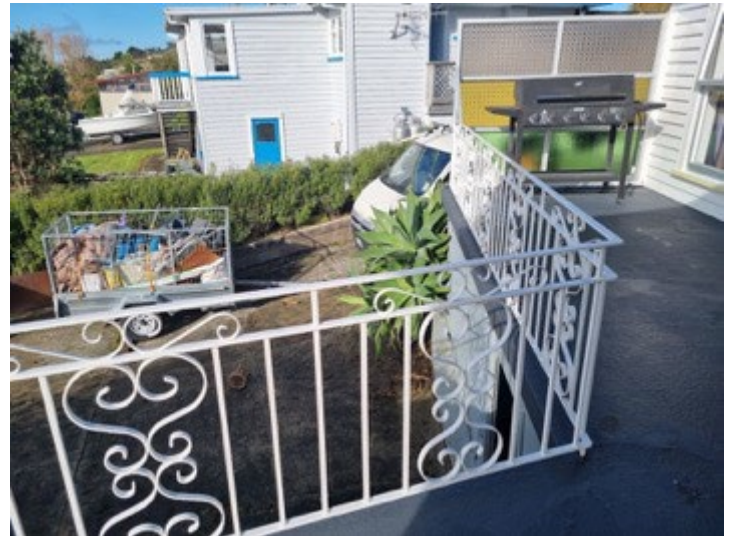
Deck handrail does not comply to today's building standards due to its low height, however it would of complied at the time if consented

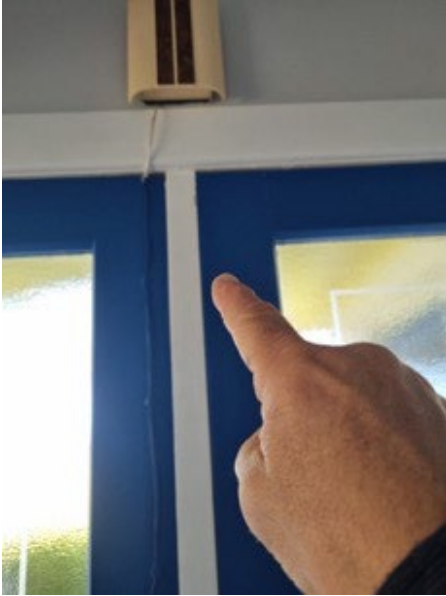
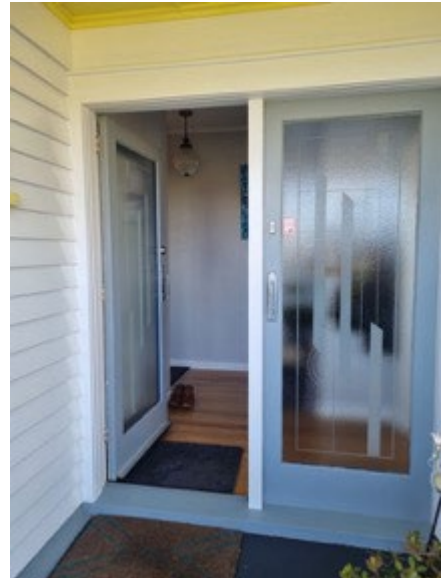
Front Entry

Front door needs a shaving, so it closes

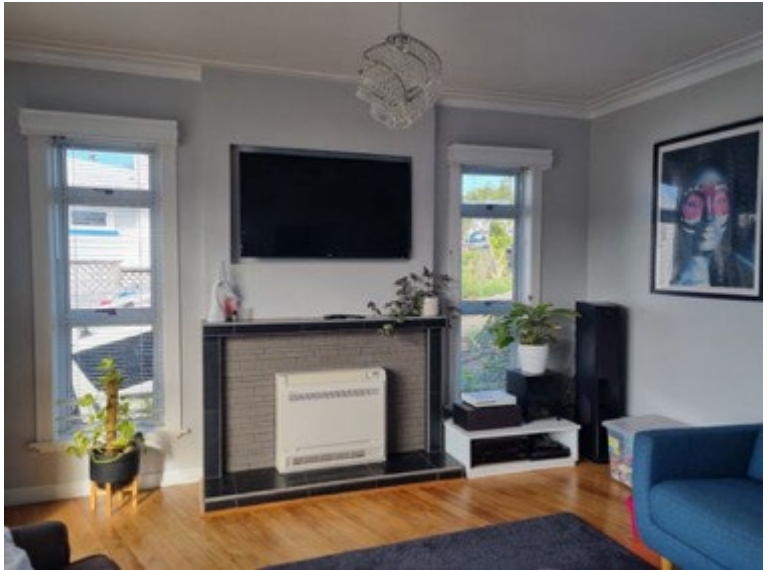
No access on left for moisture reading.

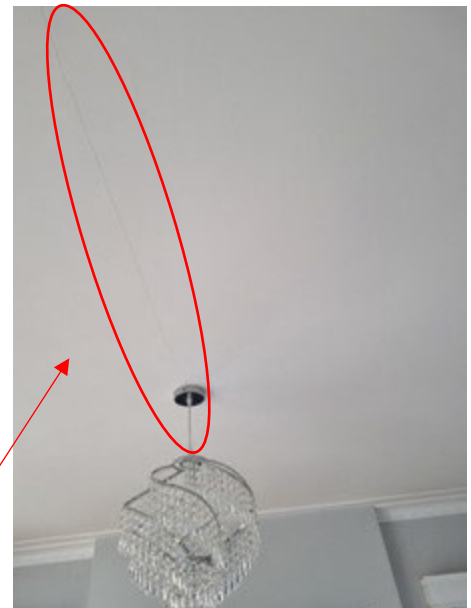
Ceiling has minor cracks in the fibrous plaster throughout due to possible movement over the years

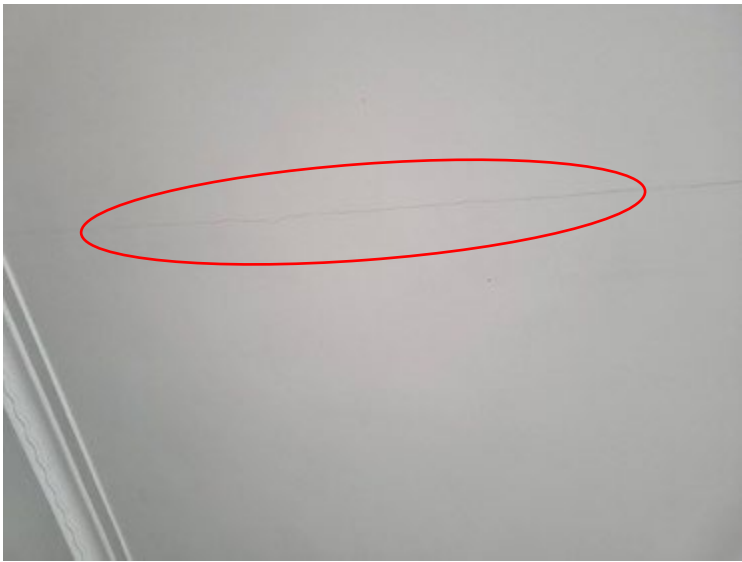
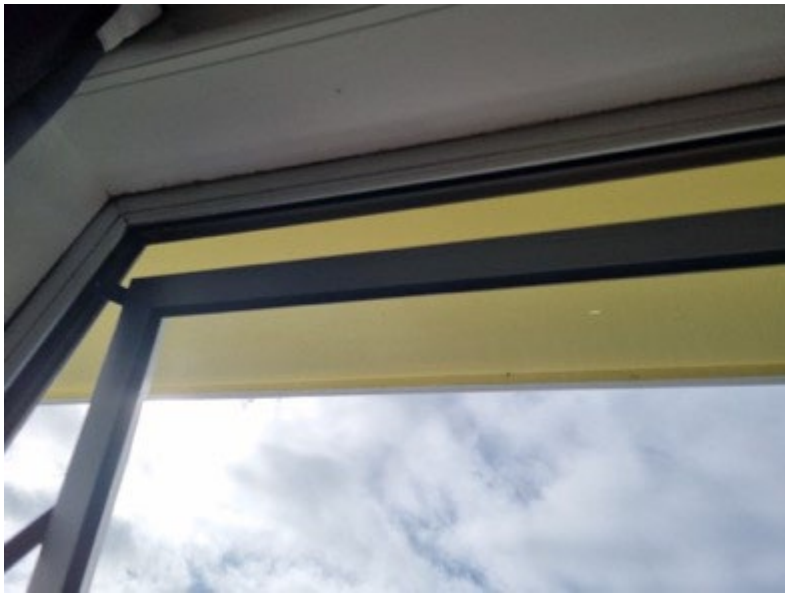
# Dining

For best practice the windows up high ie dining, office & bathroom need window stays so children cannot climb out and would not comply with today's current building standards.

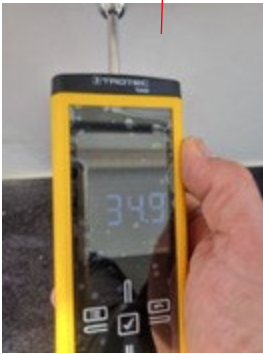
# Office

No access on the right side for reading

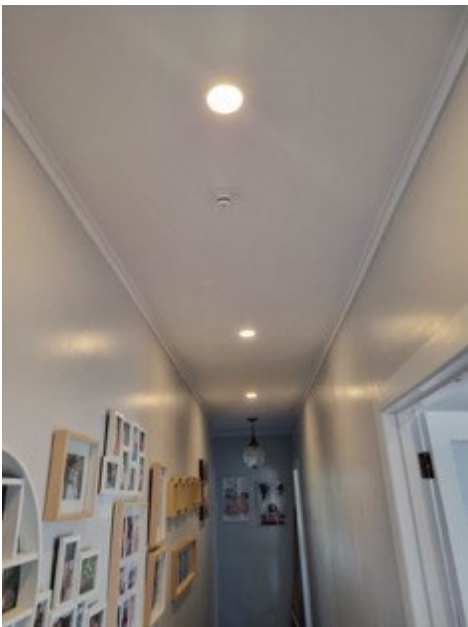
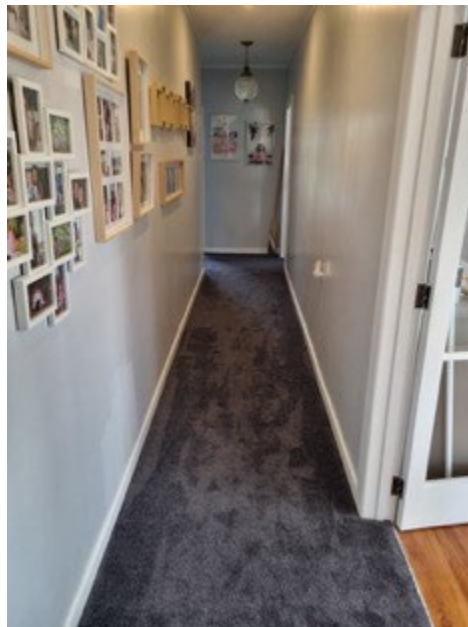
Walls have minor cracks in the gib plaster (or alike) throughout

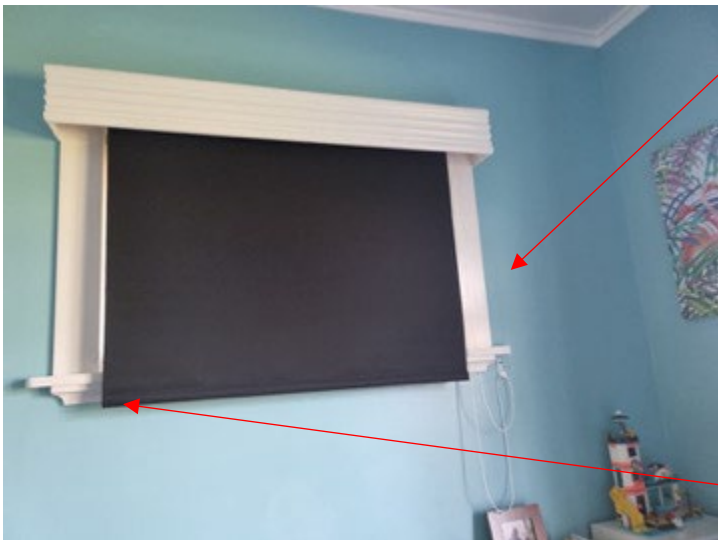
No access on the right for moisture reading.

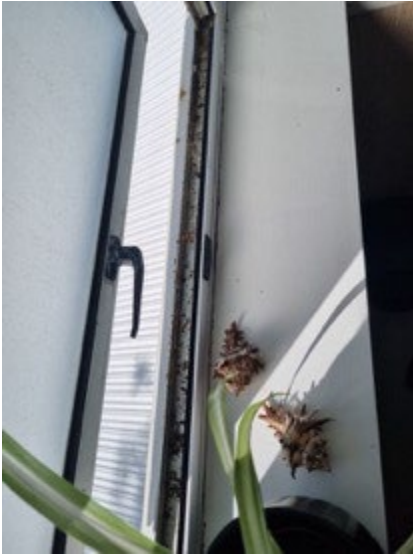
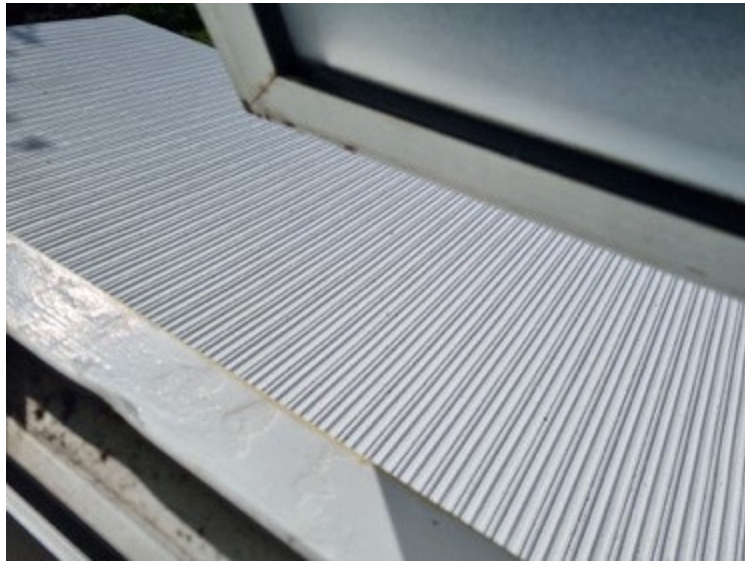
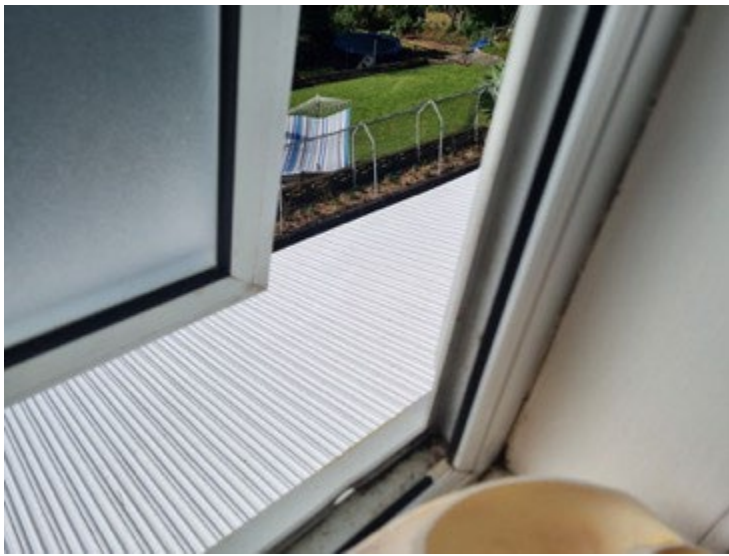
Joinery windows in ensuite & main bathroom are having trouble opening/closing

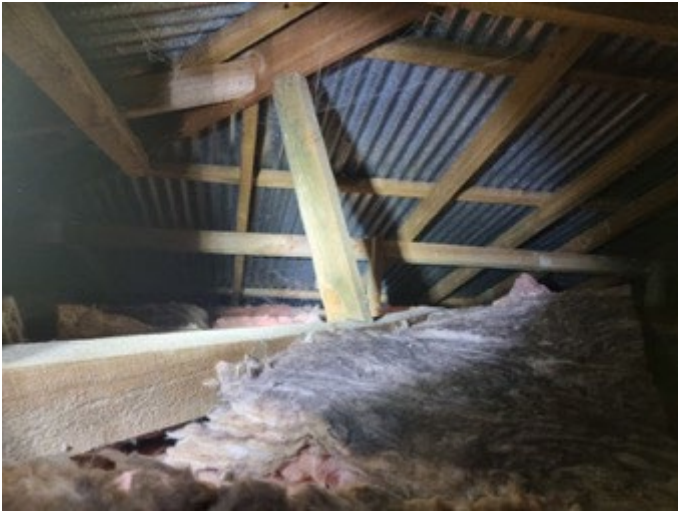
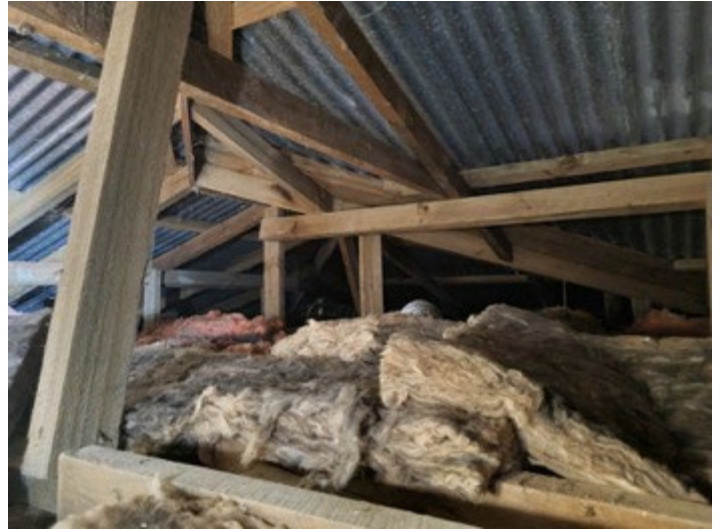
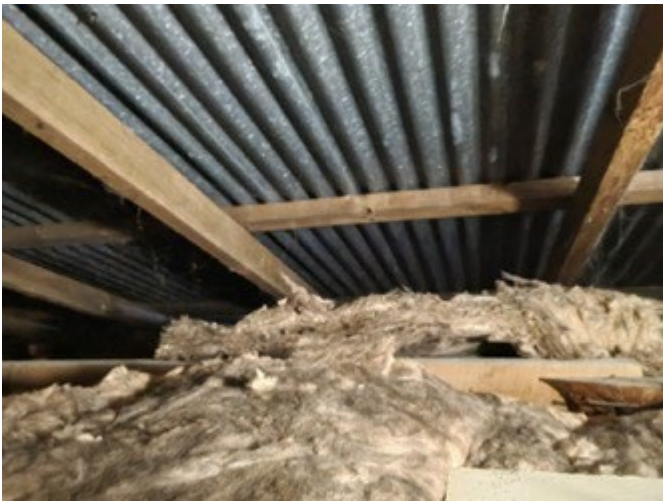
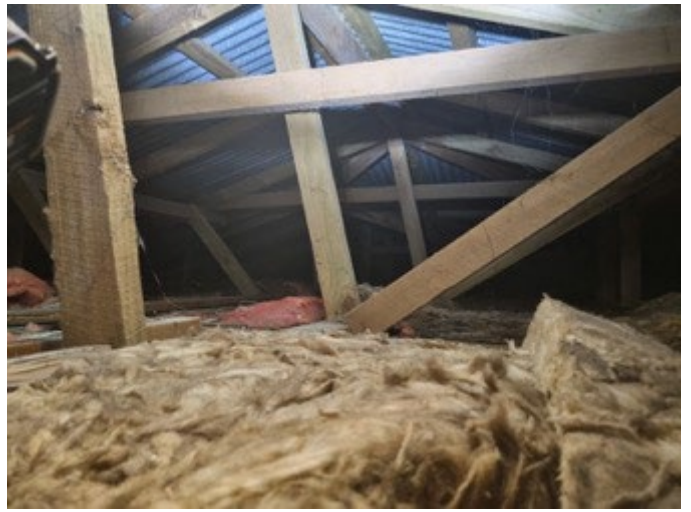
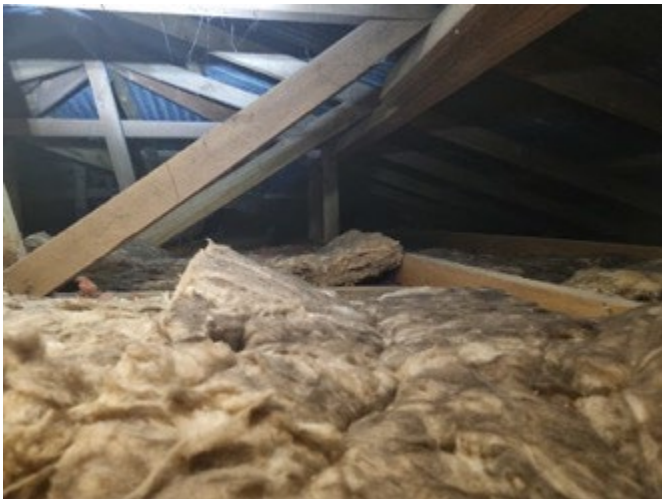
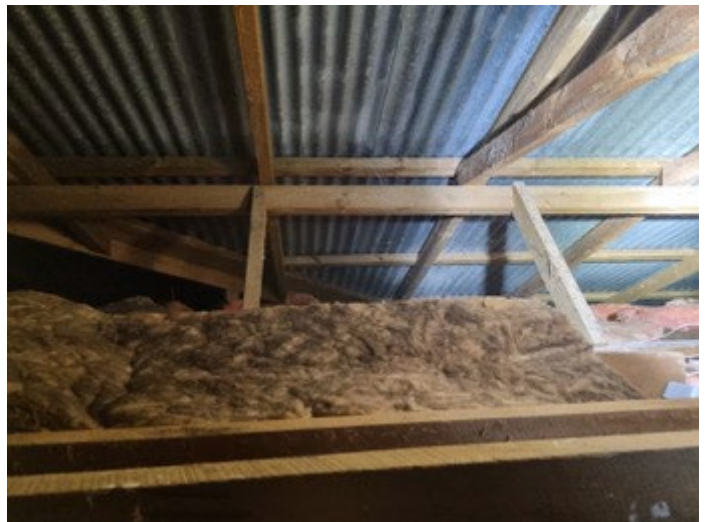
Roof space has no building paper which is typical of this age home

Roof structure appears sound

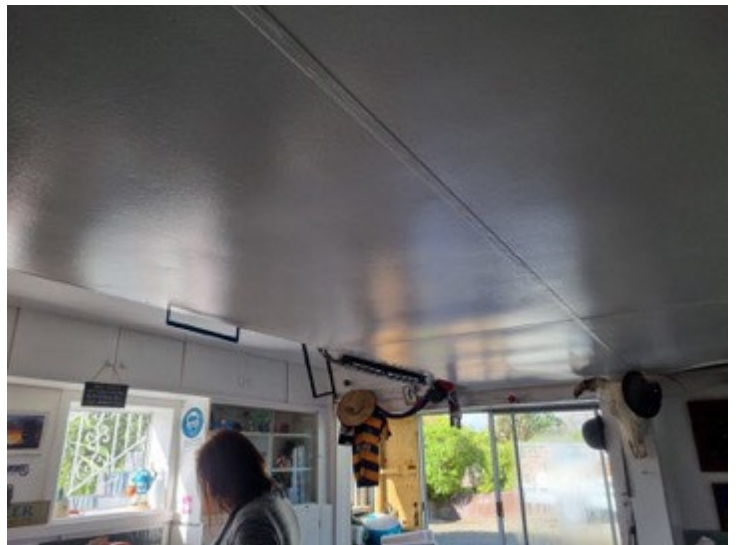
Bar area has high moisture readings and ranch slider has rotting wood bottom right hand side.

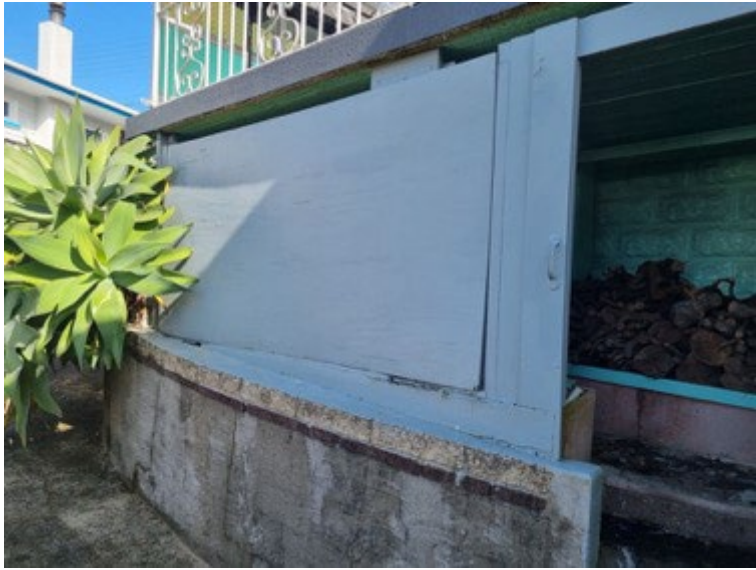
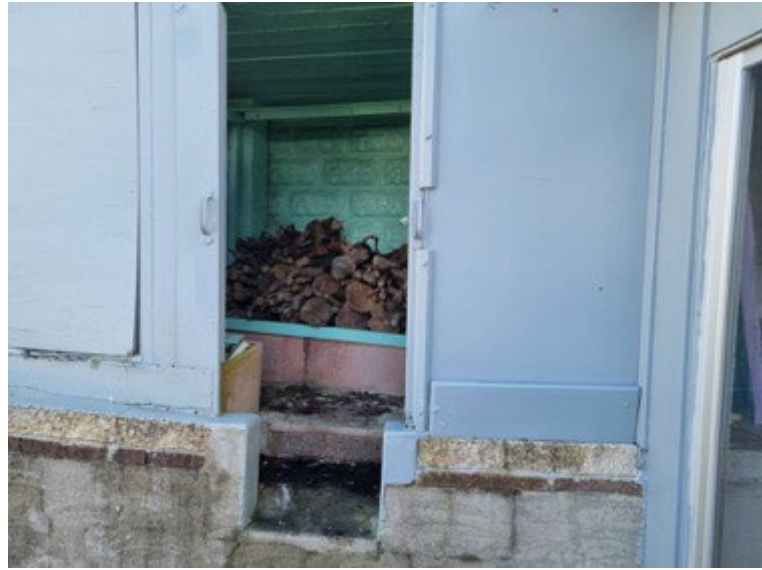
Decorative Plywood enclosure for firewood is rotting in parts
