# Building Inspection Report

Client: Paul Sumich - Bayleys  
Location: 3 Tullamore Lane  
Maunu  
Whangarei

Inspection Date: 30/08/2022

RE: Building Inspection Report, 3 Tullamore Lane, Maunu, Whangarei.

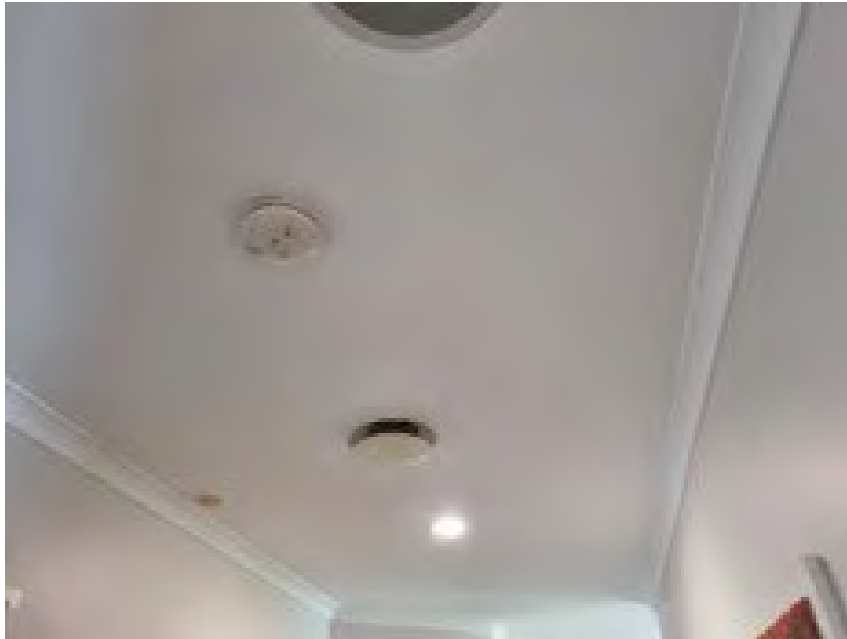
2x in hallway

No testing was done on the alarms to check if they are working.  
We recommend a smoke alarm be present in every sleeping quarter, the room closest to the kitchen, the lounge and in each level of your home.

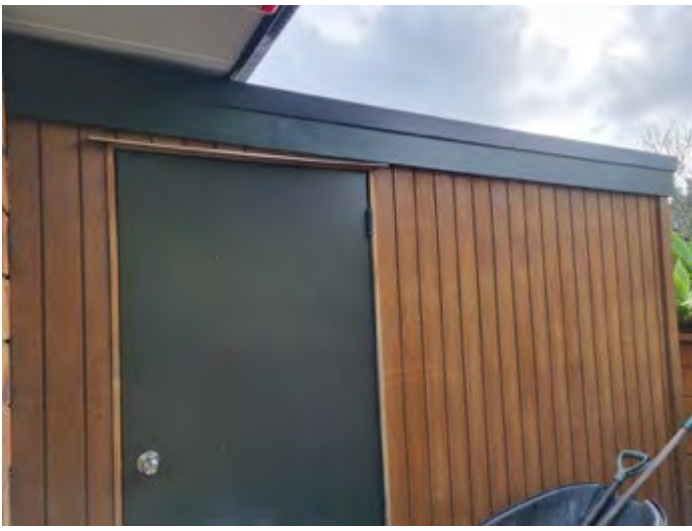
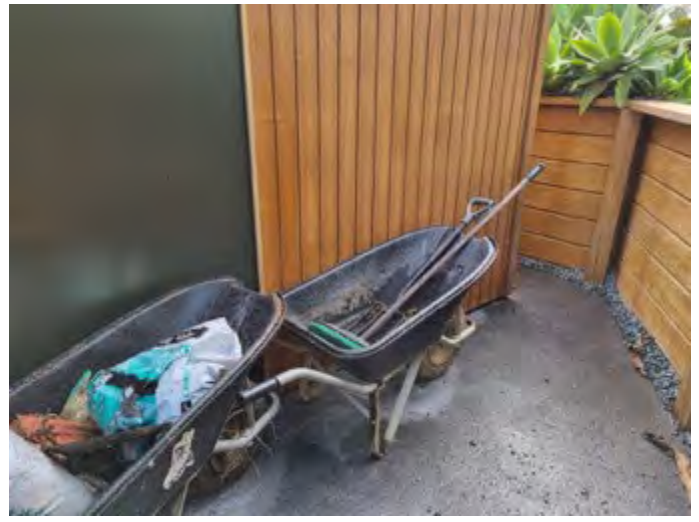
Single Garage attached to house was not inspected inside due to being locked

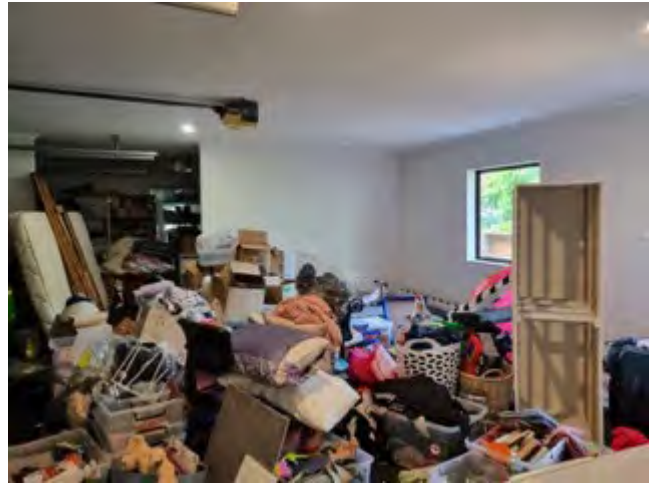
Window in garage workshop area was not moisture tested due to obstacles in the way

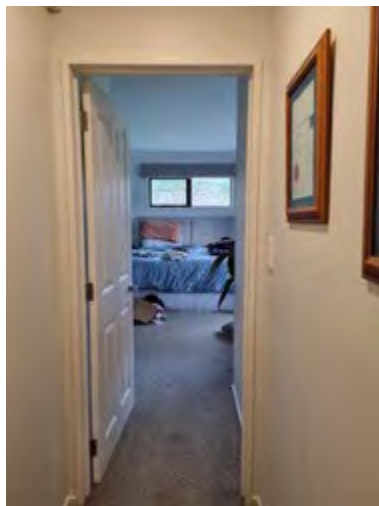
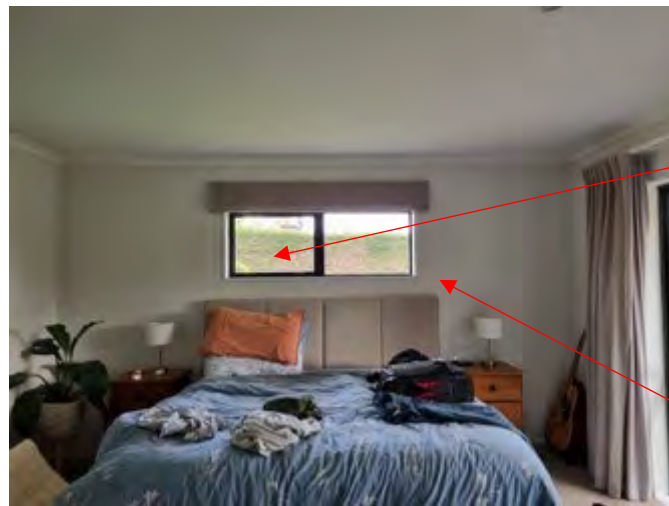
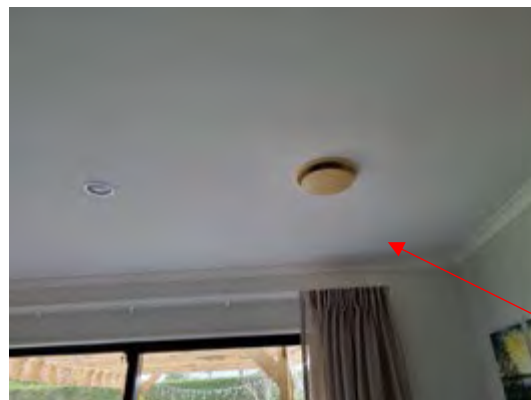
### Master Bedroom

Heat transfer system
